Hikurangi Swamp Floodway Riparian and Ox-Bow/Cut Off Channel Management Plan

March 2017

Whangarei District Council

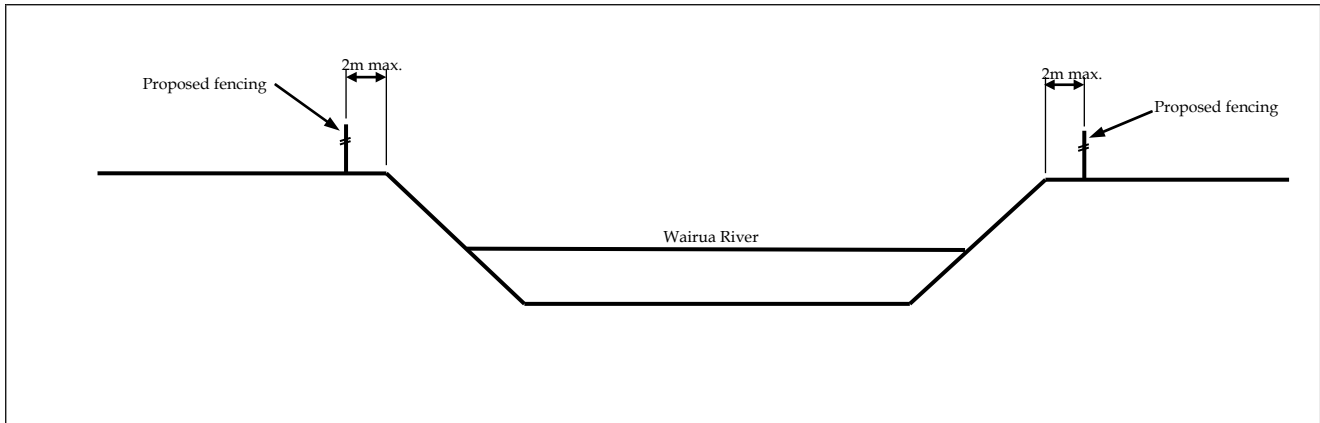
Figure 6.1: Typical Cross-section along main river bank

Figures 6.1 and 6.2 show a typical cross-section along the main river bank, and a typical cross-section along an oxbow/cut-off channel respectively.

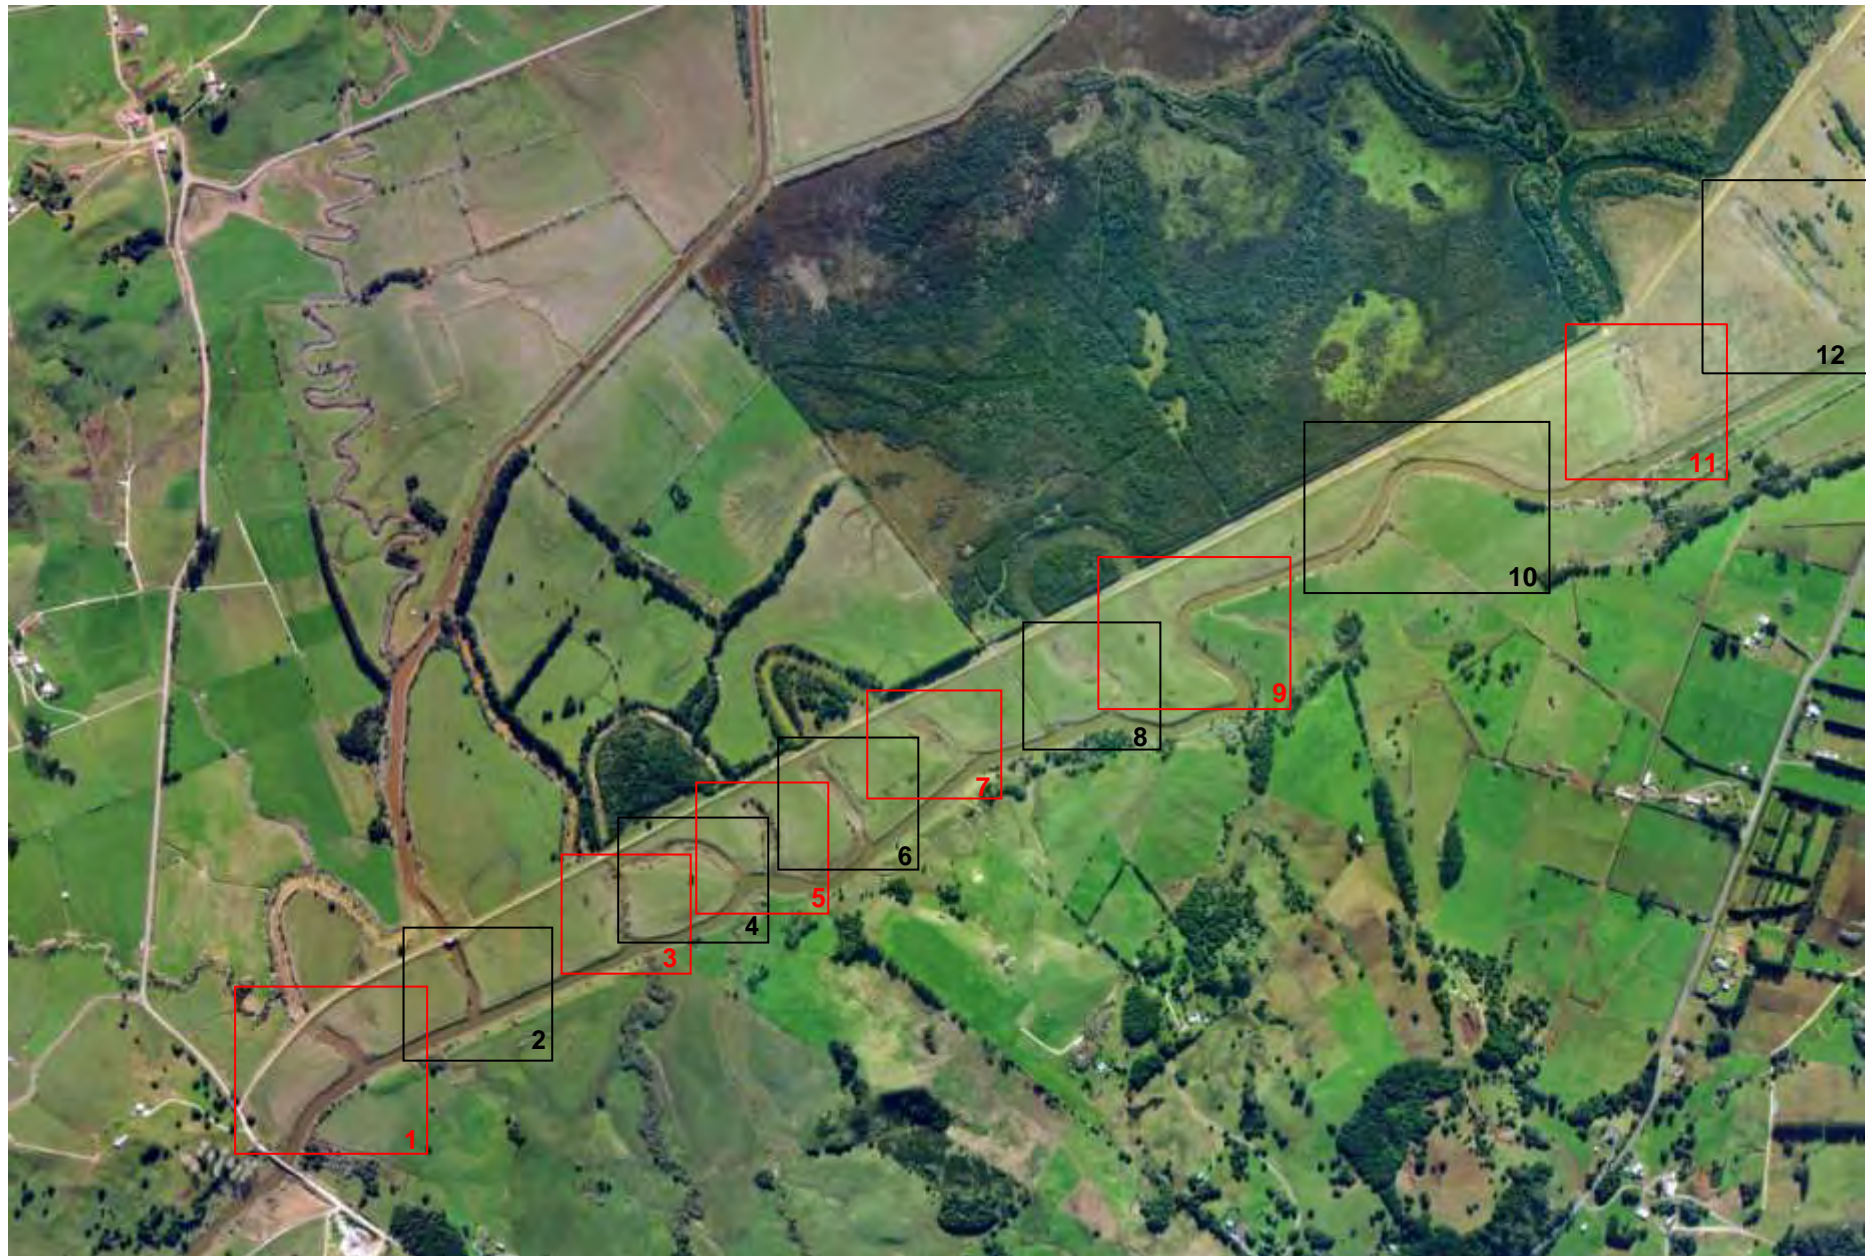
Figure 6.3: Index Plan Showing sites 1 to 12

The location of fences is indicative only and would be subject to agreement between stakeholders.

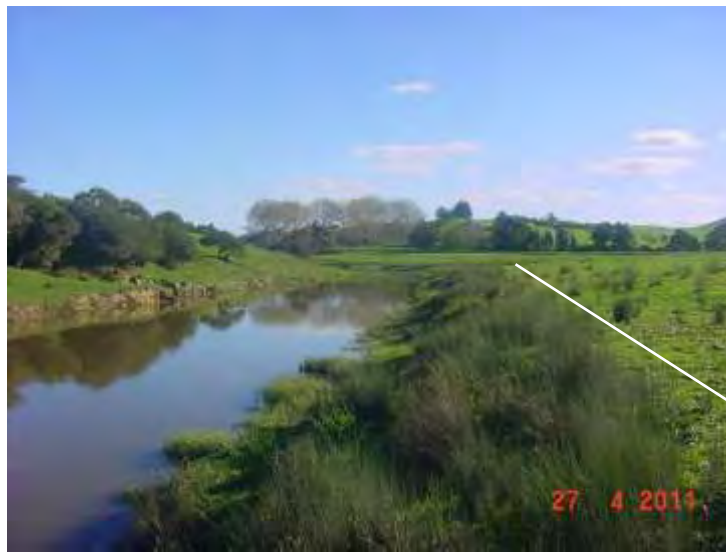
Photo 7: Site 2 – Riparian Margins of Wairua River Channel Looking Downstream

Fencing

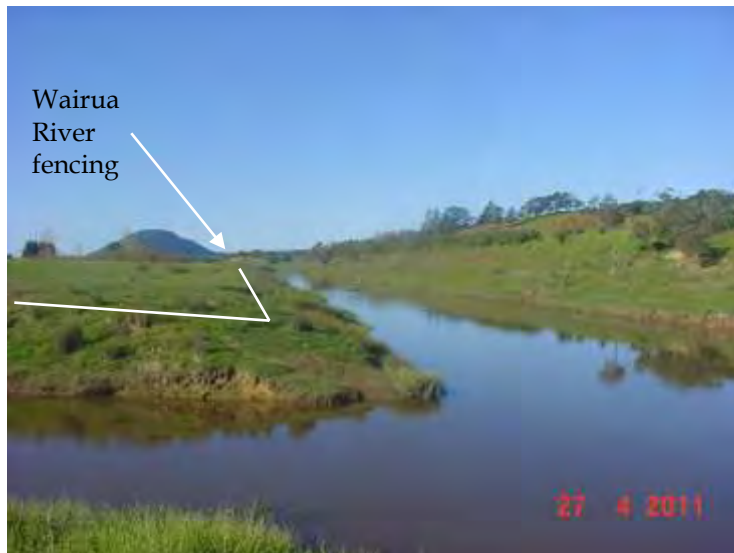
Wairua
River
fencing

Cut-off
channel
fencing

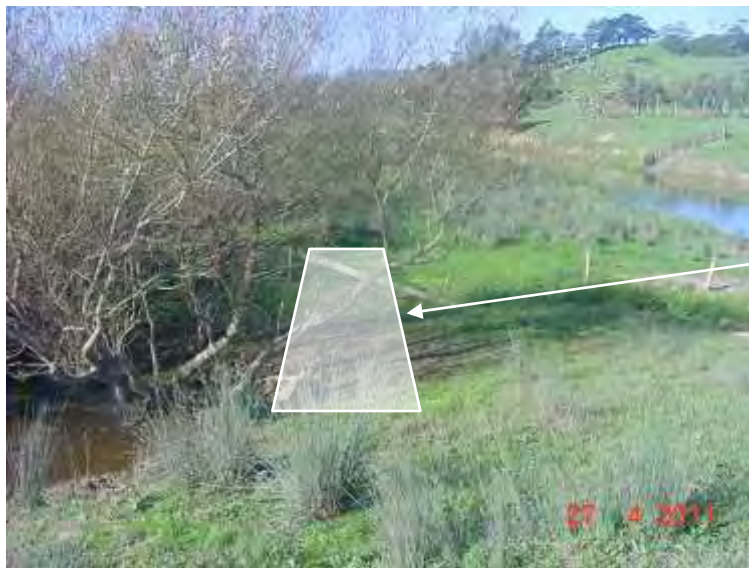
Photo 11: Site 3 – Cut-off Channel Showing Possible Location of Bundwall

Increase height
of existing
bundwall

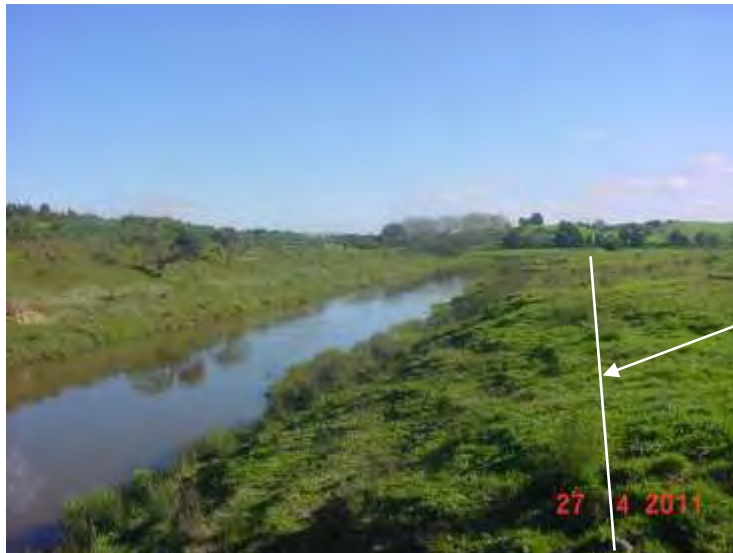
Photo 12: Site 3 – Riparian Margins of Wairua River Channel Looking Downstream

Fencing

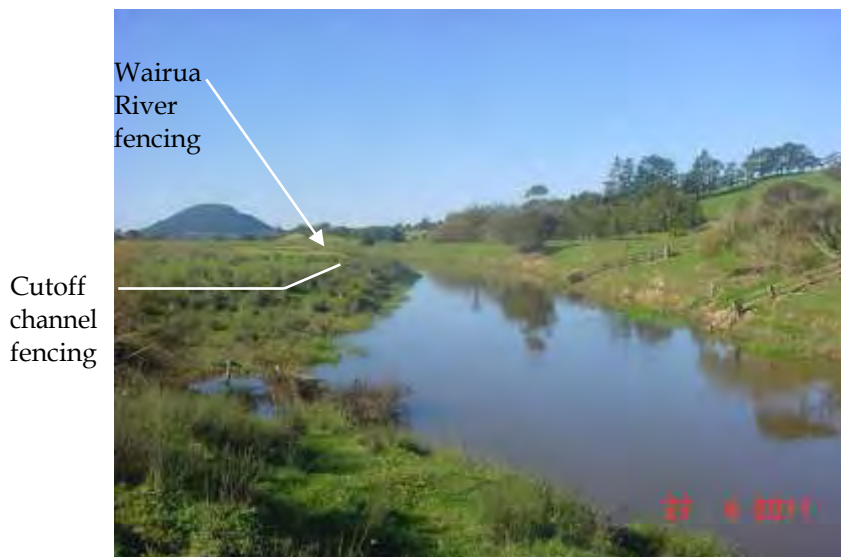
Wairua
River
fencing

Cutoff
channel
fencing

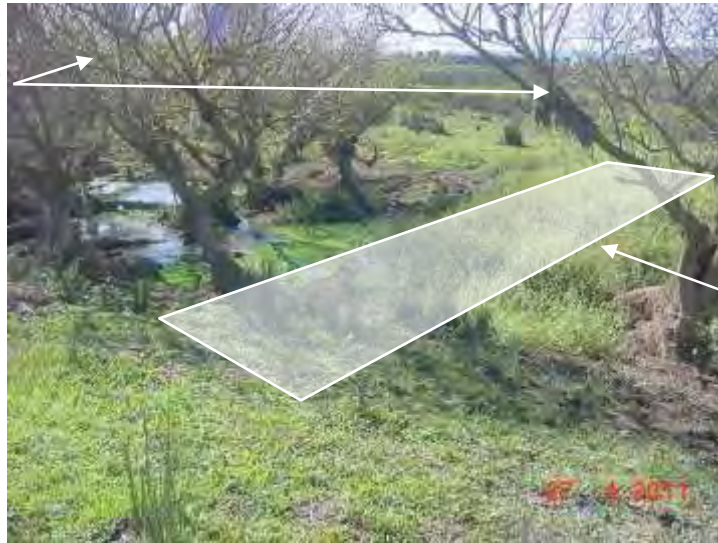
Photo 47: Site 12 - Cut-off Channel Showing Possible Location of Bundwall

Remove
Crack
Willow

Increase height of
existing bundwall

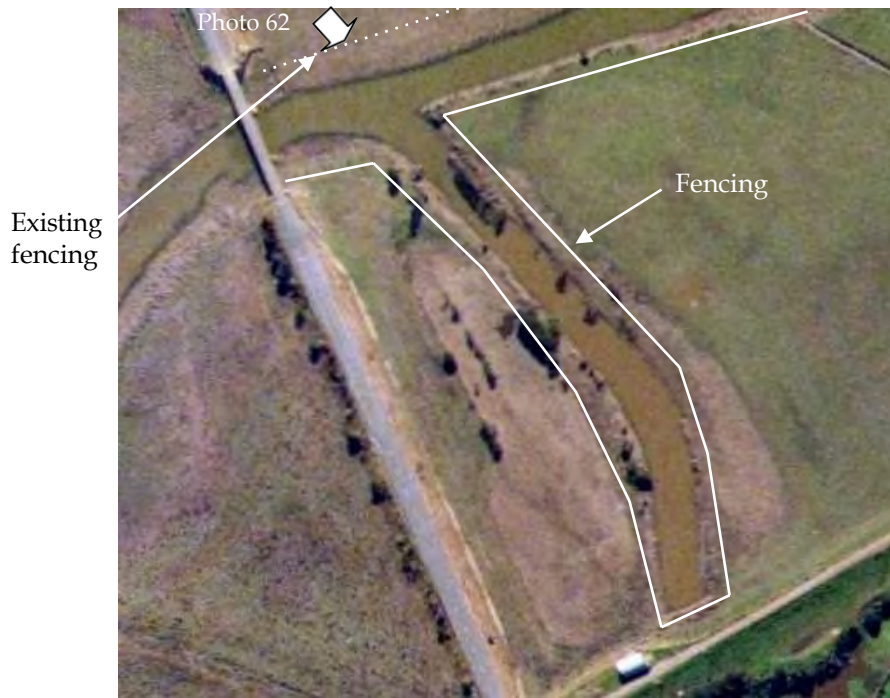
Photo 63: Site 17 - Cut-off Channel Looking Upstream

Existing Wairua River
fencing (single electric
wire on permanent
posts, 1 - 2m back from
top of bank

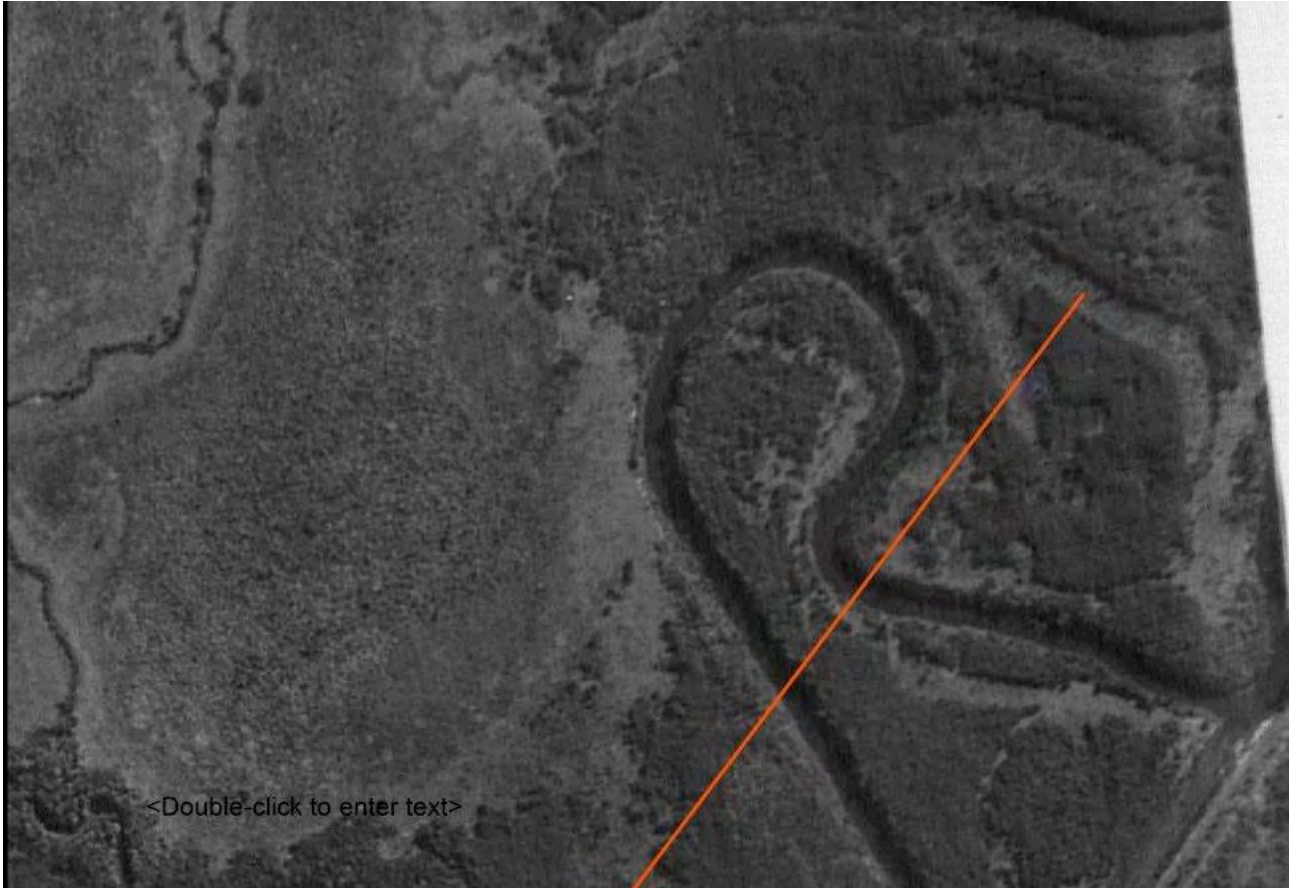
Diagram 3: Extent of vegetation of Oxbow 2 in 1942. (photography courtesy of DOC)

Explanation	Excavation works should be carried out to create shallow ephemeral wetland habitat, similar to what appears to have been present in the 1942 aerial photos (diagram 3). A mix of <u>wet root tolerant</u> manuka (i.e. manuka grown from seed collected from plants growing in wet conditions), along with mixed sedge species should be used based on those present in the Wairua Reserve, such as <i>Carex maorica</i> , <i>C. virgata</i> , <i>C. lessoniana</i> , <i>C. subdola</i> , <i>Machaerina articulata</i> and <i>Eleocharis acuta</i> .																
Approx. size	Dependant on the amount of excavation carried out. Potentially up to 7,500 m ² .																
Timing	Excavation of the site in January-February 2017. Planting to be done in April 2018 (pre-duck shooting season). This allows the excavated wetlands to be left for a winter and summer to assess peak water levels and to allow further pest plant control prior to planting.																
Spacing	Wet root tolerant manuka can be cluster planted through the site at one metre centres. Sedges can be cluster planted at 500mm centres depending on habitat suitability. Plant approximately 1,000 manuka and 10,000 mixed sedges (25% cover at 500mm centres). Broadcast additional sedge/wetland plant seeds through the non-planted areas (first ensure that pest plants are sprayed out prior to broadcast), thus spreading seed into the non-planted areas from both physical broadcasting and natural ongoing seeding from the planted clusters.

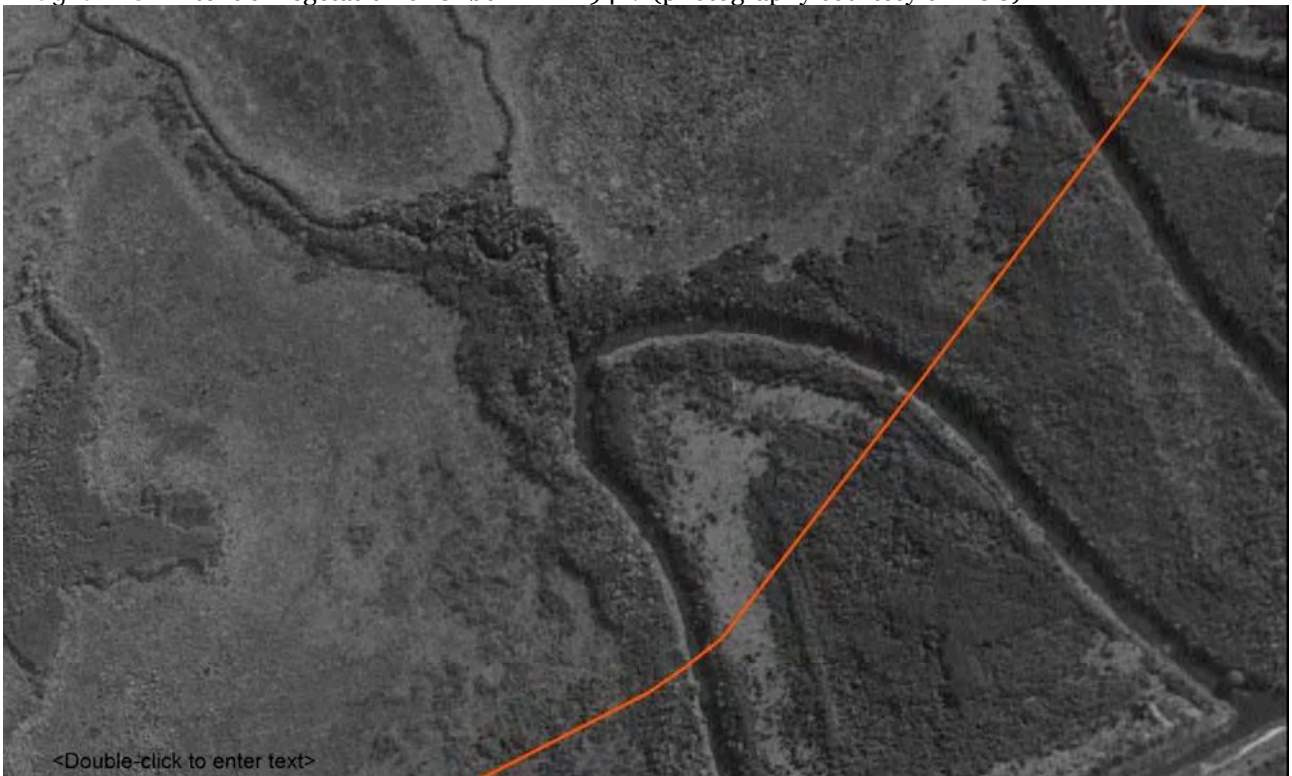
The clearer areas are potentially ephemeral wetland/sedgeland habitat, similar to that present in the Wairua Reserve.

The orange lines indicate the location of the current stopbank.

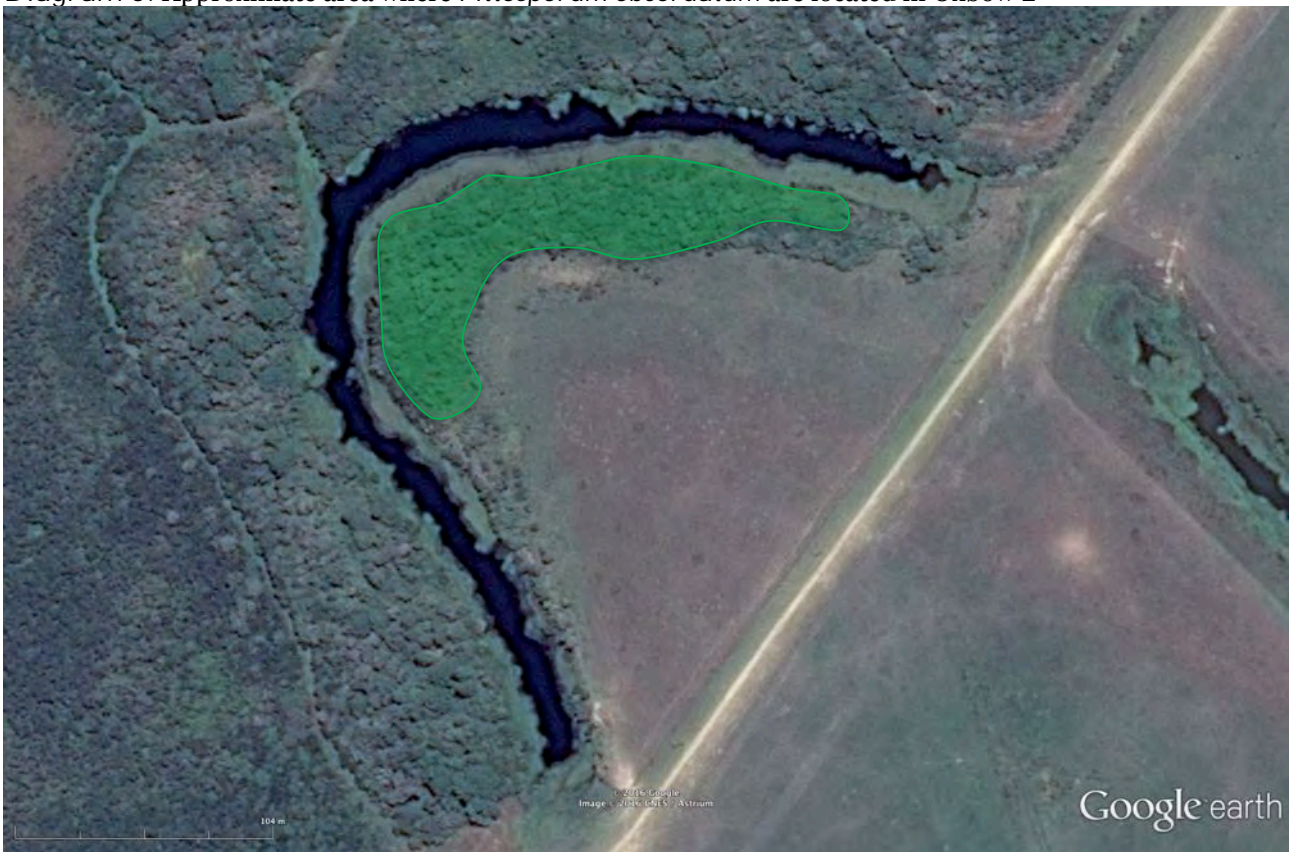
Diagram 5: Approximate area where *Pittosporum obcordatum* are located in Oxbow 2

A number of the nationally threatened heart-leaved kohuhu (*Pittosporum obcordatum*) (Nationally Vulnerable) were present in Oxbow 2 during the vegetation survey (mainly seedlings and small shrubs) (approximate location - diagram 5). However, at the time of writing this plan, stock have had extended access into the Oxbow 2 and have caused a considerable level of damage, which is likely to have impacted on the kohuhu seedlings.

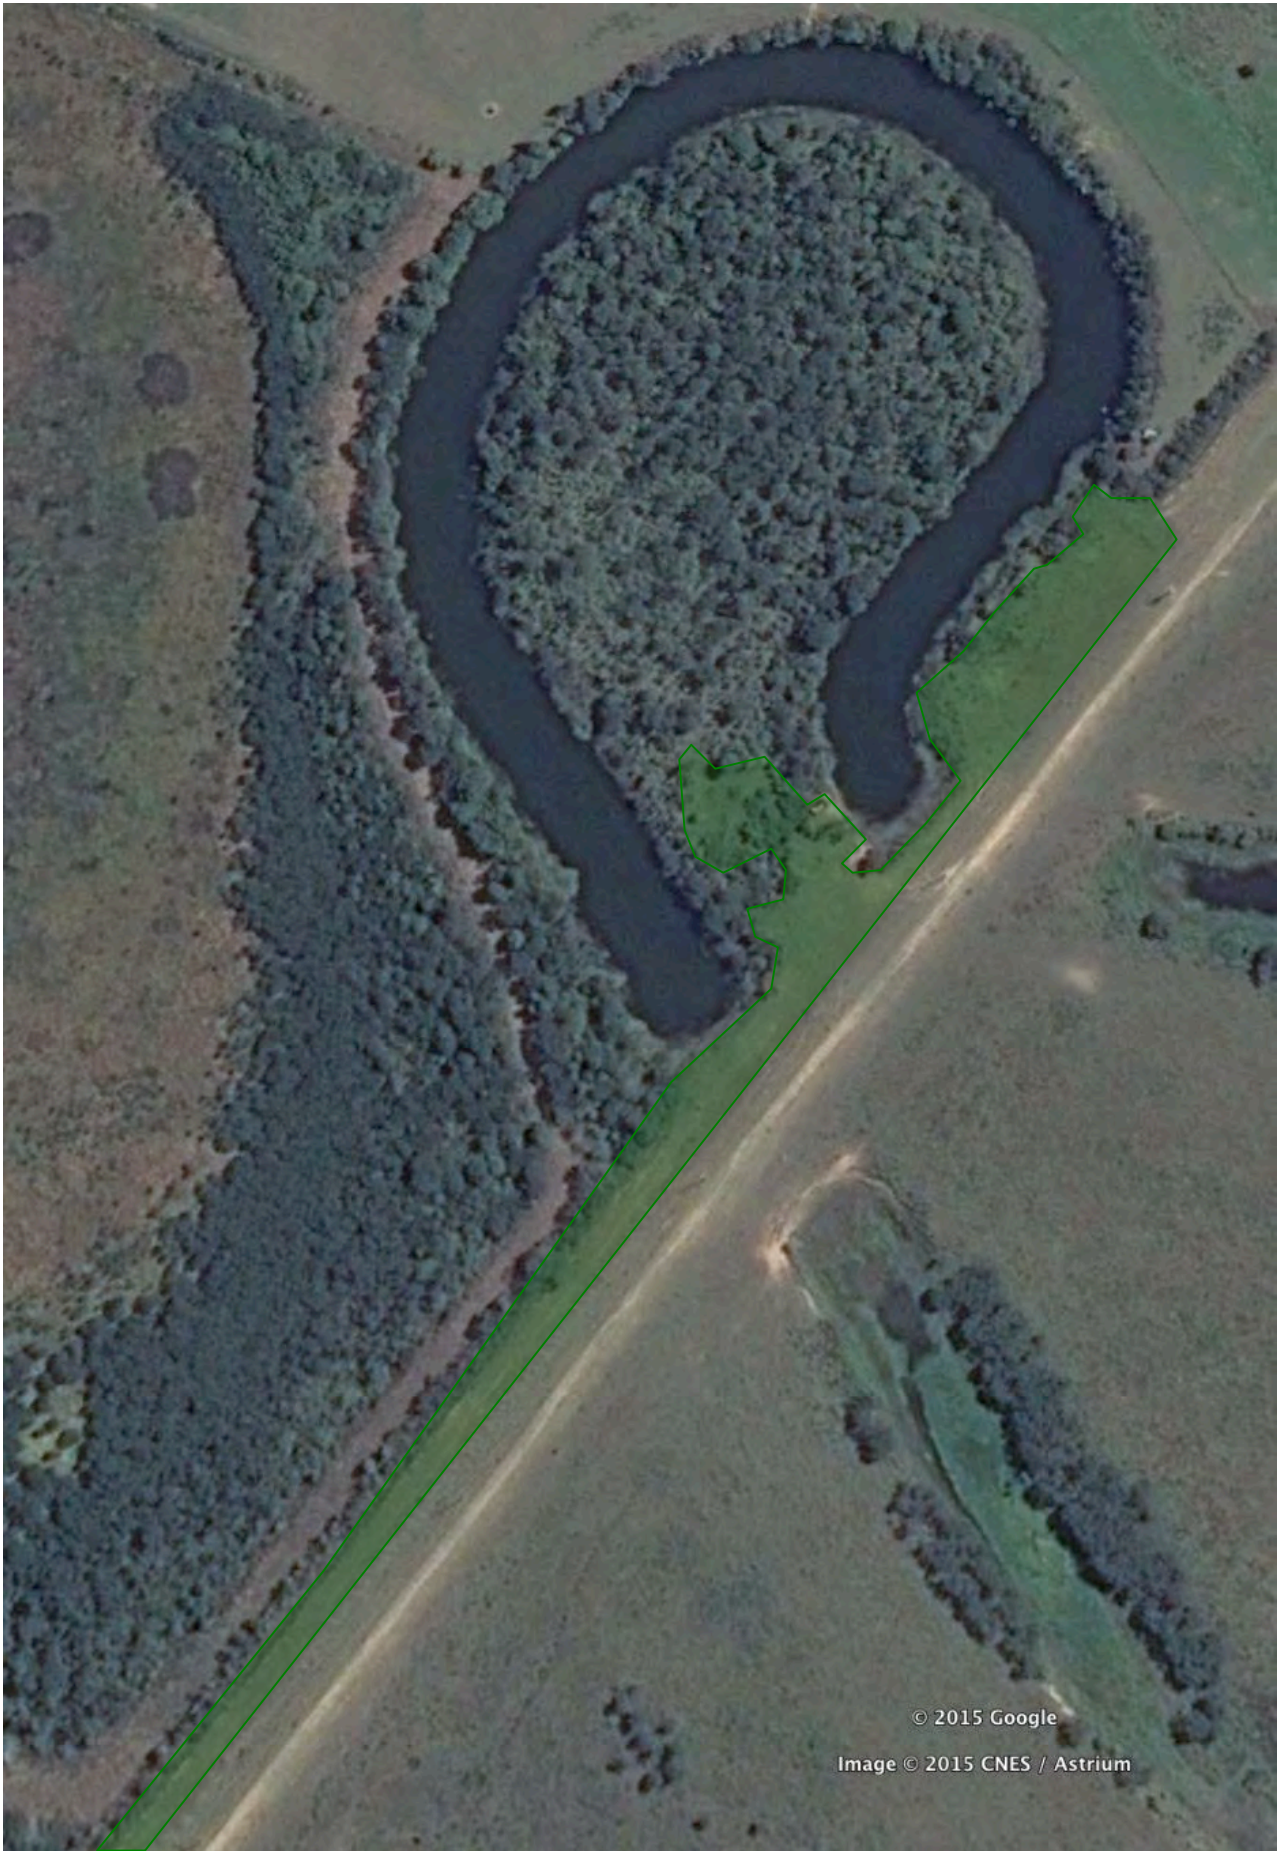
Diagram 5: Planting areas in Oxbow 1 & the connecting drain for year 1 (August 2016)

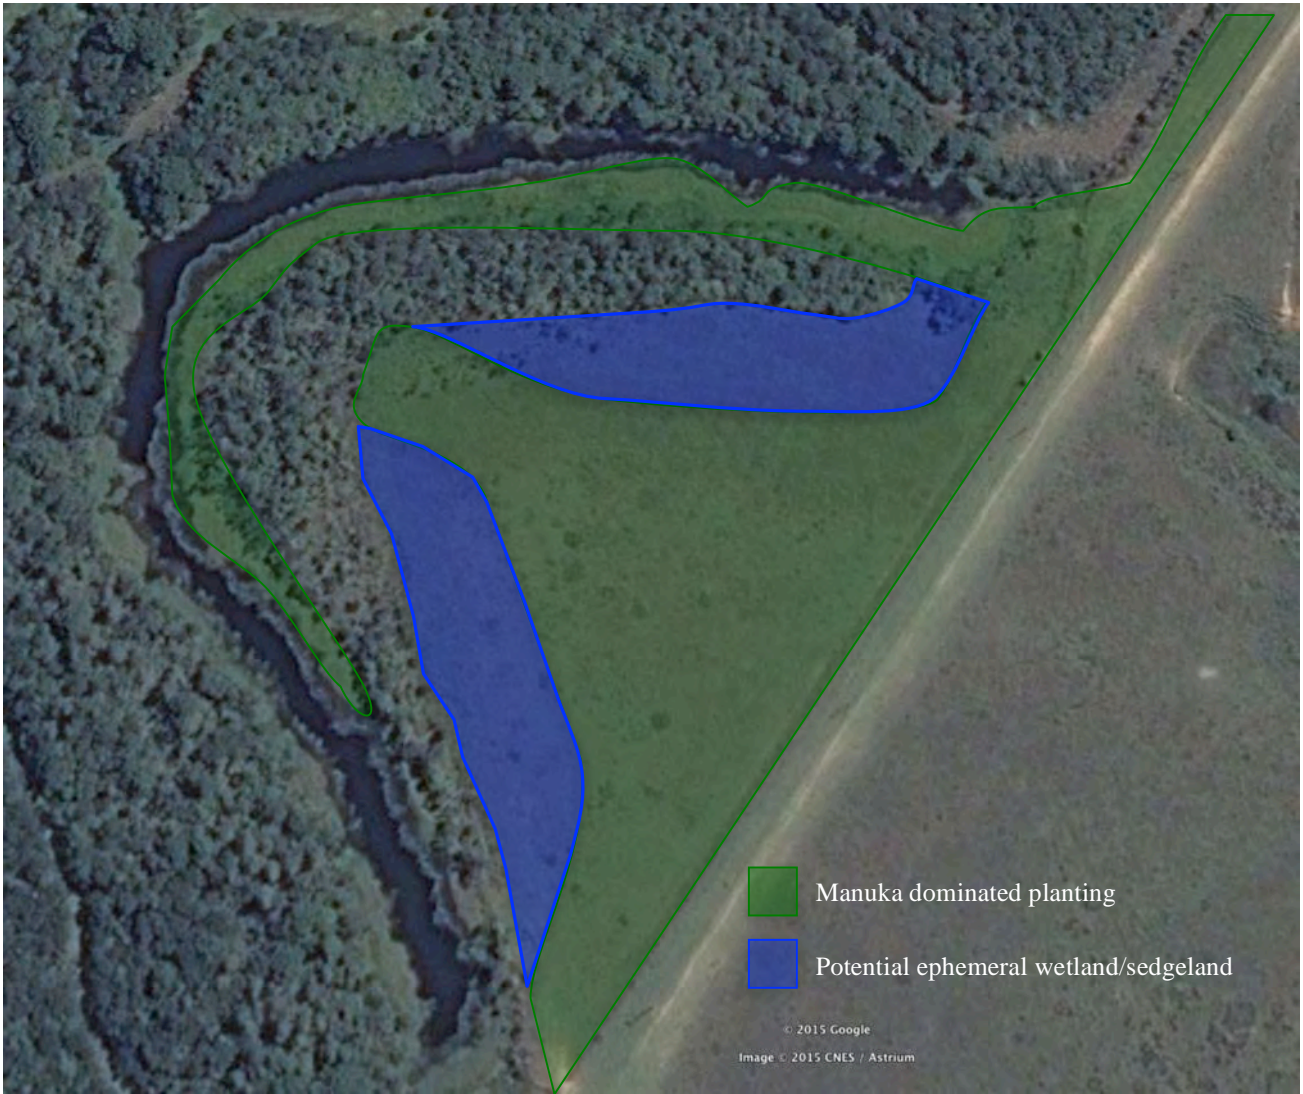
Diagram 6: Planting areas in Oxbow 2 including areas of ephemeral wetland restoration. The strip planting along the oxbow edge will only be carried out if necessary in year 4 (2019)

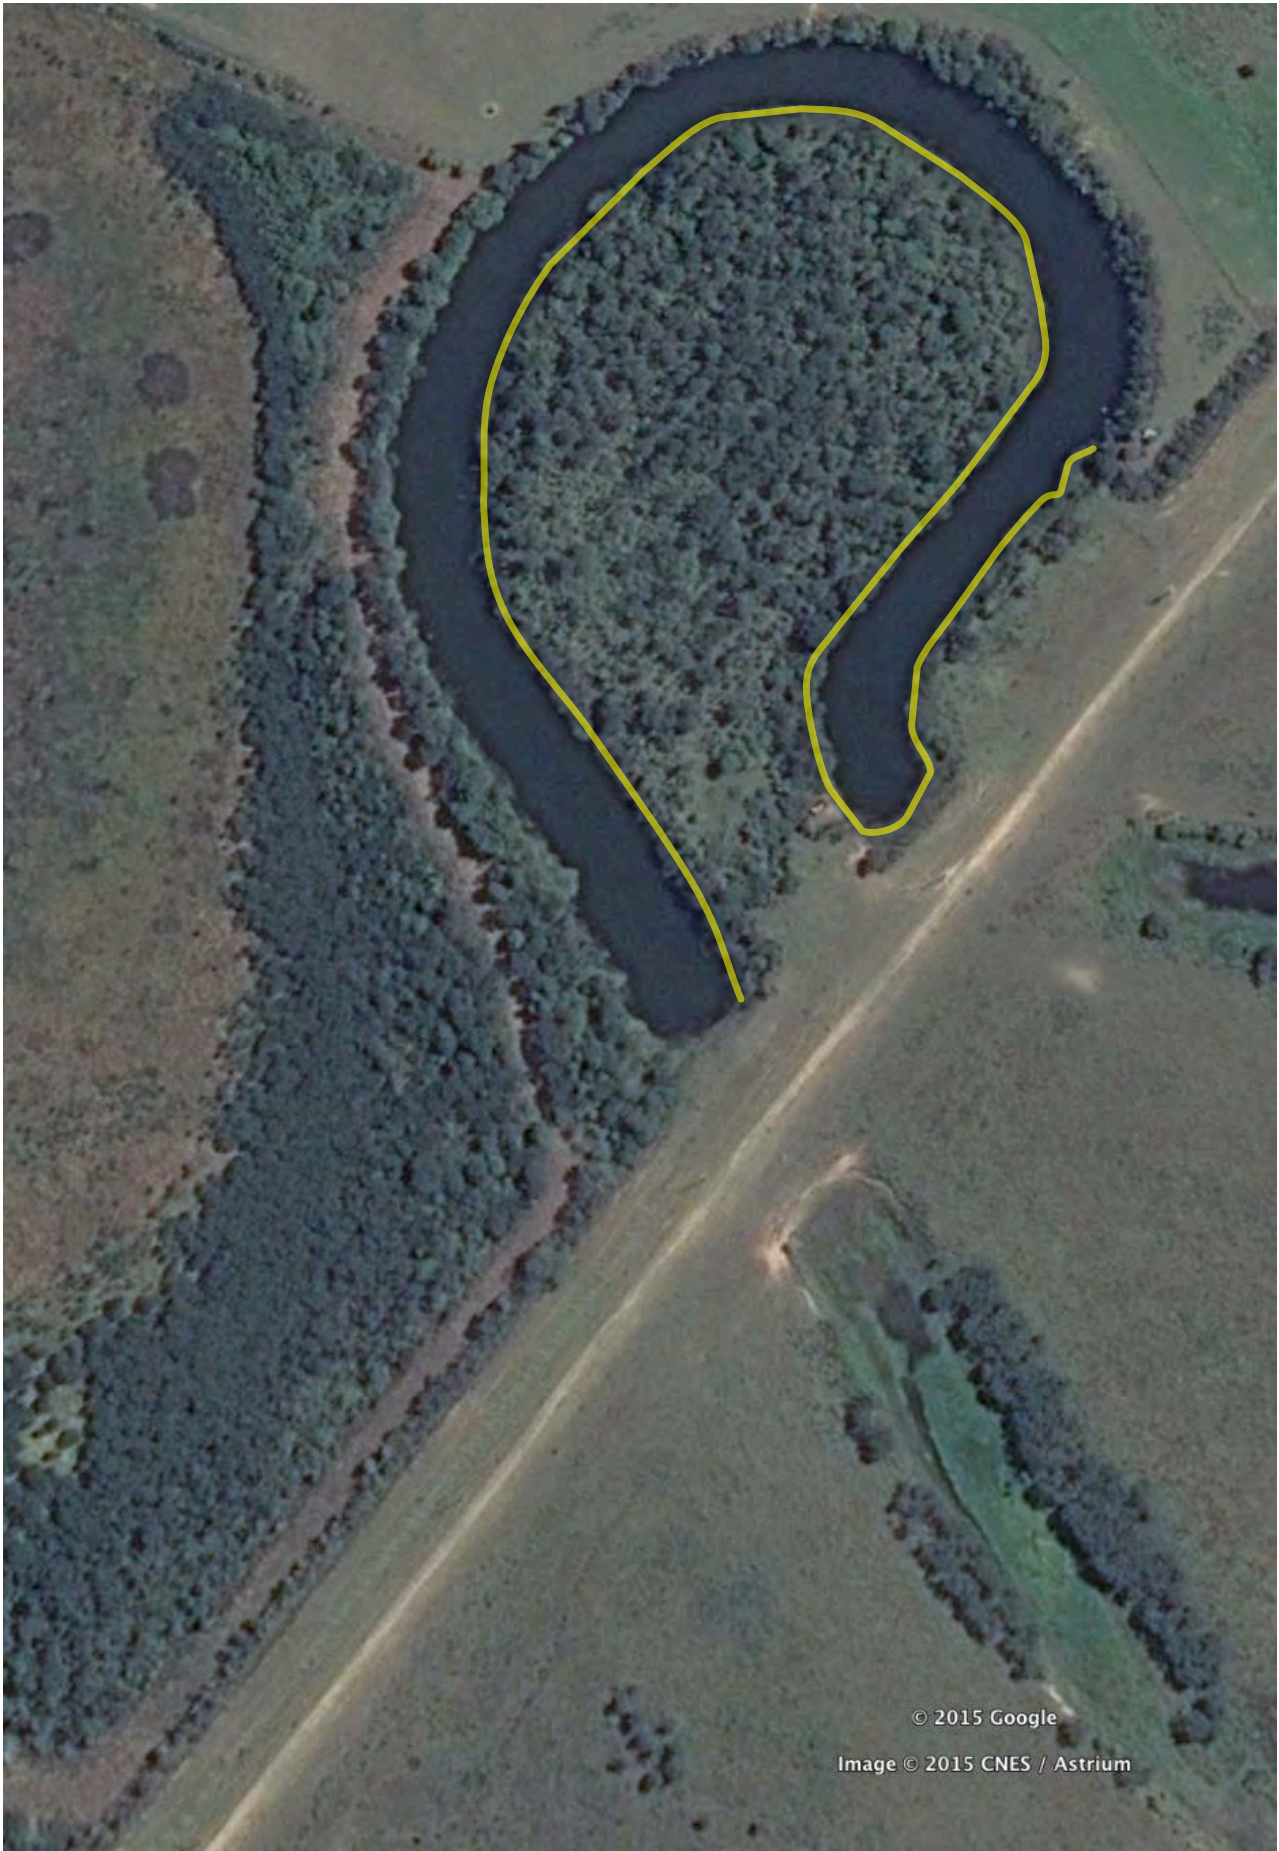
Diagram 7: Potential oxbow edge planting area in Oxbow 1

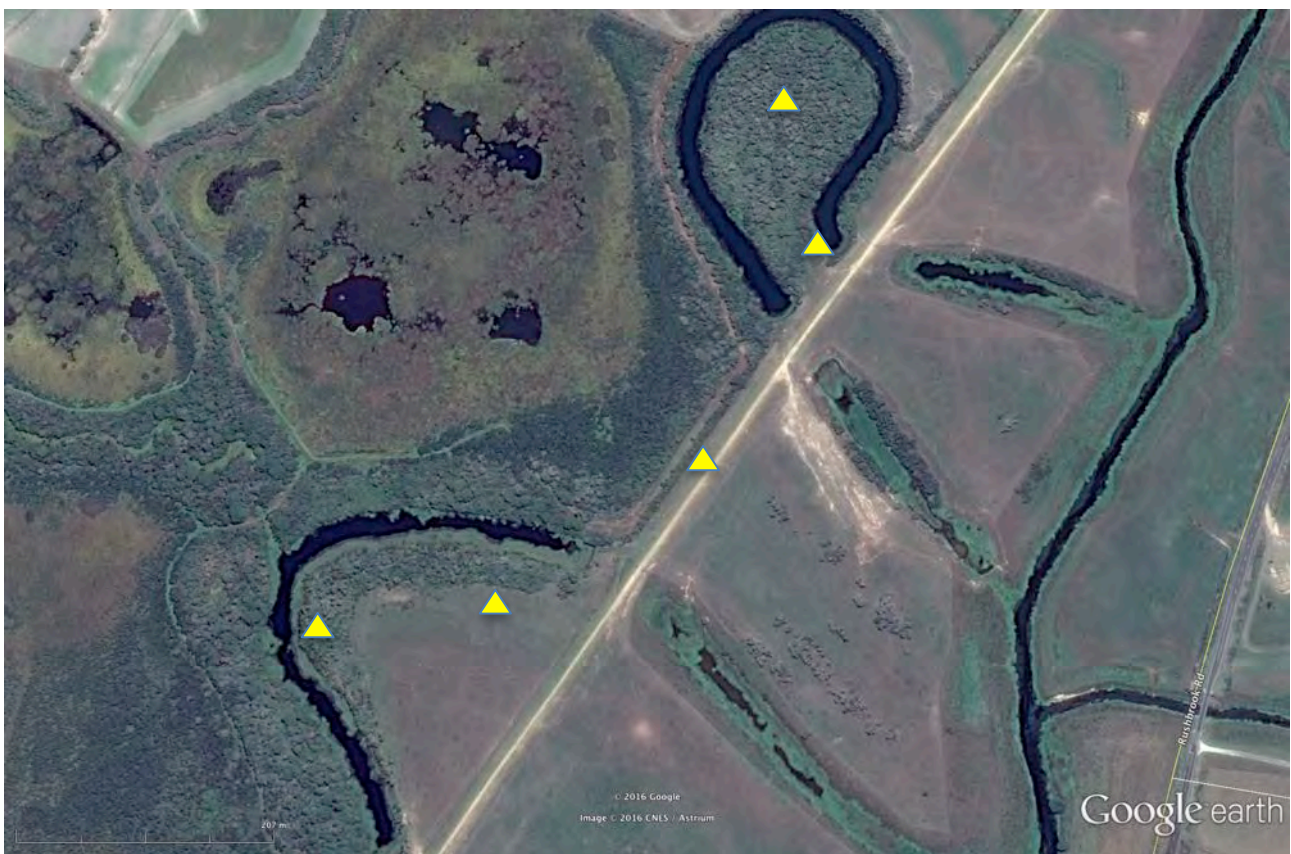
Recommended locations of five-minute bird count points

A minimum of five count points are recommended, two in each of the oxbow areas and one along the connecting drain revegetation area. Each site should be located to cover a range of habitat areas, such as lake edge, existing shrubland, revegetation planting and pasture edges.

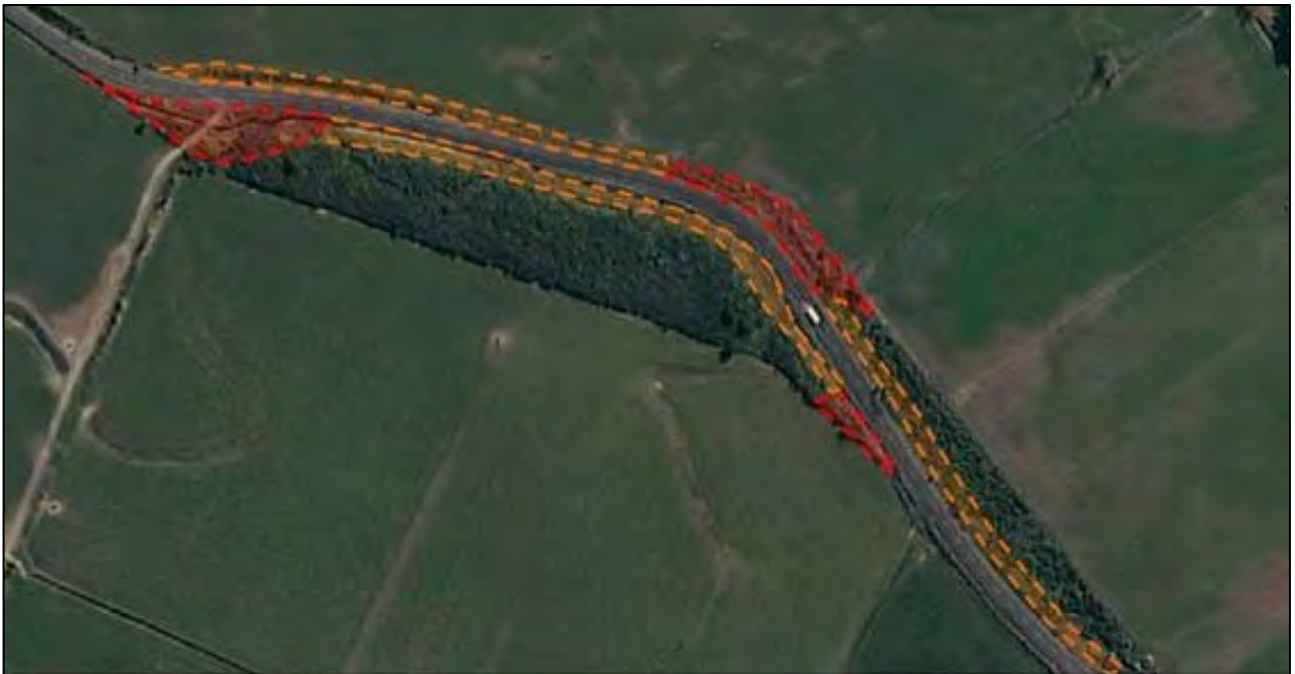
Diagram 4: Location of planting limitation zones; the red areas are tree exclusion ‘vehicle runoff’ zones (no trees to be planted >100mm diameter), and the orange indicate a 1.5 – 2 metre planting exclusion set back for road maintenance (no planning whatsoever) (source WDC)

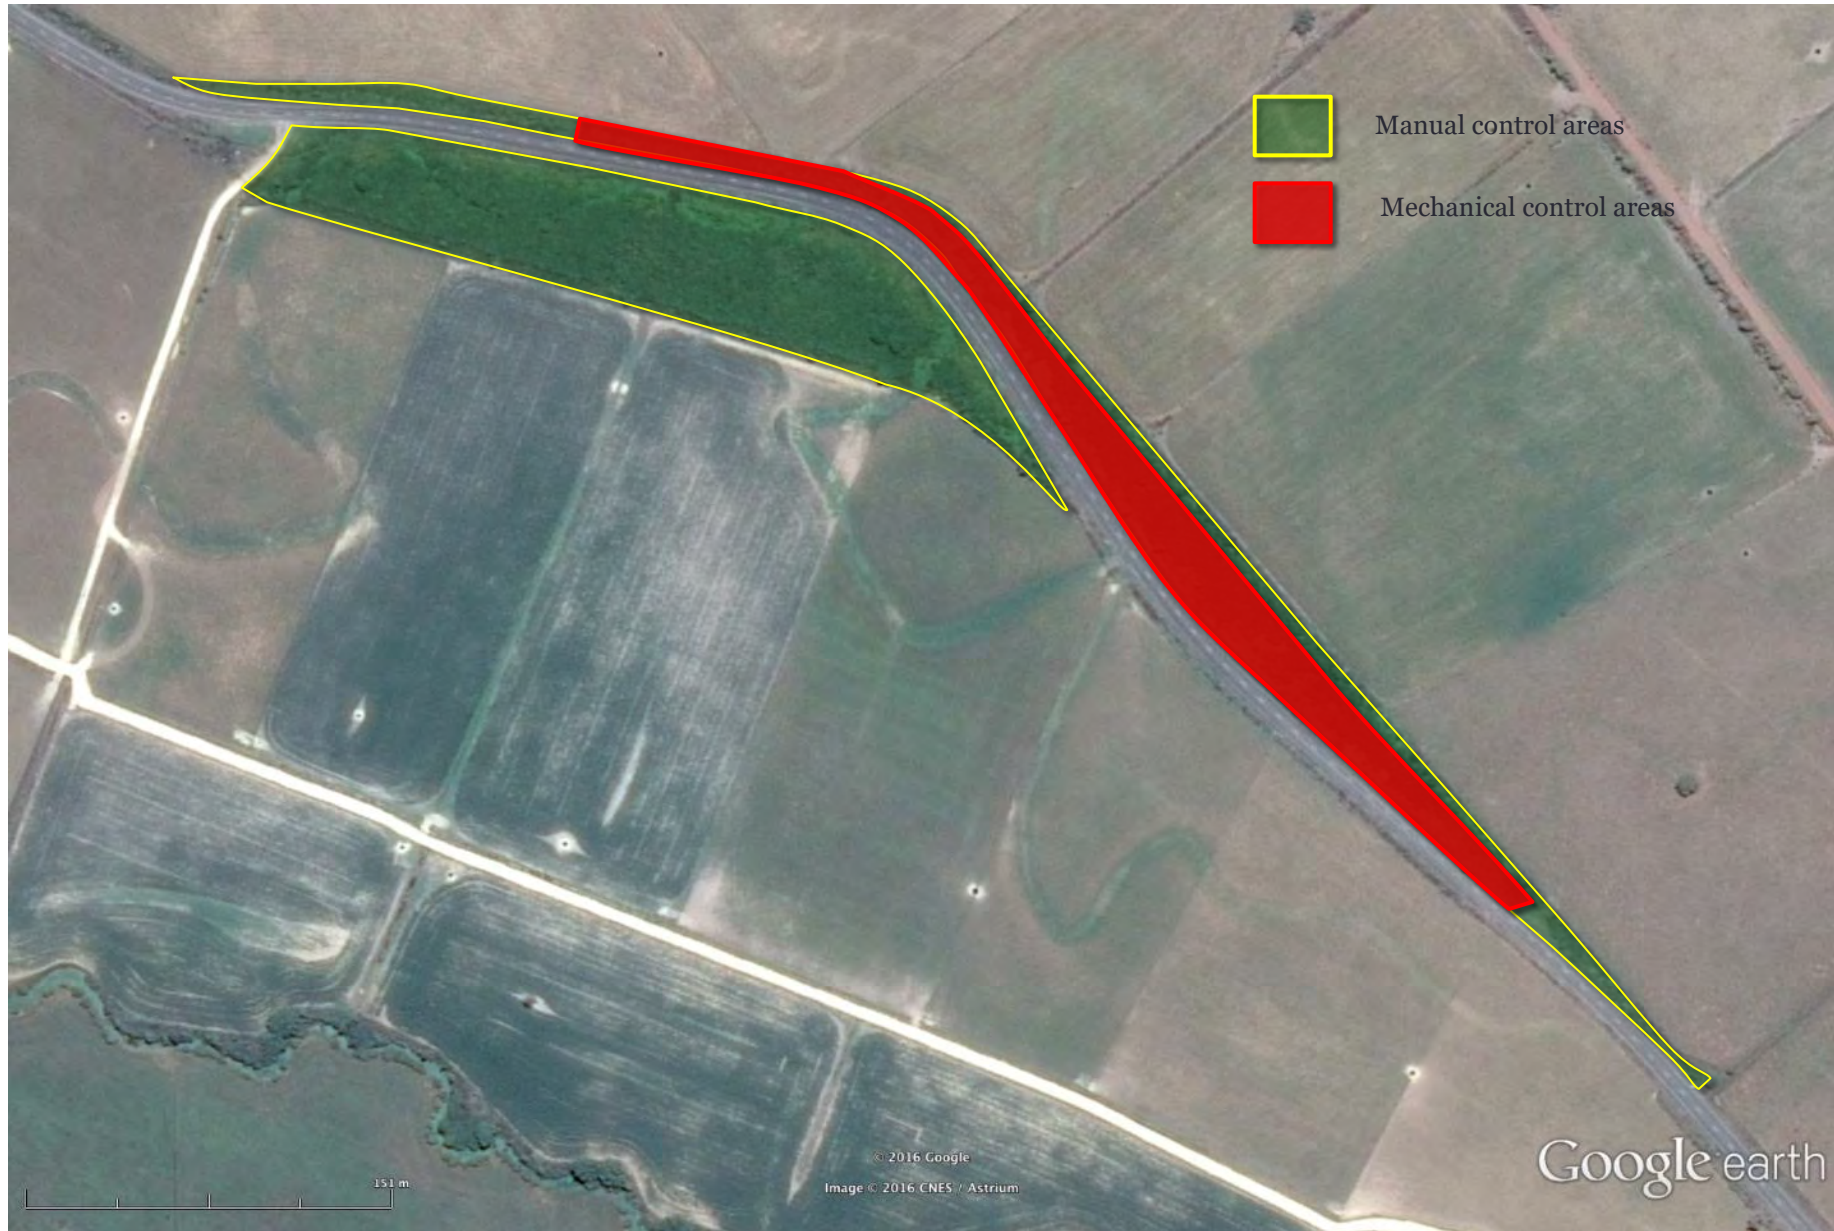
Diagram 5: Approximate outline of manual and mechanical privet control areas

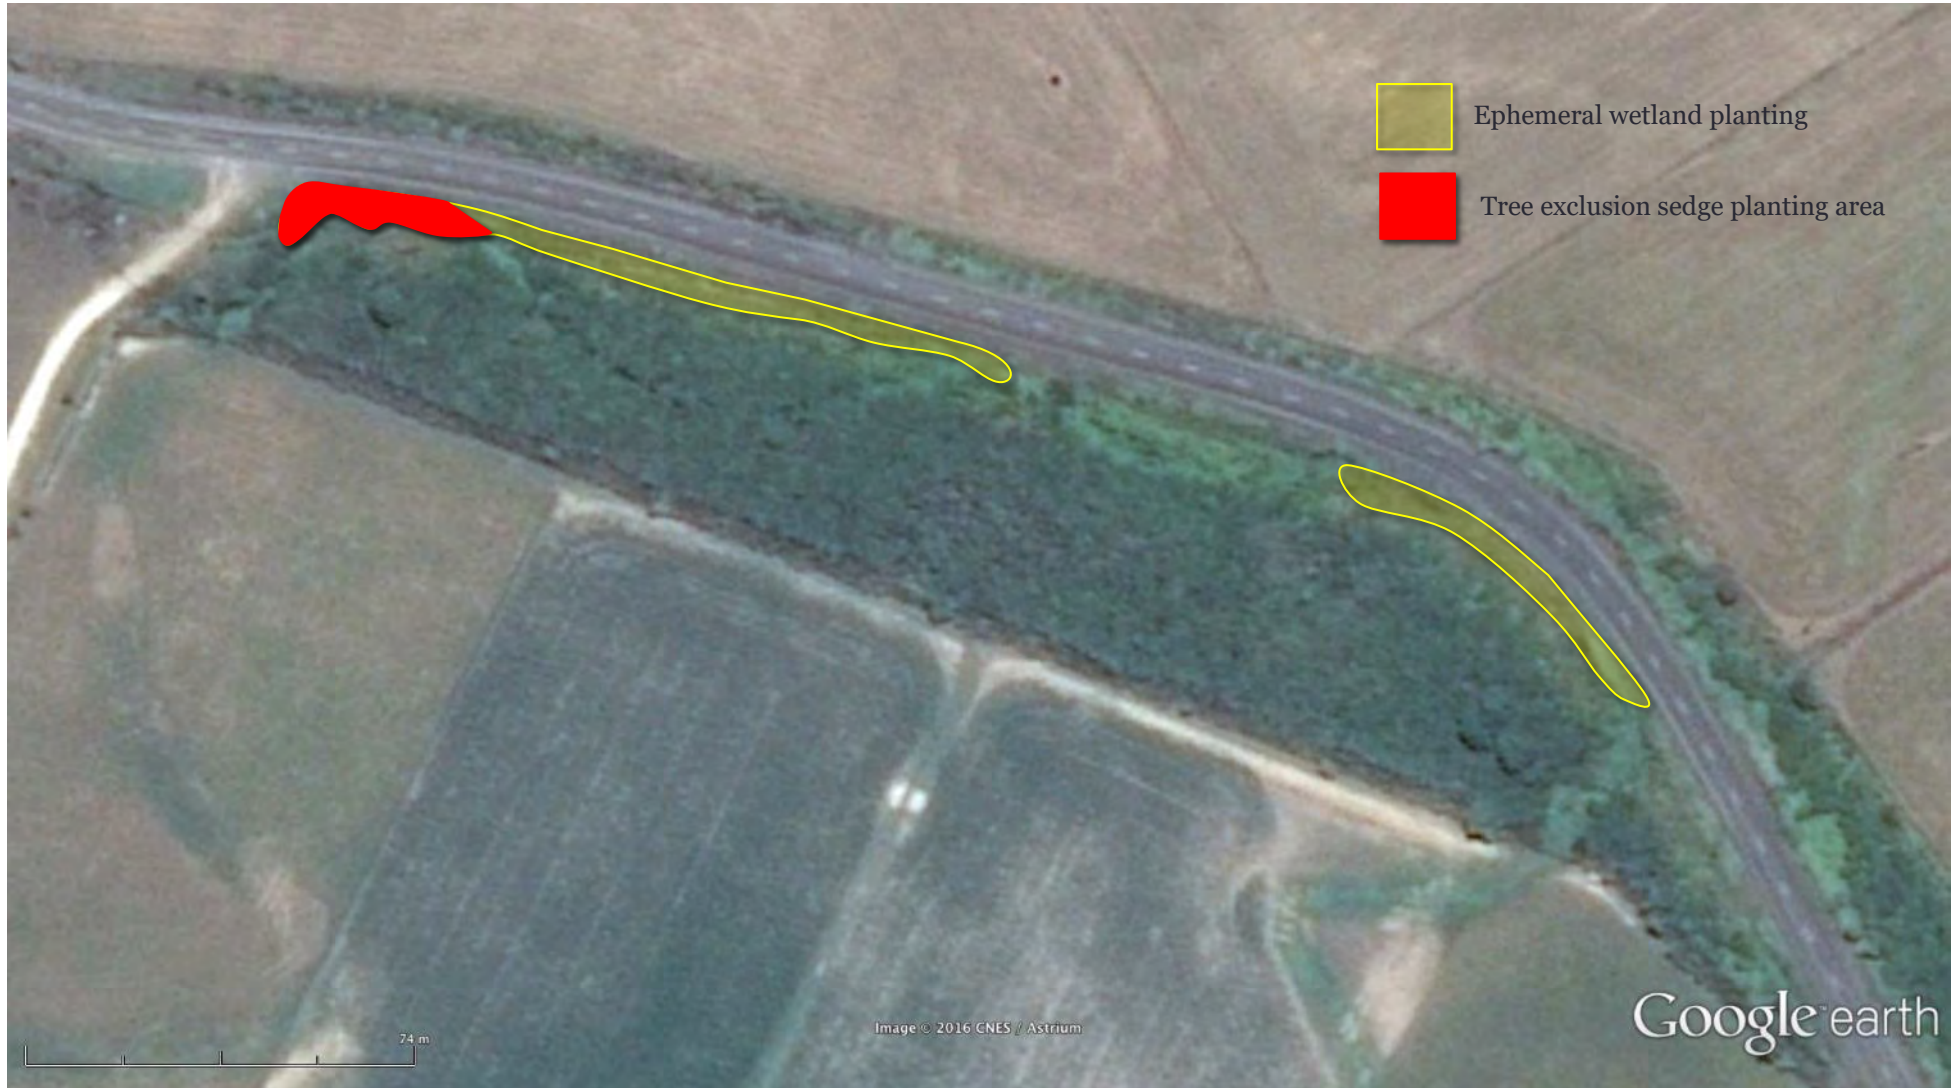
Diagram 8: Layout of ephemeral wetland excavation and planting areas

This wetland species mix is based on those present at the site and in close by wetland areas. However, it is possible that once excavated, the site may not be suited to this range of species, depending on the soil types. If necessary, this species list may require changing to suit the conditions.
