Hikurangi Swamp Floodway Riparian and Ox-Bow/Cut Off Channel Management Plan

March 2017

Whangarei District Council

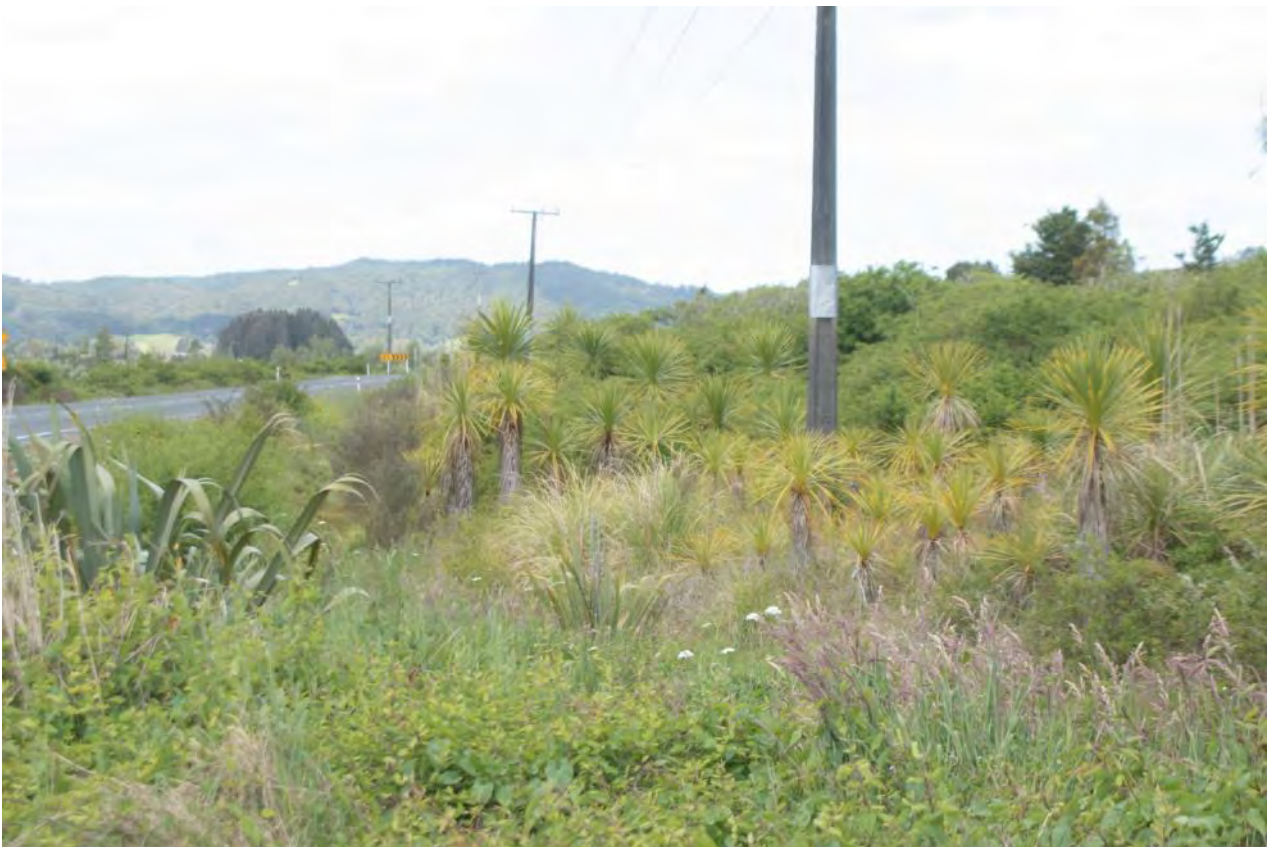
PP1

Location	Photopoint 1
Date	17 October 2016
Time	13.40
Weather conditions	Sun/cloud – light south westerly
Zoom	50mm
Focus	Infinity
Shutter speed	250/second
Compass bearing	100° (magnetic)
Tripod height	1700mm
GPS Co-ordinates	E1712924 N6058702
Site characteristics	Taken from edge of gravel accessway on southern side of road

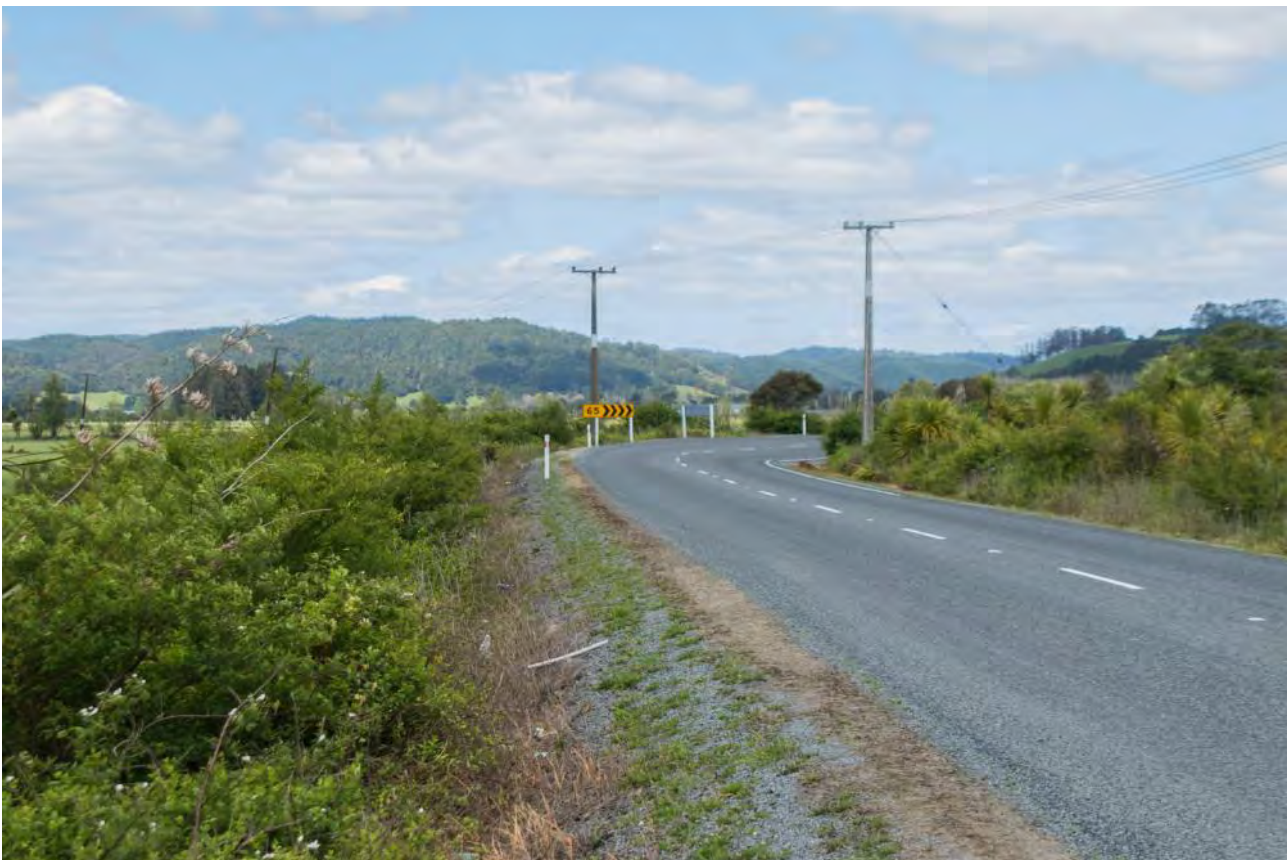
PP2

Location	Photopoint 2
Date	17 October 2016
Time	13.48
Weather conditions	Sun/cloud – light south westerly
Zoom	50mm
Focus	Infinity
Shutter speed	250/second
Compass bearing	104° (magnetic)
Tripod height	1600mm
GPS Co-ordinates	E1713042 N6058692
Site characteristics	Approximately 120 east of PP1 on northern side of road in small pull off area.

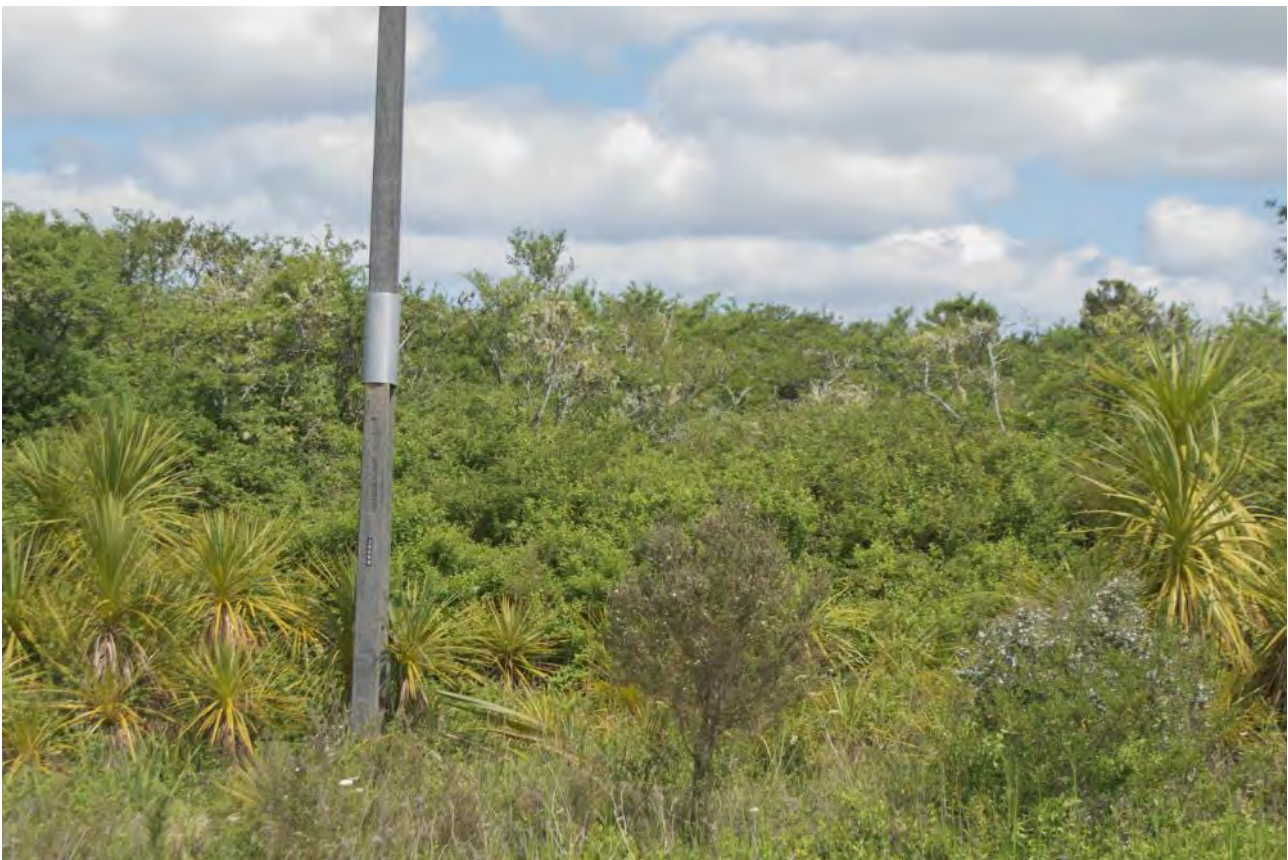
PP2A

Location	Photopoint 2A
Date	17 October 2016
Time	13.50
Weather conditions	Sun/cloud – light south westerly
Zoom	50mm
Focus	Infinity
Shutter speed	250/second
Compass bearing	173° (magnetic)
Tripod height	1600mm
GPS Co-ordinates	E1713042 N6058692
Site characteristics	Approximately 120 east of PP1 on northern side of road in small pull off area.

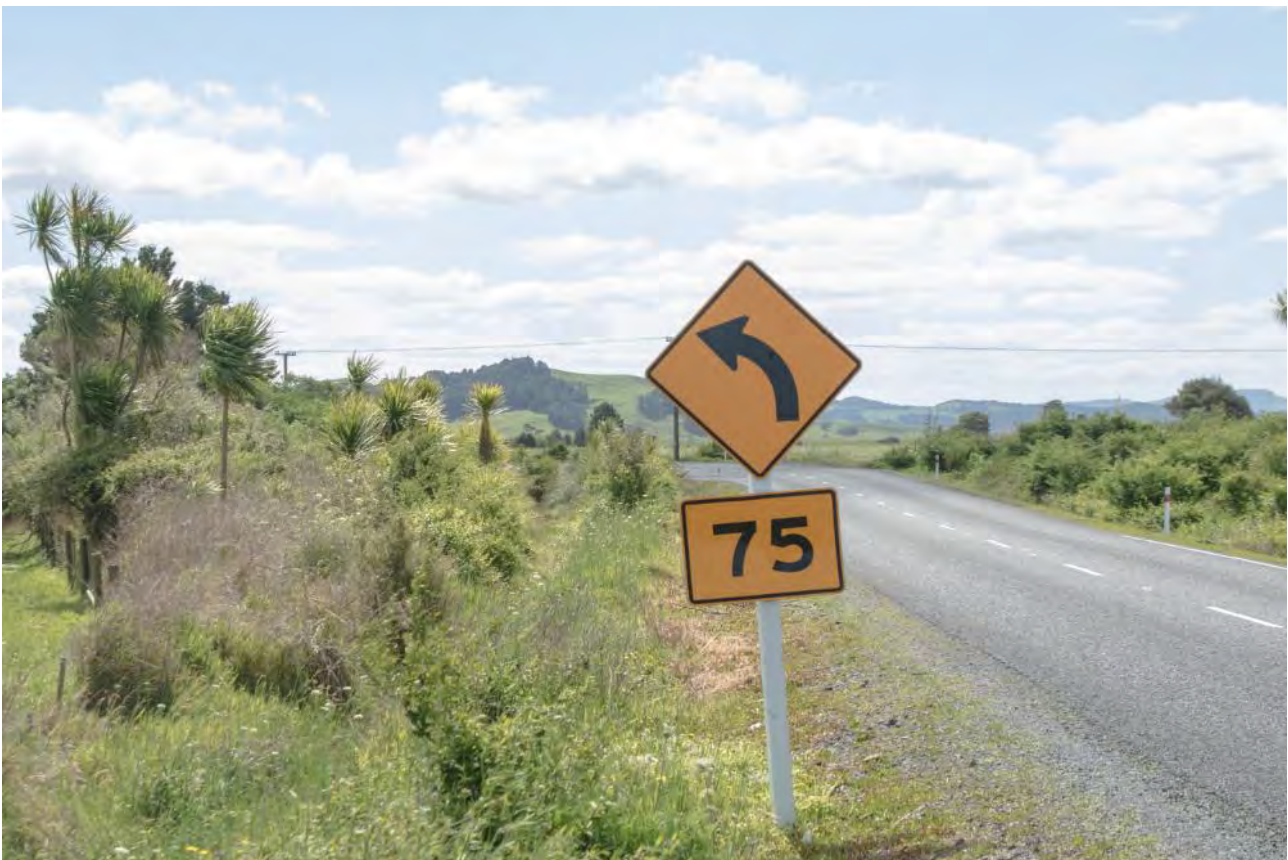
PP3

Location	Photopoint 3
Date	17 October 2016
Time	13.55
Weather conditions	Sun/cloud – light south westerly
Zoom	50mm
Focus	Infinity
Shutter speed	250/second
Compass bearing	286° (magnetic)
Tripod height	1720mm
GPS Co-ordinates	E1713258 N6058512
Site characteristics	Taken from edge of gravel accessway on southwestern side of road

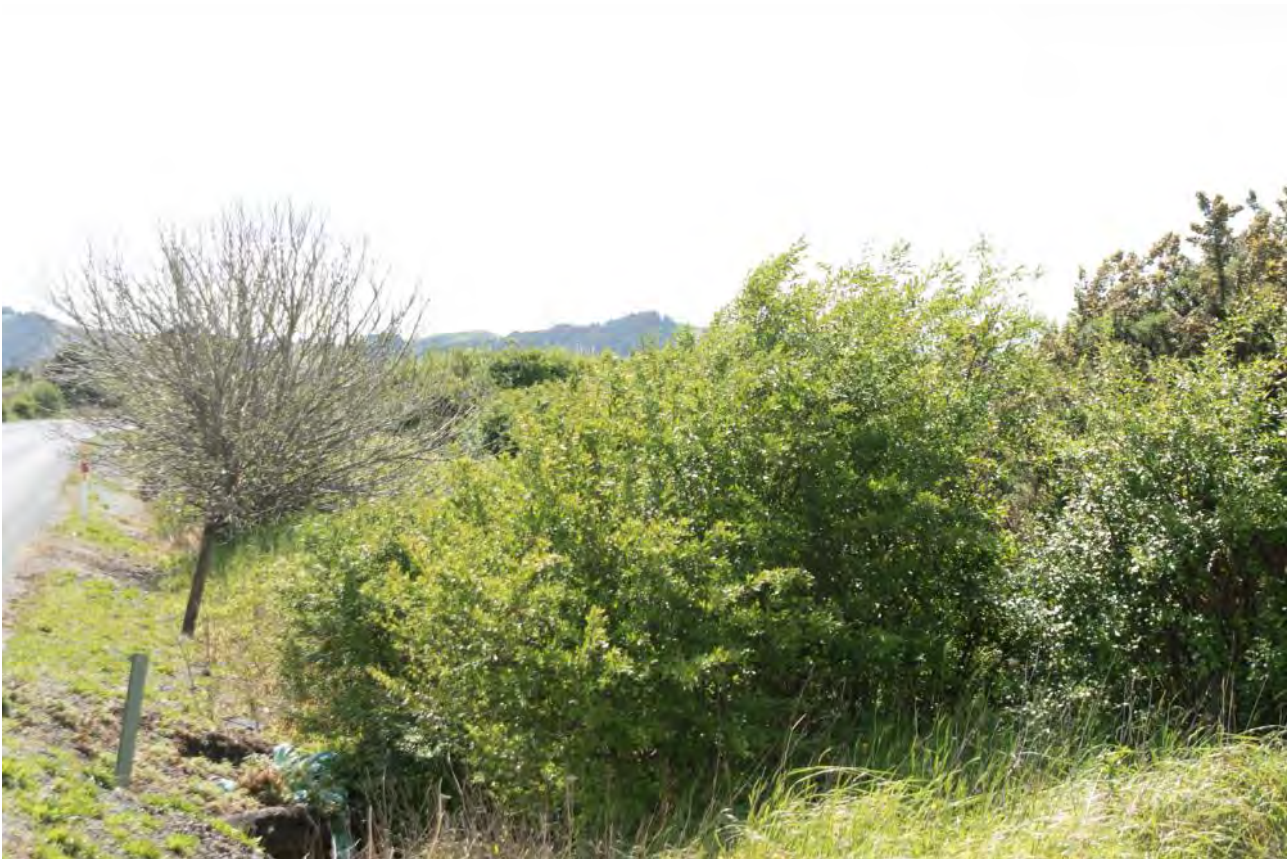
PP4

Location	Photopoint 4
Date	17 October 2016
Time	14.02
Weather conditions	Sun/cloud – light south westerly
Zoom	50mm
Focus	Infinity
Shutter speed	250/second
Compass bearing	290° (magnetic)
Tripod height	1700mm
GPS Co-ordinates	E1713258 N6058512
Site characteristics	Taken from edge of gravel accessway on northeastern side of road
