# **PROPOSED RUAKAKA SERVICE CENTRE, RUAKAKA, NORTHLAND: PRELIMINARY ARCHAEOLOGICAL ASSESSMENT**

Prepared for Ruakaka Developments Ltd

June 2020

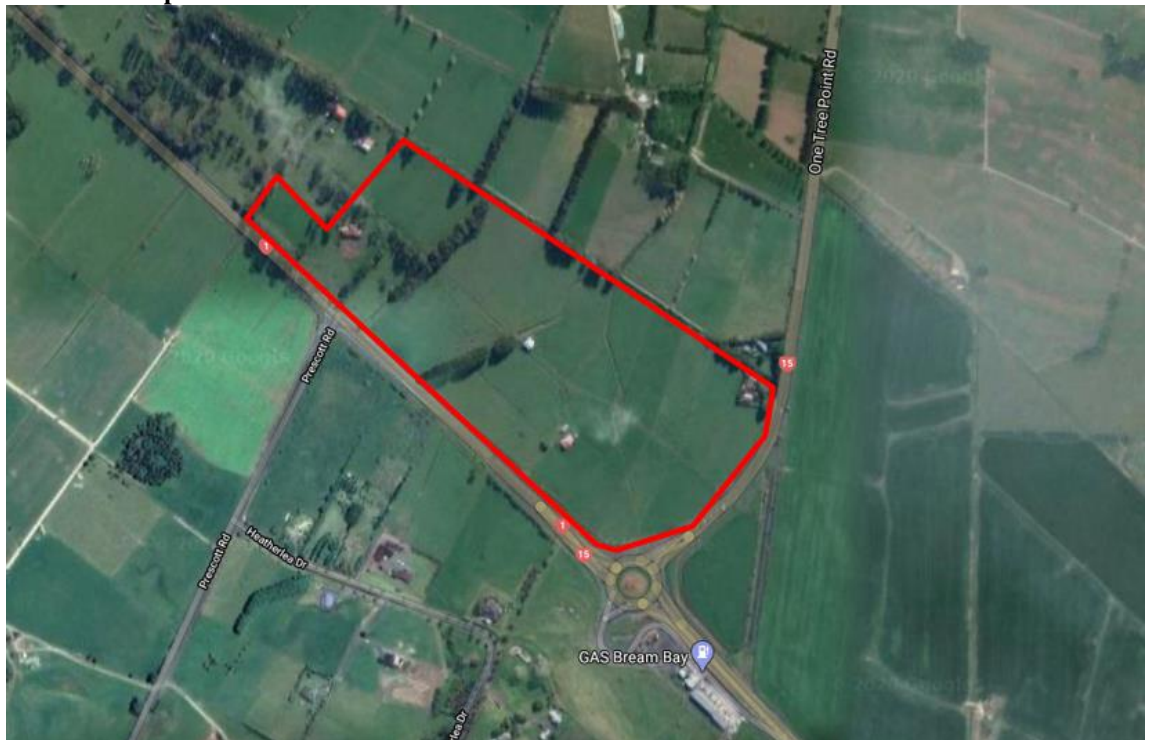
**Figure 3. Aerial showing the extent of the current archaeological survey (outlined in red). Aerial source: Google Maps 2020**

A visual inspection of the main portion of the property, located on the northern side of the intersection of State Highway 1 and State Highway 15A (Figure 3) was conducted on 9

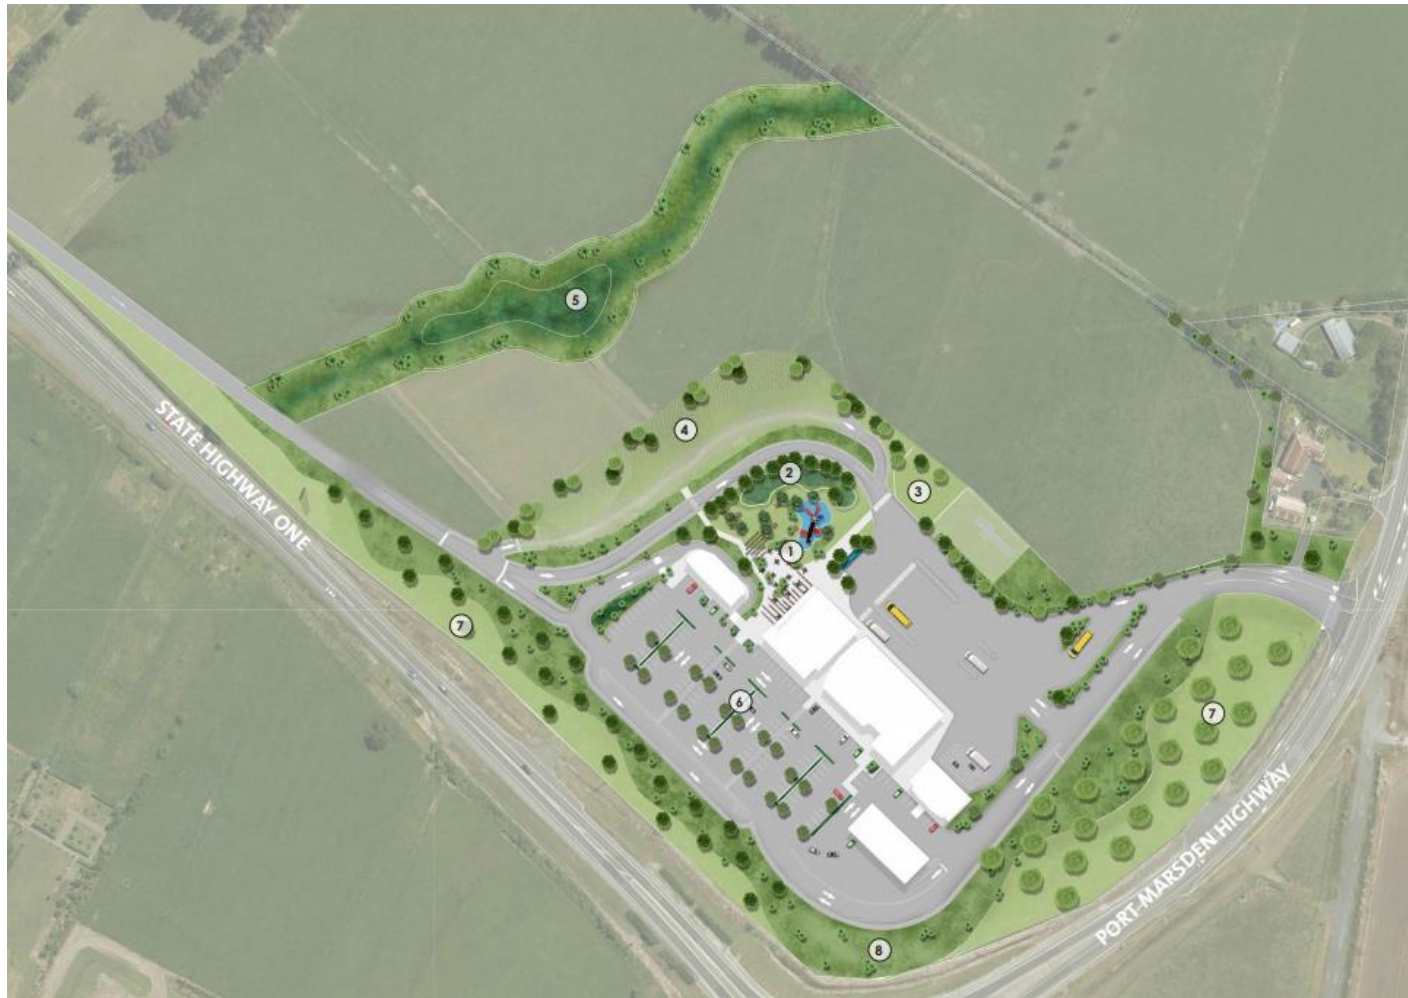
Figure 5. Landscape Masterplan prepared by Boffa Miskell (Tattico 2020)

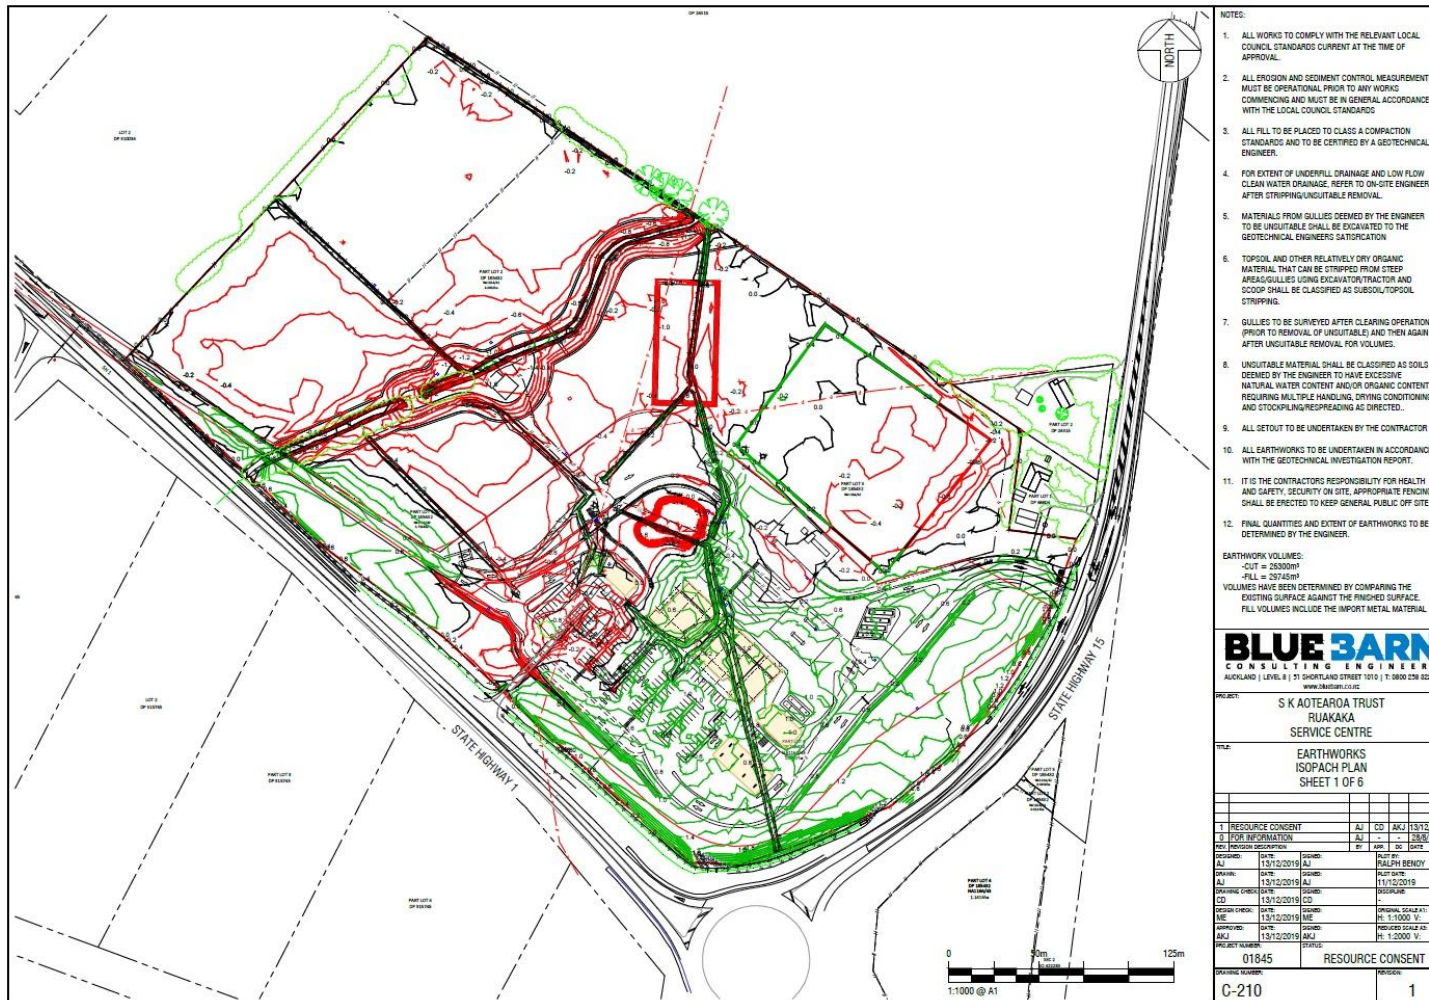
Figure 6. Earthworks Isopach Plan (Blue Barn 2019)

The development of the service centre will require significant earthworks as shown on Figure 6 and Figure 7. The works include:

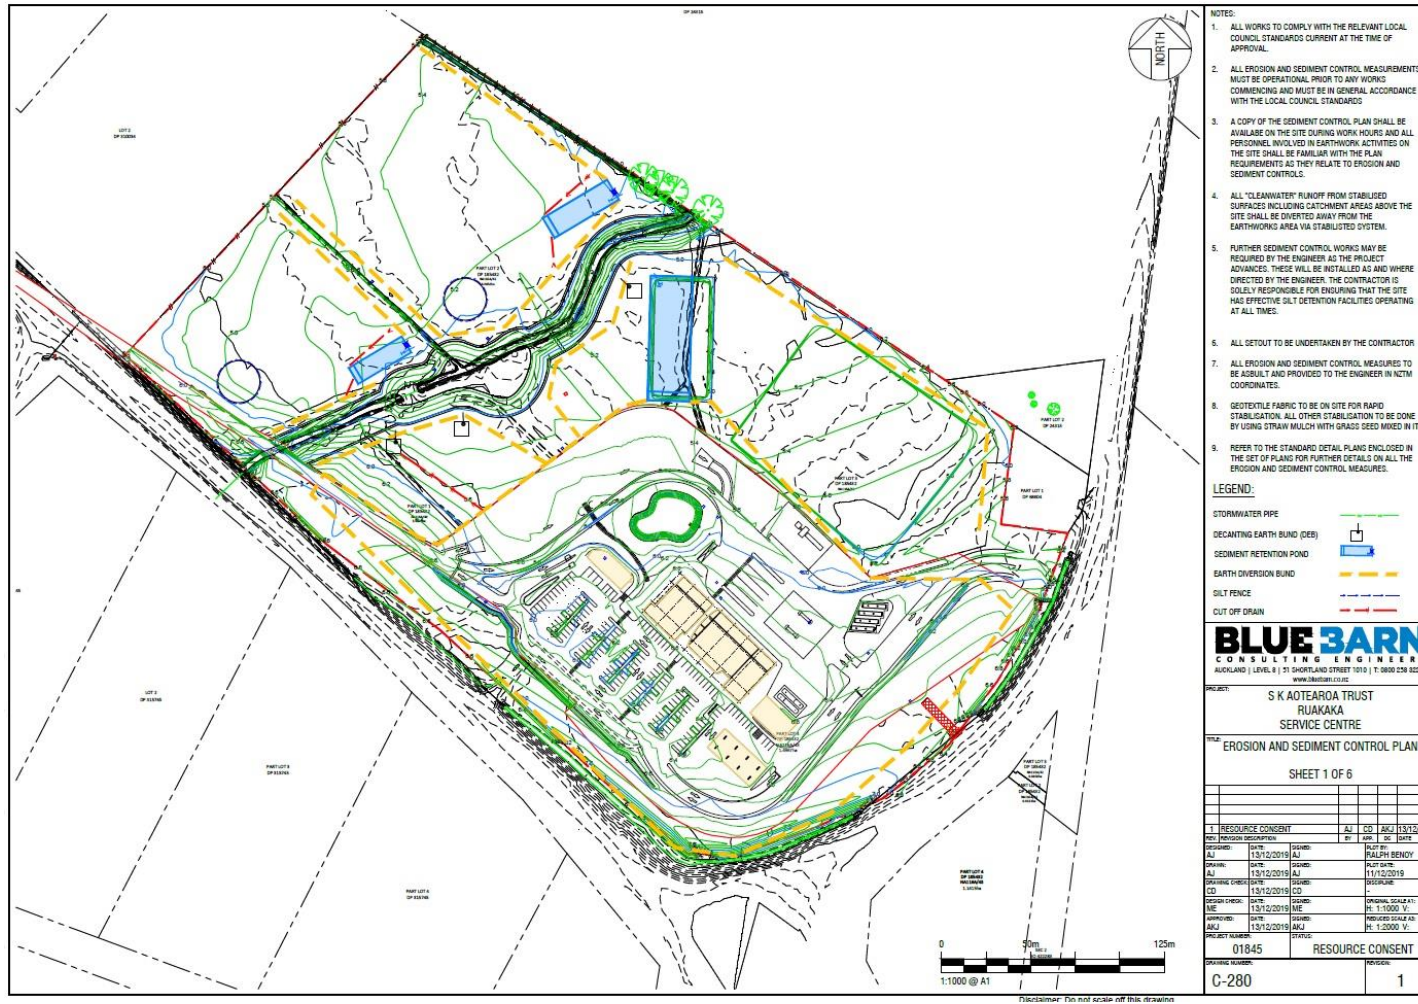
Figure 7. Erosion and Sediment Control Plan (Bluebarn 2019)

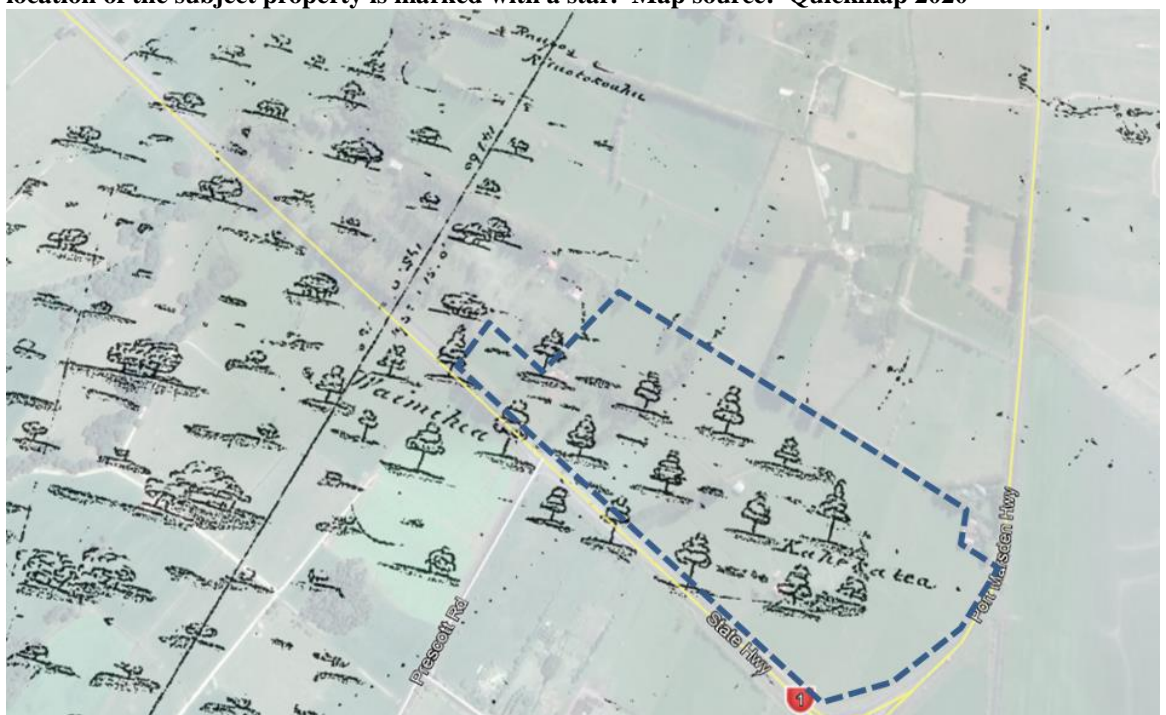
Figure 11. Detail of SO40A overlaid onto a modern aerial map showing the project area (approximate boundary outlined). Aerial source: Google Earth 2020

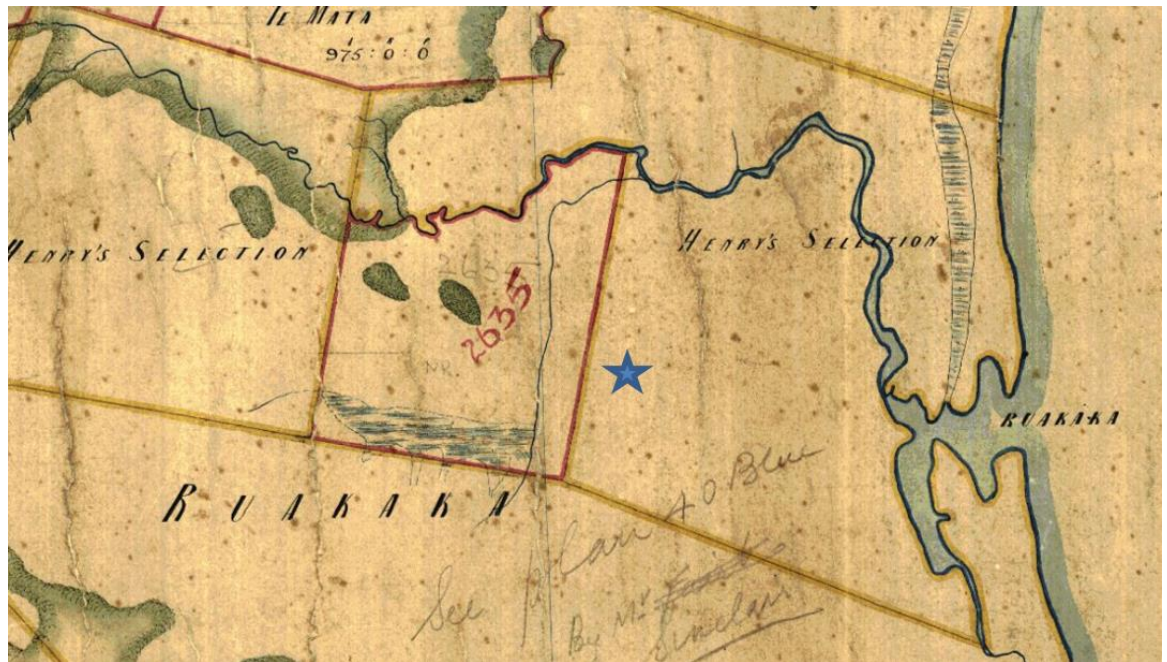
Figure 12. Detail of Roll 7(4) showing the approximate current project area (marked with star). Plan source: Quickmap 2020

A further undated plan from a similar period shows the Ruakaka area with the subject property being located within ‘*Henry’s Selection*’, immediately east of the Waiwarawara Block boundary (Figure 12).

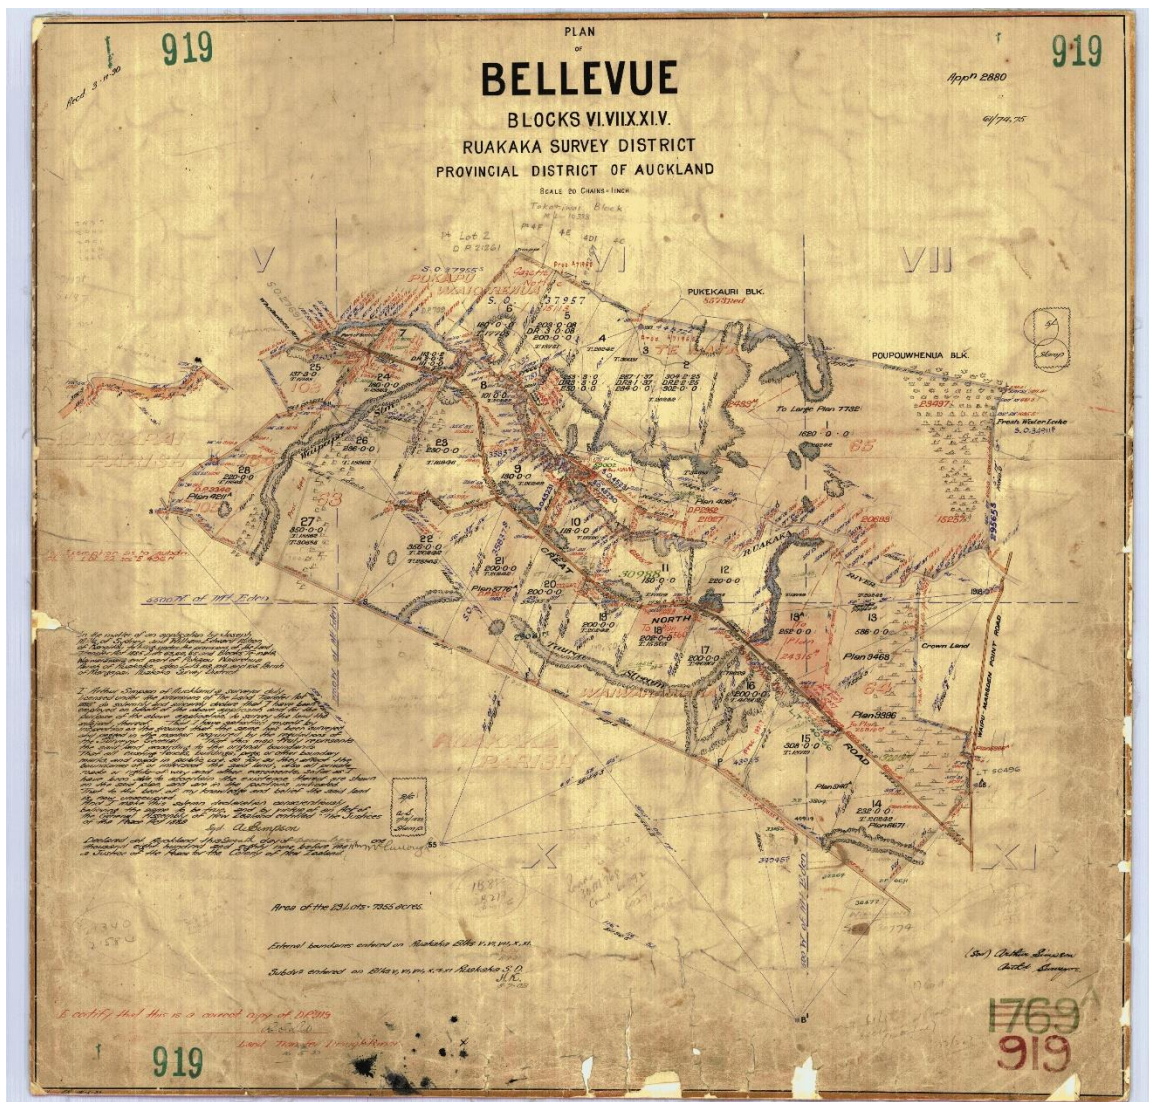
Figure 15. DP 919 (1889) entitled 'Plan of Bellevue Blocks VI.VII.X.XIV. Ruakaka Survey District Provincial District of Auckland'. Plan source: Quickmap 2020

A later plan dated to 1889 was undertaken to show the ‘Bellevue’ blocks (Figure 15). Bellevue was an estate developed by Irishman Thomas Henry from an extensive block of land purchased from the Crown, including the adjacent Waiwarawara Block which was originally designated as ‘Native Land’ but was inadequately protected by the Native Land Court (Gudex 2013, Chetham 2019). The plan does not add greatly to our understanding of the project area, however it does show the alignment of a small tributary to the Ruakaka River, running north-south through the property (Figure 16).

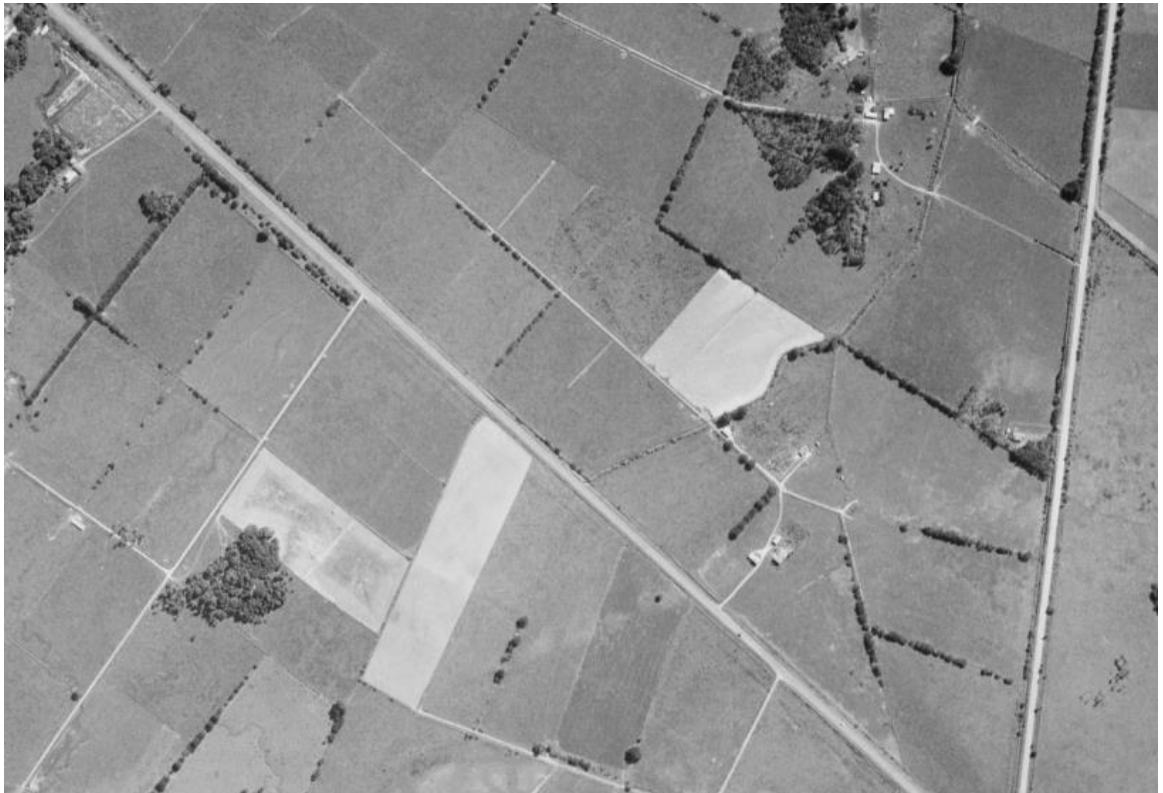
Analysis of historic aerial photographs of the project area is useful to determine historic landuse which may have affected archaeological remains. An aerial dating to 1961 shows the property in pasture with small hedgerows evident and minimal planting along the waterway that runs north-east to south-west through the property (Figure 18).

**Figure 18. Detail of 1961 aerial photograph showing the project area (outlined). Aerial source: Retrolens ref. Crown 212-414-64**

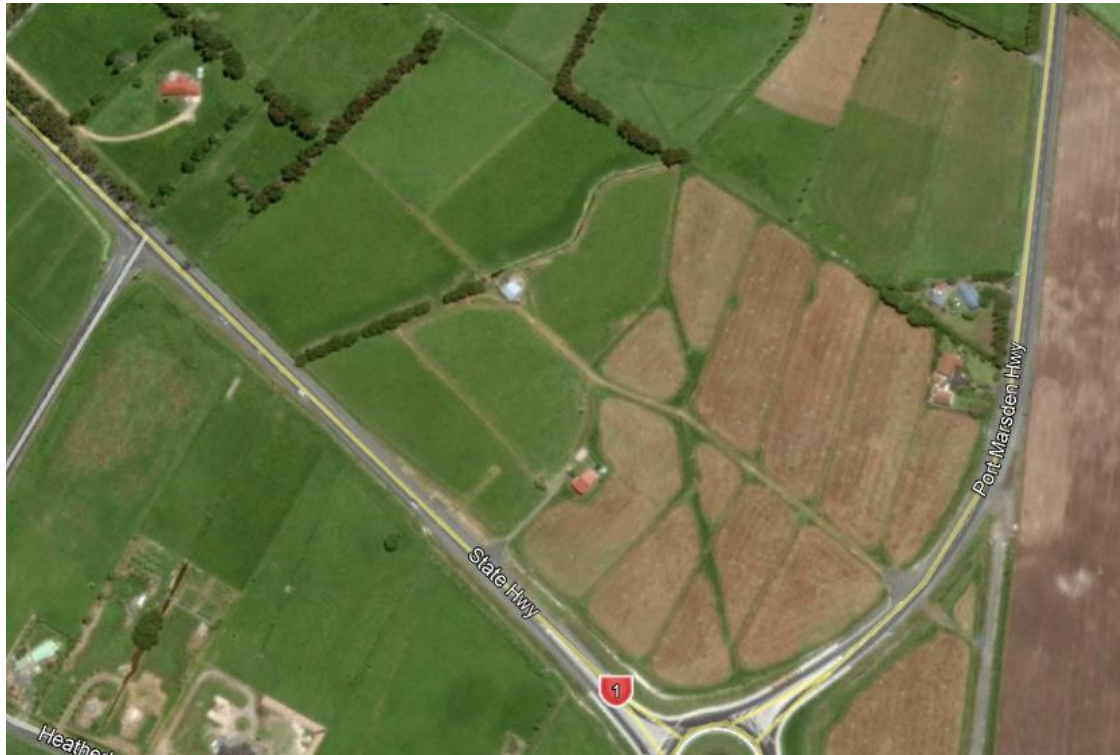
**Figure 19. 2010 aerial photograph showing the project area (outlined). Aerial source: Google Earth 2020**

Later aerials dating to the early 2000s show evidence of cropping across much of the eastern end of the property (Figure 19, Figure 20). While a more recent aerial dating to 2018 shows cropping within the paddocks along the eastern boundary (Figure 21). Detail from an aerial dated to January 2020 shows earthworks around the existing farmhouse that fronts onto State Highway 1 (Figure 22).

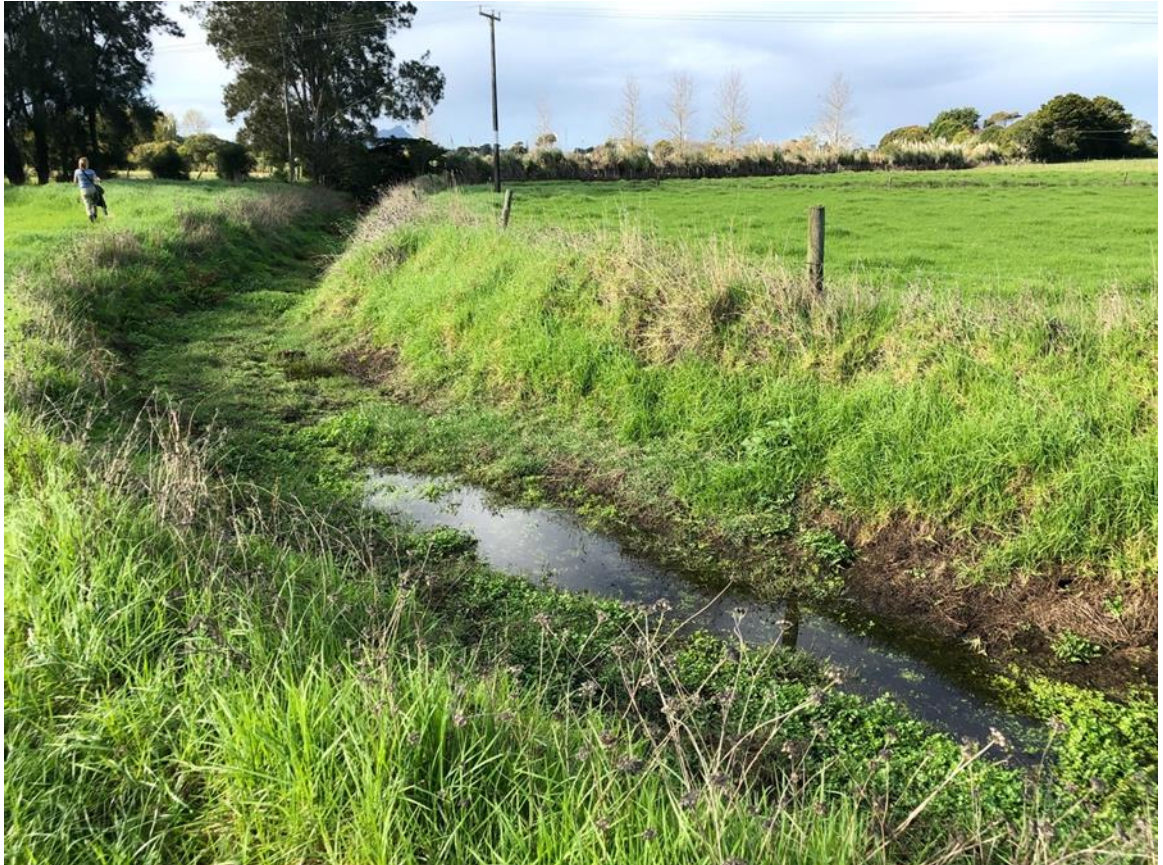
The project area generally encompasses low lying flat farmland intersected by deep drainage features which may be modified minor tributary alignments (Figure 26). The area is wholly covered in grazing pasture with occasional tree planting for use as windbreaks or to enhance residential areas (Figure 27), two residential houses with associated garaging and farm sheds. Currently, the majority of the survey area is utilised for grazing cattle. The area appears to have been subject to modification through drainage in order to convert the landscape into farmland.

**Figure 26. Main stream alignment that runs through the property**

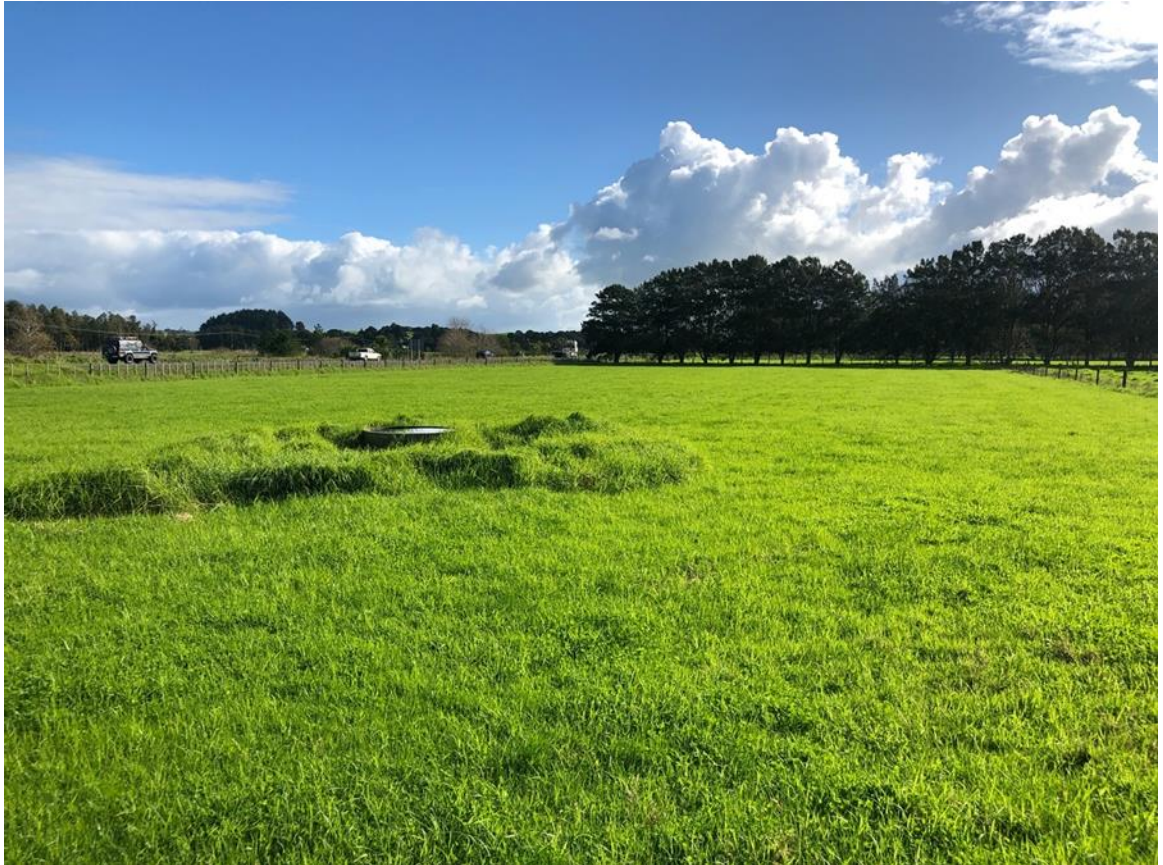
**Figure 27. View looking north over grazing pasture towards areas of tree planting**

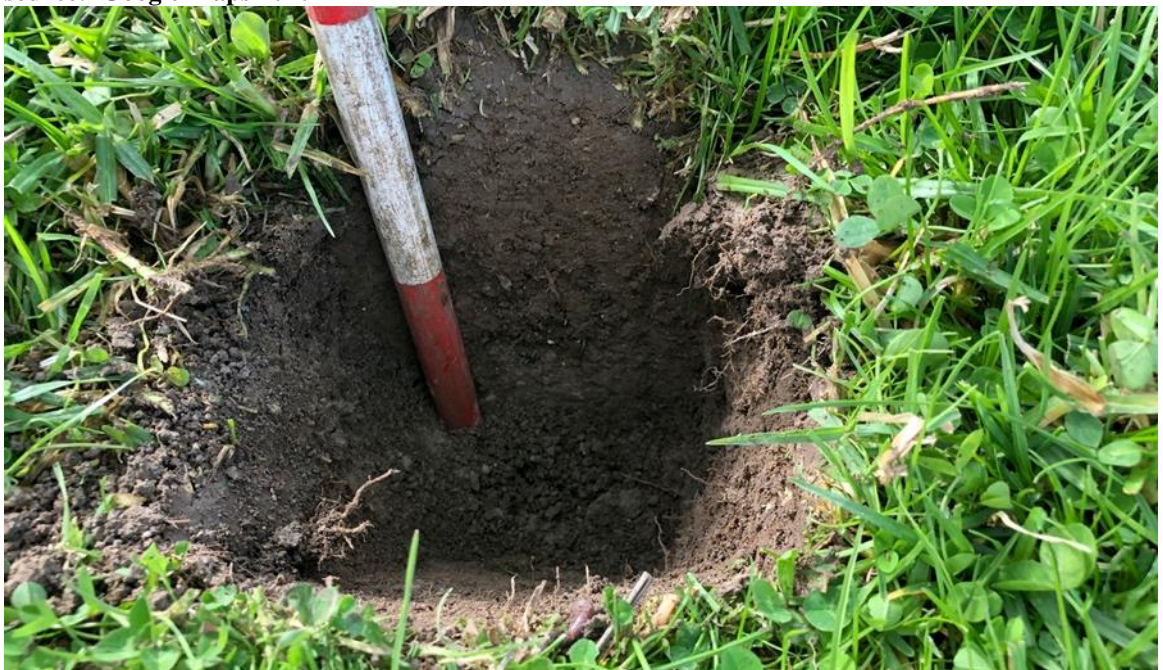
Test pits were largely consistent over the central and western sections of the property, displaying silty soils of a mid-brown grey colour (Figure 29), although test pits towards the eastern boundary of the property revealed the natural peaty subsoils, consistent with a band of Ruakaka peaty sandy loam soils (RK) that is recorded within this area (Figure 30). Test pits around the central farm house showed a modern modified soil profile (Figure 28 – Test Pits 12 & 13). A concrete pad identified beneath grass cover within the vicinity of Test Pit 5 (Figure 28) is likely associated with mid-20th century activity rather than pre-1900 occupation.

Figure 29. Typical soil profile across the central and western sections of the property

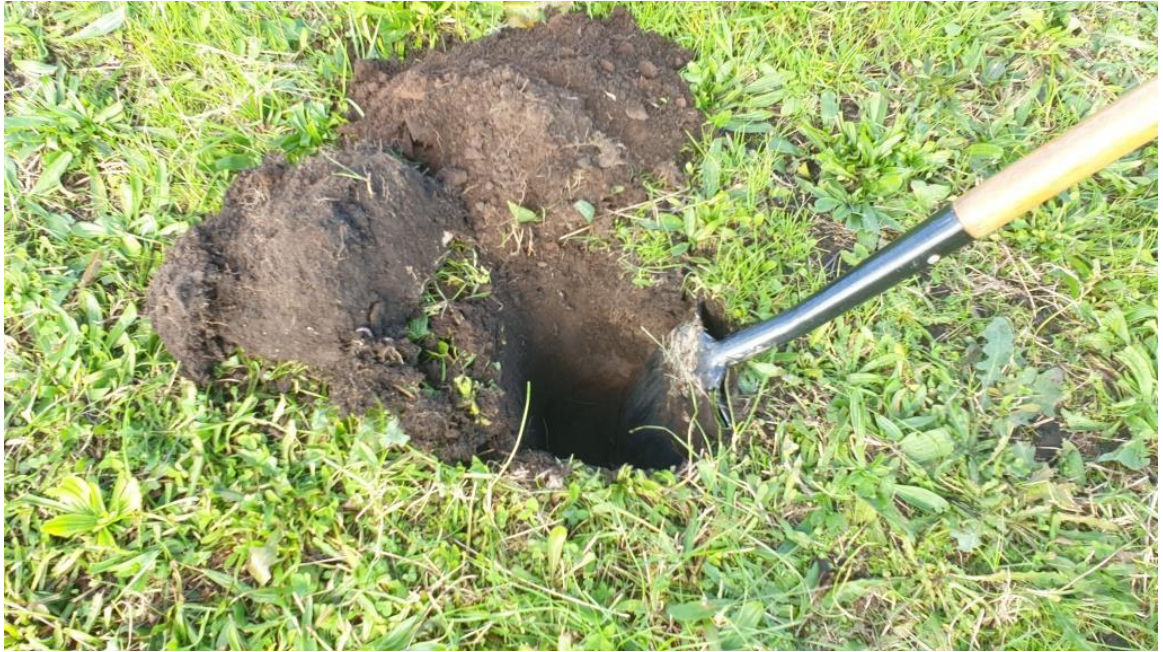
**Figure 30. Dry peat soils exposed in Test Pit 1 at the eastern boundary of the property**

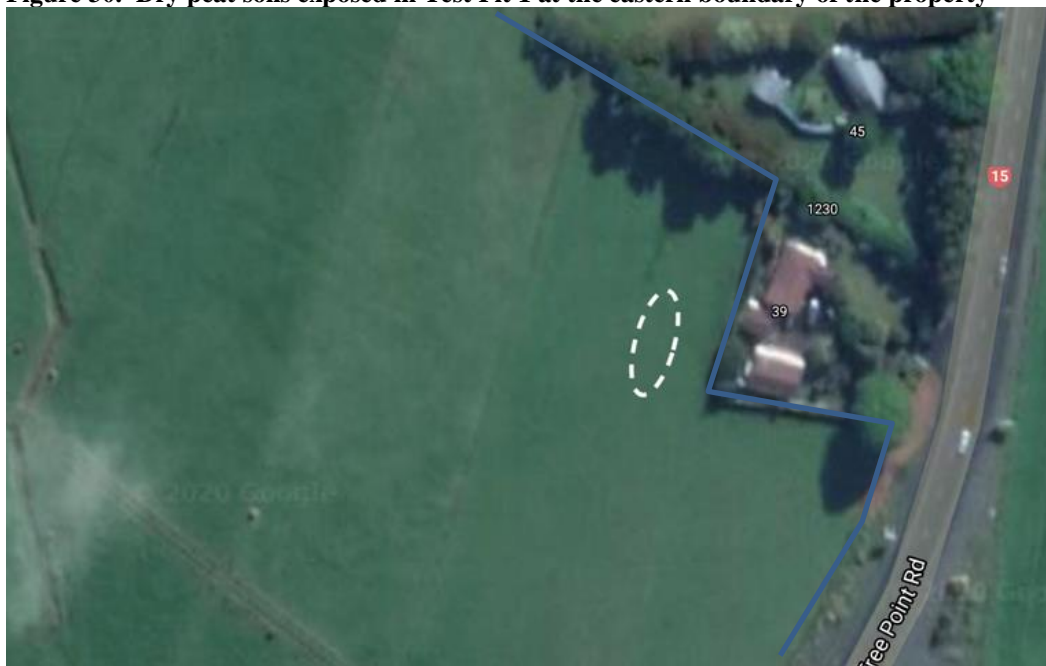
One archaeological site was identified within the project area as a result of the recent field assessment. The site was identified on the slightly elevated peaty ridge located at the far north-eastern corner of the property (Figure 31). The site comprises a subsurface heavily disturbed deposit of shell midden that has been spread (no doubt through modern cultivation) across an area of c.20 x 5m across the crest of the low lying ridge. The midden deposit comprises a 10-12cm thick layer of highly fragmented shell in a charcoal stained mixed soil, located immediately beneath the turf. The midden was identified through probing and was confirmed in Test Pit 17 (Figure 28, Figure 33). The midden forms part of recorded site Q07/334. No other archaeological material was identified within the area and it is likely that other recorded deposits are located within the adjacent private properties.

**Figure 31. Aerial showing the location of the identified portion of Q07/334 (outlined in white) in relation to the eastern property boundary (overlaid in blue).**

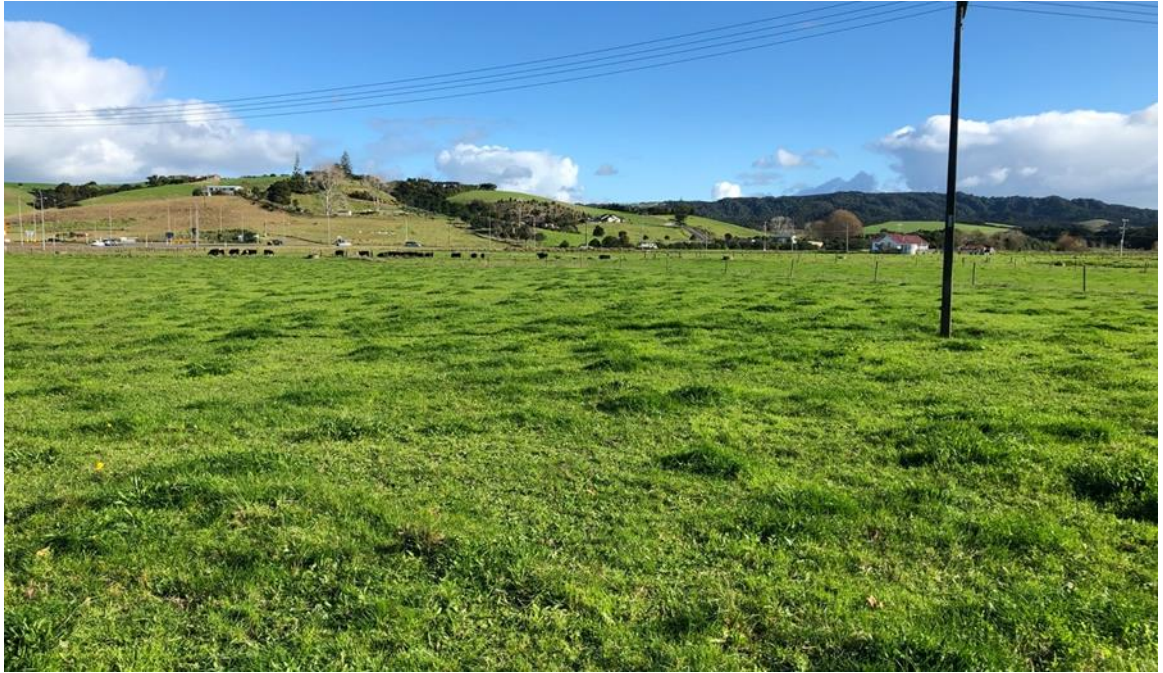
**Figure 32. View looking southwest over the location of shell midden Q07/334**

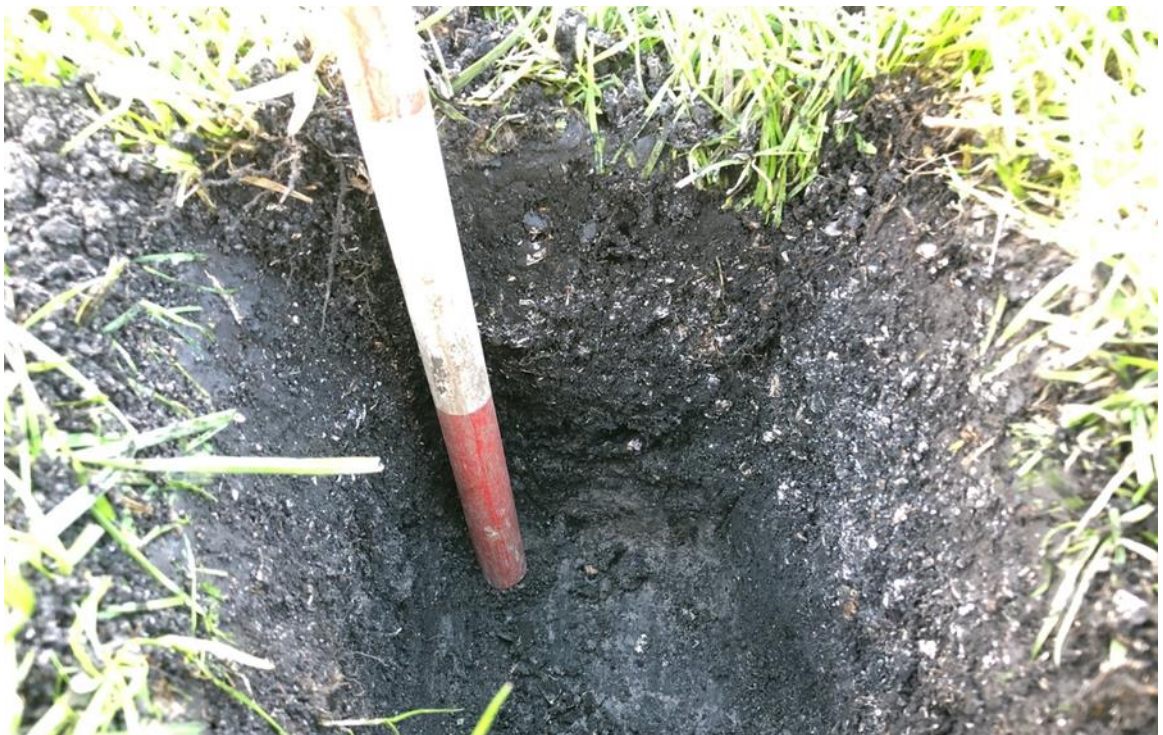
**Figure 33. Test Pit 17 showing the profile of midden deposit Q07/334**

Value	Assessment
Condition	The site is currently in poor condition, having suffered significant damage through modern cultivation activities.
Rarity	Shell midden sites such as these are the most common site type recorded throughout the region.
Contextual value	The site forms part of the pre-European Maori cultural landscape of the Ruakaka area and provides evidence of activity and occupation within and around the Ruakaka wetlands.
Information potential	The site retains limited information potential as there is no longer an intact cultural layer evident. Information may be limited to analysis of shell species and potentially a radiocarbon date if a suitable sample were to be obtained. There is some potential for previously unidentified subsurface features to be present within this area also (e.g. postholes, firescoops).
Amenity value	The component of the site that is located within the subject property currently has no identified amenity values as it is located within private property and is located entirely subsurface.

- Preliminary earthworks should be monitored by an archaeologist to establish whether any sites are present.
- If no authority has been obtained and subsurface archaeological evidence should be unearthed during earthworks (e.g. intact shell midden, hangi, storage pits relating to Maori occupation, or cobbled floors, brick or stone foundation, and rubbish pits relating to 19th century European occupation), work should cease in the immediate vicinity of the remains and Heritage NZ and the Council should be notified. An Authority must be obtained before any further work can proceed which affects the archaeological site. (Note that this is a legal requirement).
