**Freshwater Habitat Assessment:
Ruakaka Visitors Centre Site, SH1 –
SH 15, Northland
November 2020**

Document title:	Freshwater Habitat Assessment: Ruakaka Visitors Centre Site, SH1 – SH 15, Northland
Prepared for:	Ruakaka Developments Limited
Version:	Version 3
Date:	19 November 2020
Document name:	63536 Ruakaka Visitors Centre Site Ecological Assessment Nov20

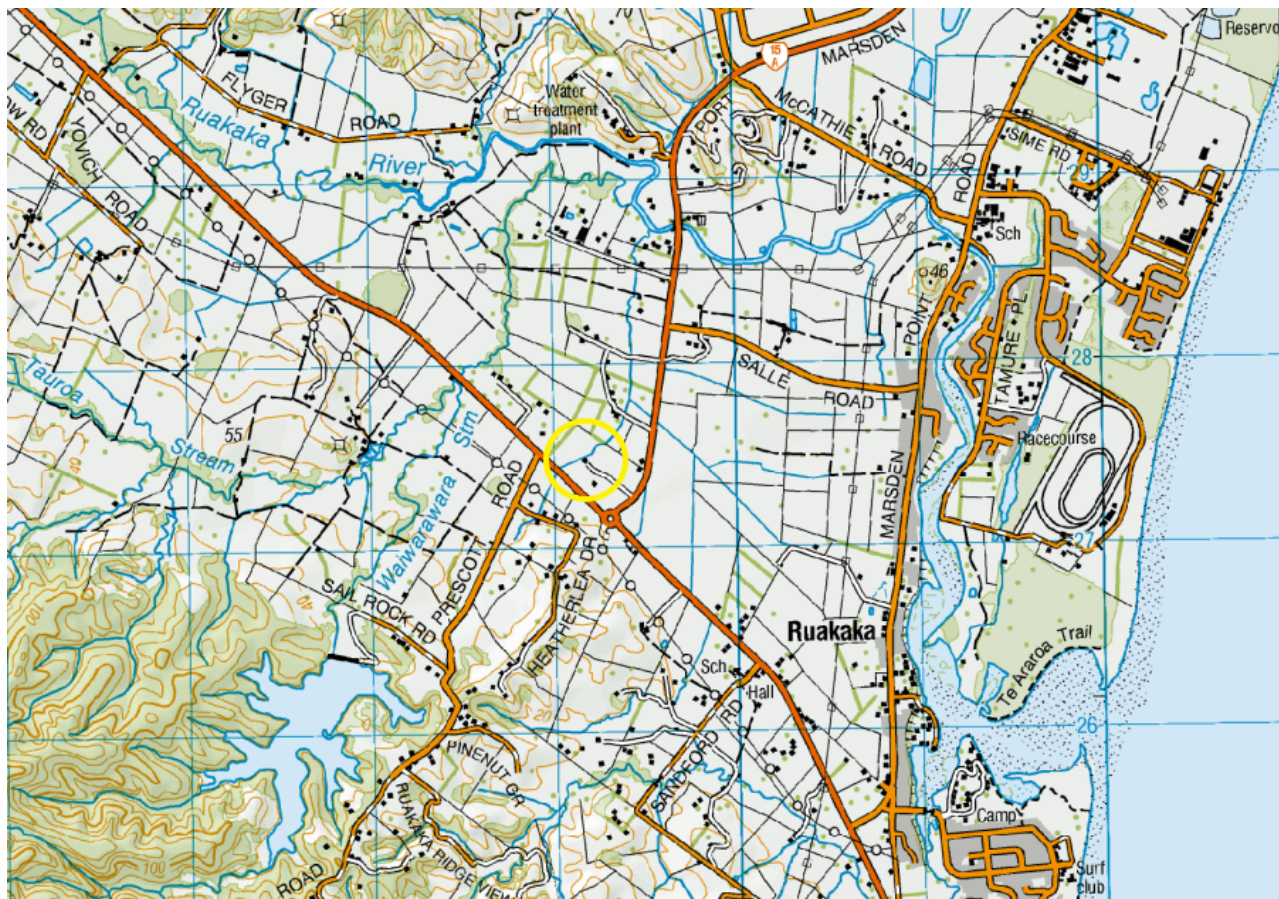
The stream is a lower tributary to the Ruakaka River. From SH1 the stream flows north, parallel to SH15a (Port Marsden Highway) for 1.6km to the tidal reaches of Ruakaka River (Figure 1Figure 2).

Figure 2. Location of site watercourse (yellow circle) and the Ruakaka River.

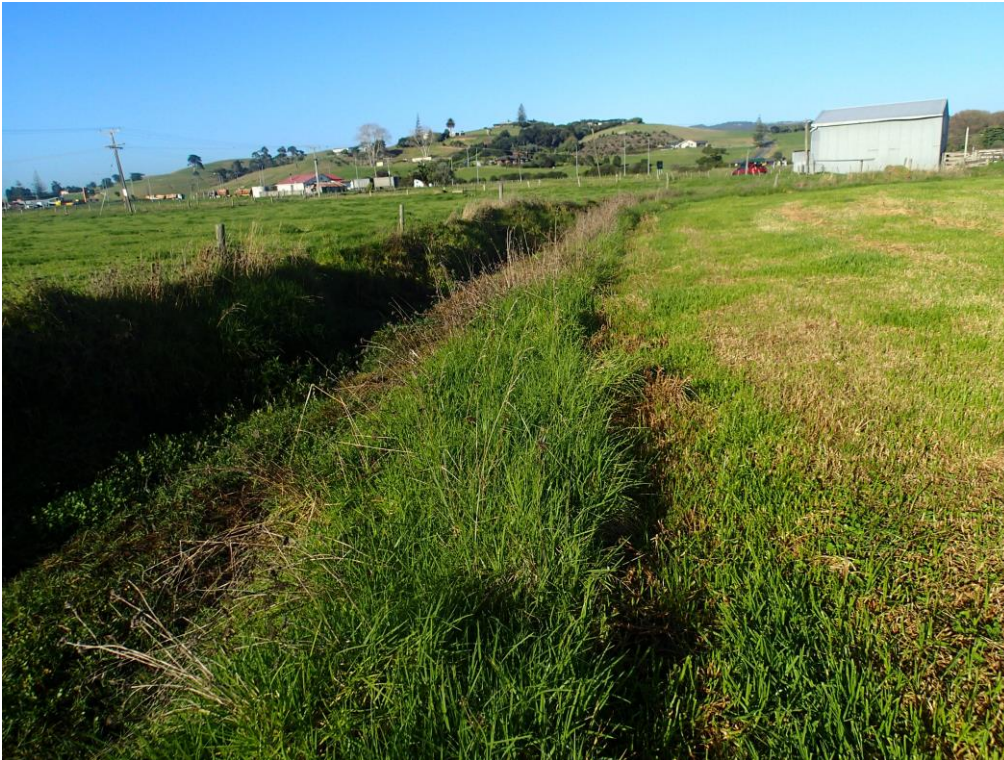
boundary. The stream path had been clearly modified and has been maintained for stormwater / flood control with a straightened channel, wide flat base and uniform banks (Photo 1).

Photo 1. Straightened and deepened watercourse view upstream

The previous modifications have widened the channel base which reduces the length of time aquatic habitat is present. The site development provides an opportunity to mitigate this effect with the inclusion of a low flow channel in the base of the wider channel to allow for longer retention of aquatic habitat. Additional aquatic ecological benefits can be gained with the addition of meander to the low flow channel (within the existing high flow channel) and the addition of plants or trees in and adjacent to the channel to increase hydrologic variability.

The low flow channel would only require an approximate 0.3m wide, by 0.15 - 0.2m deep (maximum) excavation, within the main channel including a long meander (e.g. two bends within a 20m length). The emphasis on the meander is to provide variation in form. The use of *Carex* species in patches within the main channel and occasional trees that prefer damp habitats, such as kahikatea (*Dacrycarpus dacrydioides*) or pukatea (*Laurelia novae-zelandiae*), on the outer edges of the main channel next to the banks, would provide additional hydrologic variation and shading to the immediate channel. Native *Carex* species provide the ecological benefits of shading, leafy inputs, filtration and velocity control, without major effects during high flows, as they flatten down with the increase in water and velocity, springing back when the water levels recede.

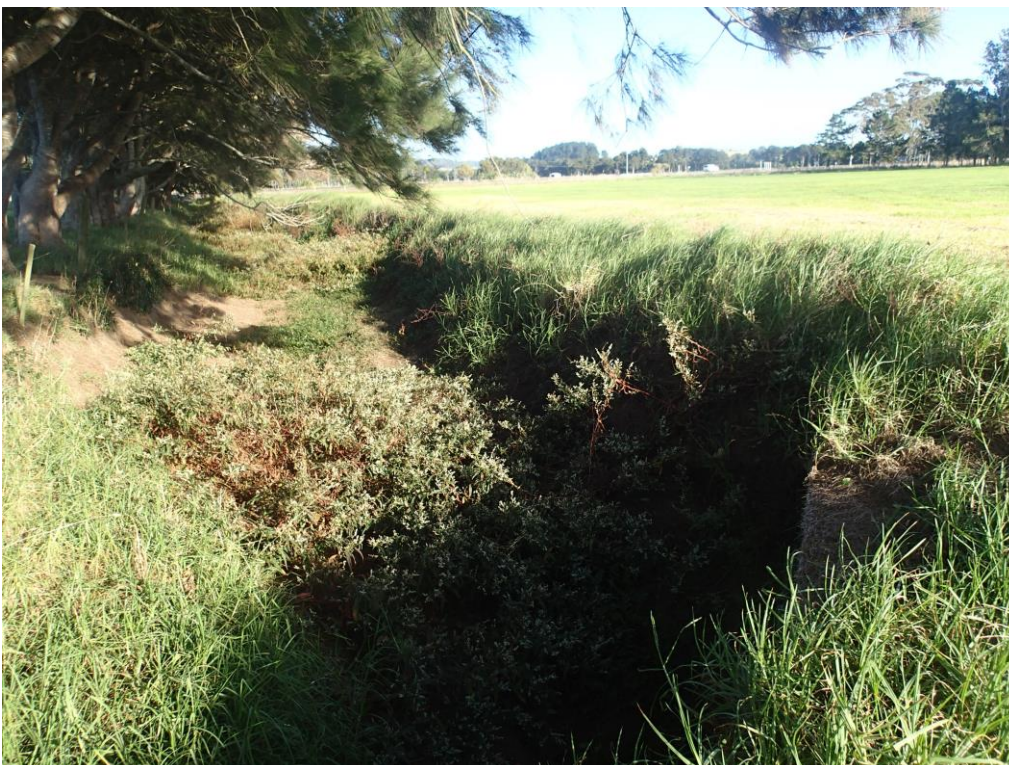
Although the channel was dry, exotic plants that are commonly found in damp areas were present throughout the flow path. Water pepper (*Persicaria hydropiper*) dominated with occasional patches of Mercer grass (*Paspalum distichum*) and water celery (*Apium nodiflorum*). From approximately 10m downstream of SH1 to the end of the line of trees on the true right bank water pepper dominated the stream (Photo 2).

The flattened base of the channel averaged 3m wide with a bank to bank width of 5m.

Photo 2. Wide flat bottomed straightened stream bed with water pepper.

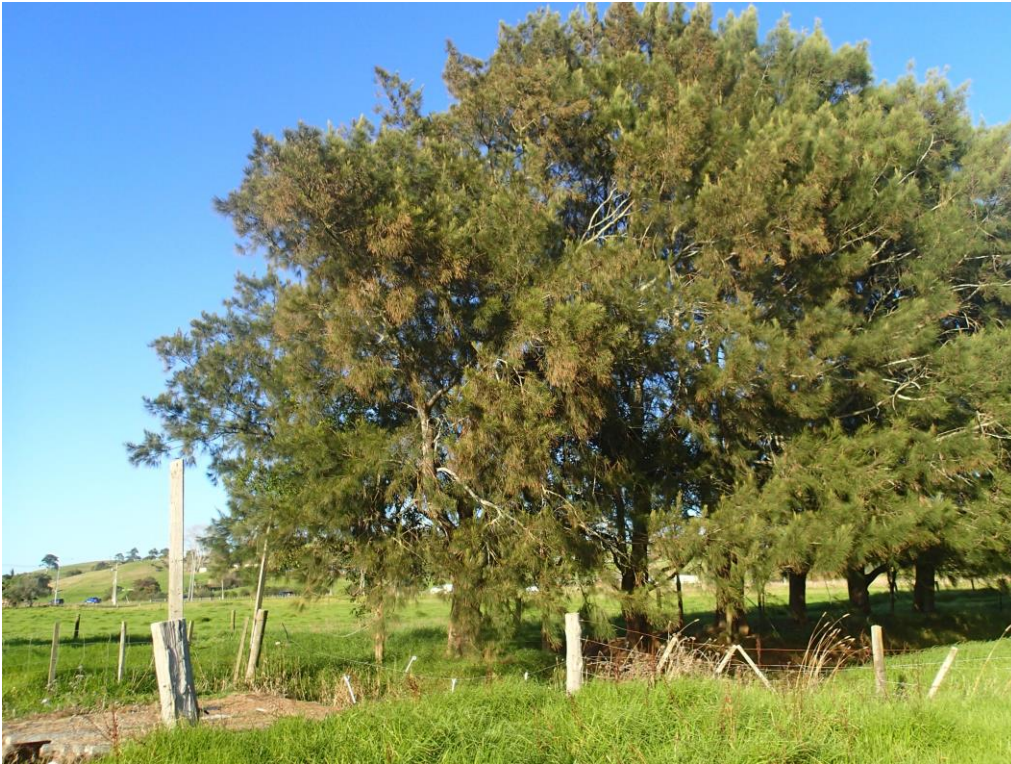
An access bridge (Photo 3) and a culvert was present in the flow path. The culvert was approximately 10m long, 1.2m internal diameter and dry, with variable substrate throughout the length of the pipe. The dried marks of previous water levels ranged between 0.27m depth (1.06m width) and 0.4m depth (1.16m width) within the culvert (Photo 4). Upstream, the ground level rose about 0.3m above the culvert in a wide shallow swale approximately 4m wide, with 1.5m banks and 5 -6m width at the top of the banks. Water pepper formed a monoculture in the base of the dry flow path (Photo 2, Photo 5).

Photo 3. Sheoaks and access bridge with channel and base of trees.

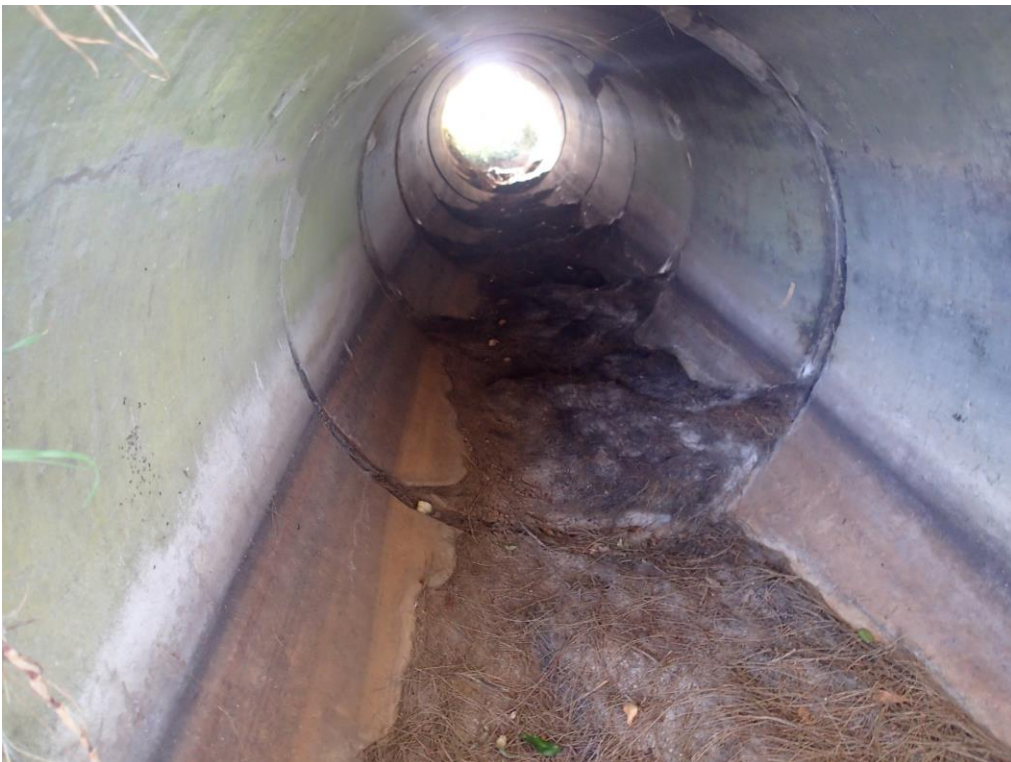
Photo 4. Culvert with natural substrate in base

- removing the existing culvert in the watercourse approximately 100m downstream of SH1;
- adding a road crossing culvert in the main stream (for access to the site for southbound vehicles);
- riparian planting of the stream banks; and
- fencing to exclude stock access.

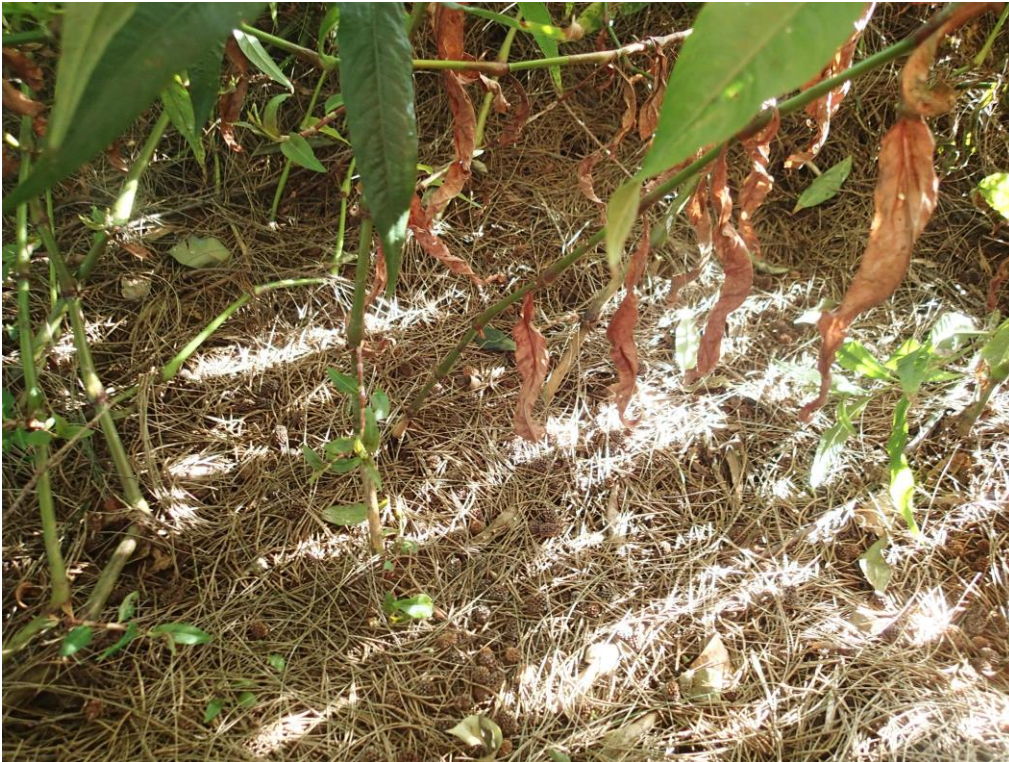
Photo 5. Dry stream bed covered by sheoak needles under the water pepper

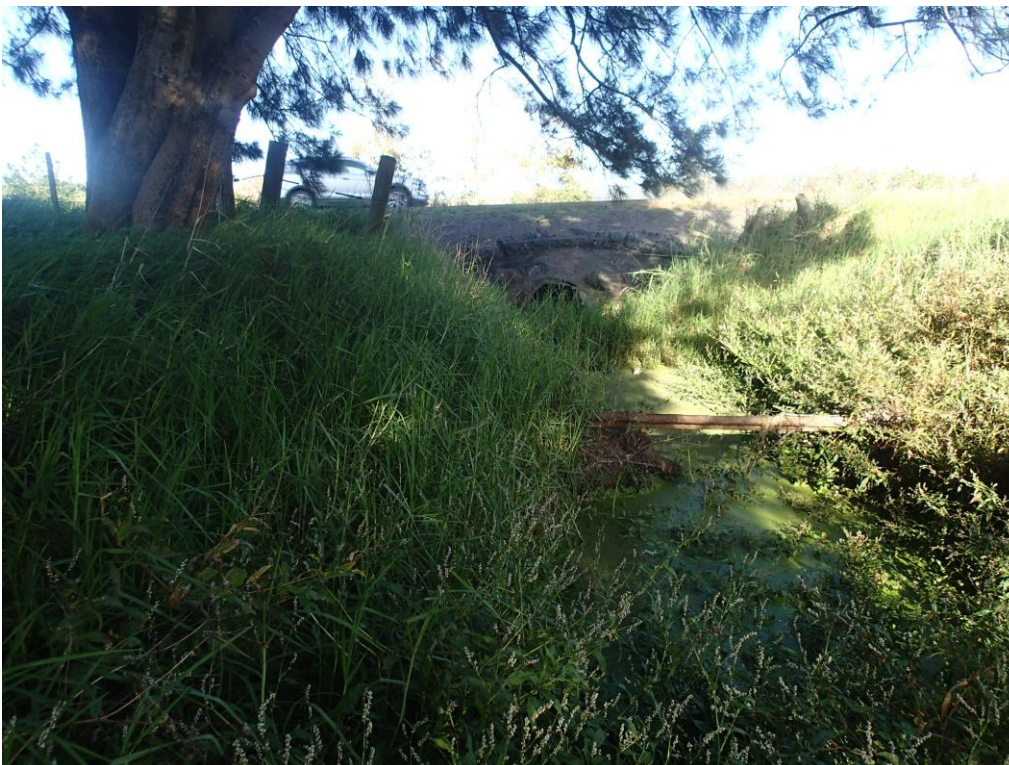
Near the SH1 boundary fence a 10m long by 2m wide culvert outlet pool was present. There was no flow into or out of the pool. The top of the water level extended past the boundary fence and roadside drains to approximately 4m into the SH1 culvert. Duckweed (*Lemna minor*) and azolla (*Azolla pinnata*) covered the water surface in distinct zones, separated by kikuyu covered fencing (Photo 6).

Photo 6. SH1 culvert outlet pool with pond weed in foreground transitioning to azolla. Pool divided by kikuyu covered fence wire at the boundary, partially obscuring culvert in background.

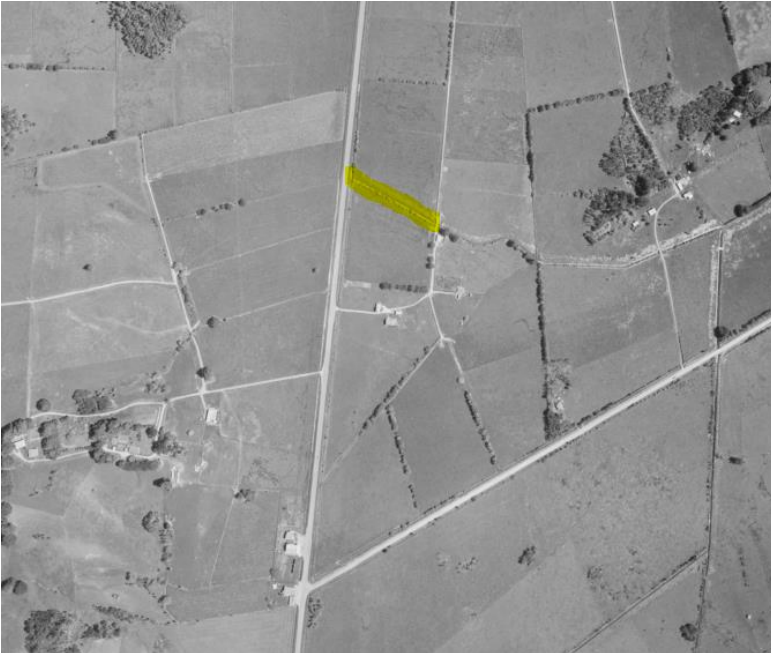
Straightened flow path clear in March 1961 (Source: Retrolense)

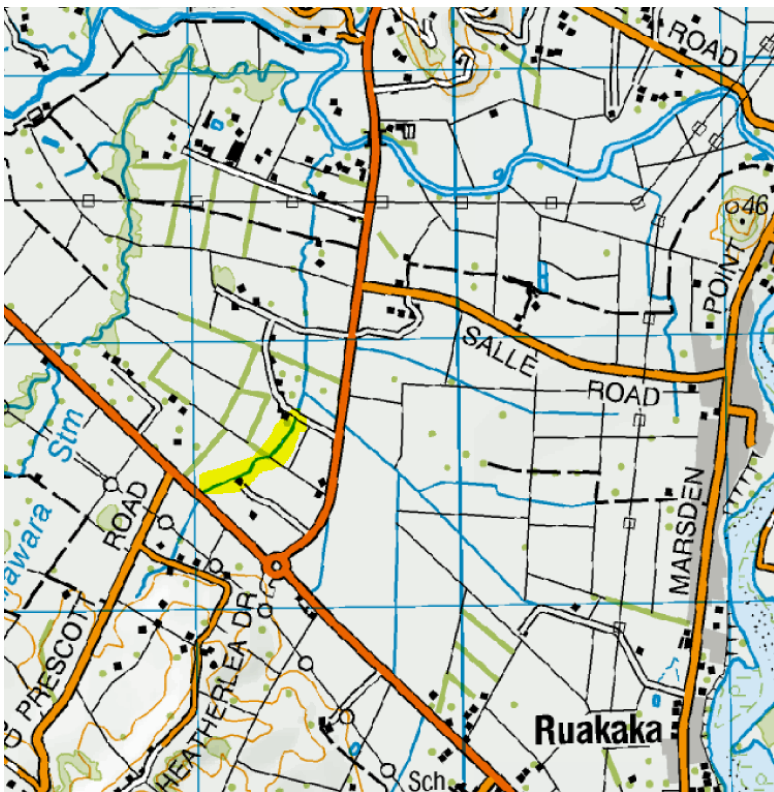
Site tributary appears as a river on NZ Topographical Maps (1: 50,000)
