GEOTECHNICAL INVESTIGATION REPORT
FOR
PROPOSED RESIDENTIAL DEVELOPMENT
SECTION 1 SO 65970, DIP ROAD, KAMO, WHANGAREI

Project Reference: 19103
2 July 2021

LDE LTD

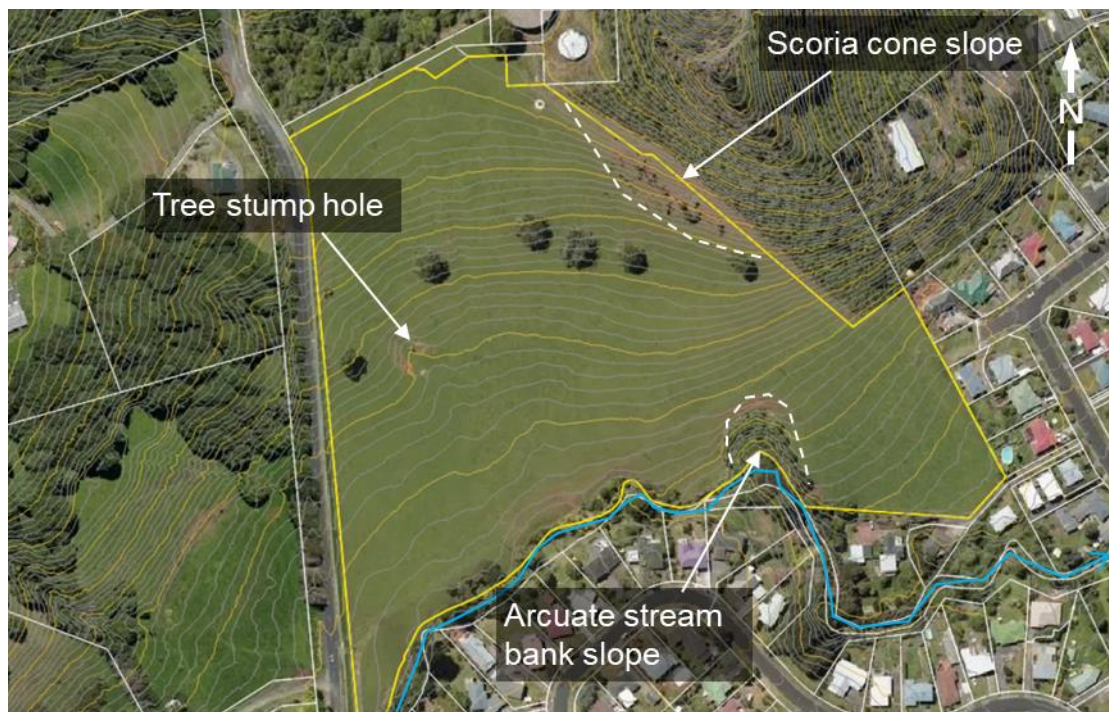
Figure 4: Topographic plan of the subject site with notable site features identified. Contours shown at 1m interval with 5m major contours, falling from north to south through the site. See attached investigation for full scale plan.

Qualitative assessment of the stability hazard through these areas has been undertaken based on the findings of the subsurface investigation, laboratory testing, and geomorphic study. These areas are photographed in Figure 5 and 6 respectively, and are broadly delineated by the white dashed line on Figure 4.

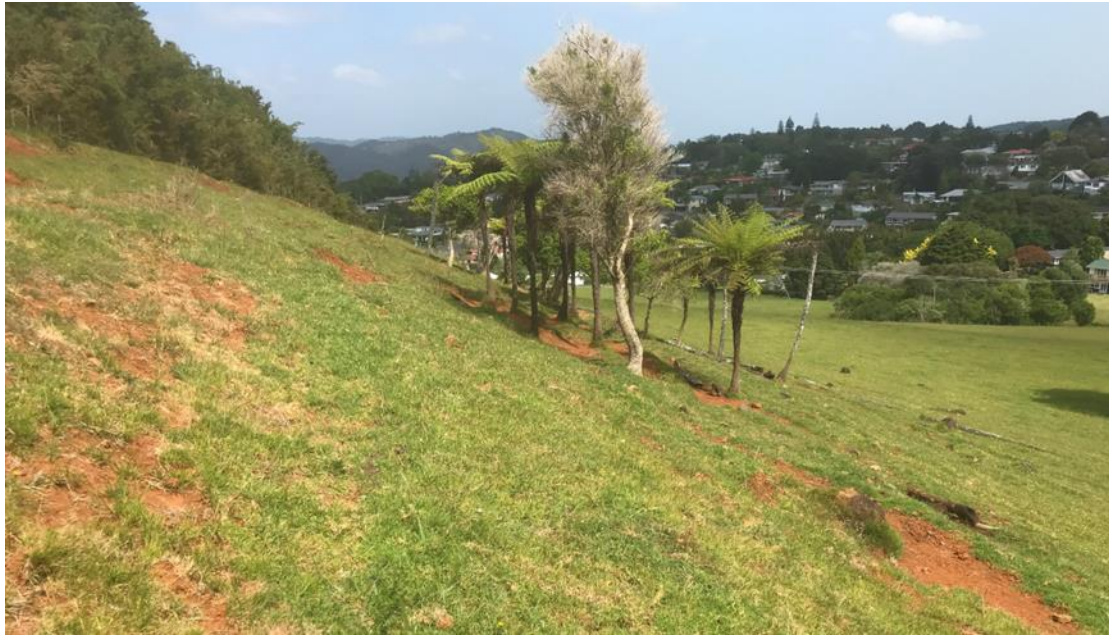
Figure 5: Photo showing the steep slope at the north-eastern boundary.

The north-eastern edge of the site borders the mapped scoria cone, with the side slope of this feature forming a steep bank at the boundary, with slopes up to approximately 1V:2H (27°) (Figure 4). A rough track is cut along of the top of this slope, appearing to follow the alignment of the watermains which pass through the site.

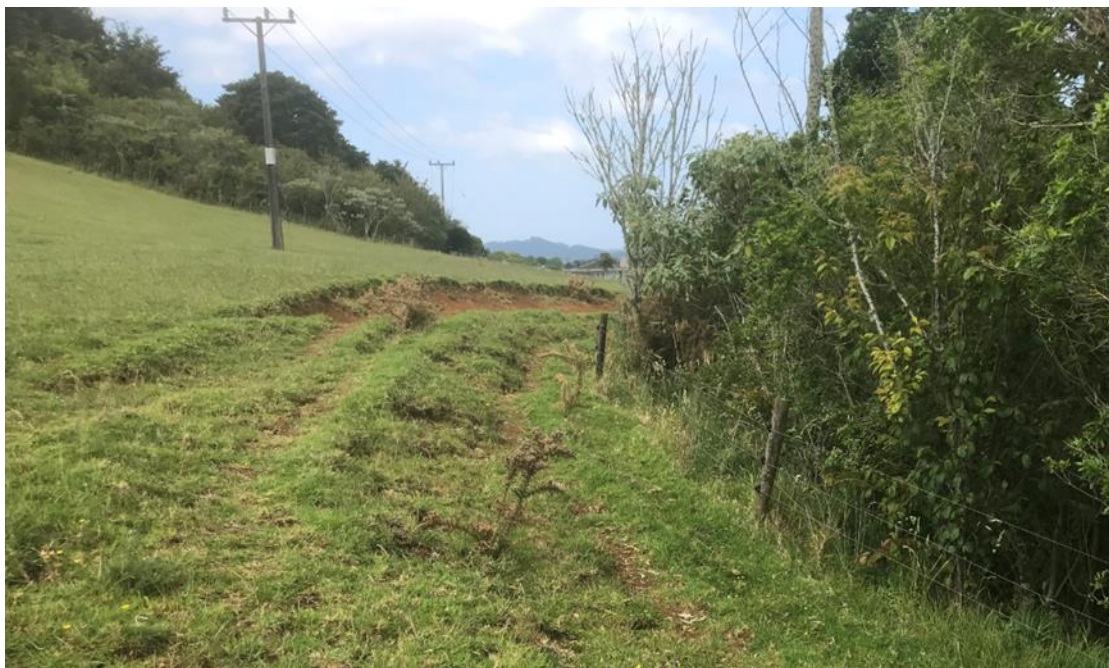
Figure 6: View east over the crest of the arcuate stream bank slope, showing area of erosion or livestock tracking.

This slope affects a relatively small areas of the site against the southern boundary. The slope itself is largely obscured in bush, below the fenceline, however the head of the slope is noted by an area of minor erosion and terracettes. The erosion in this area is likely the result of livestock damage.

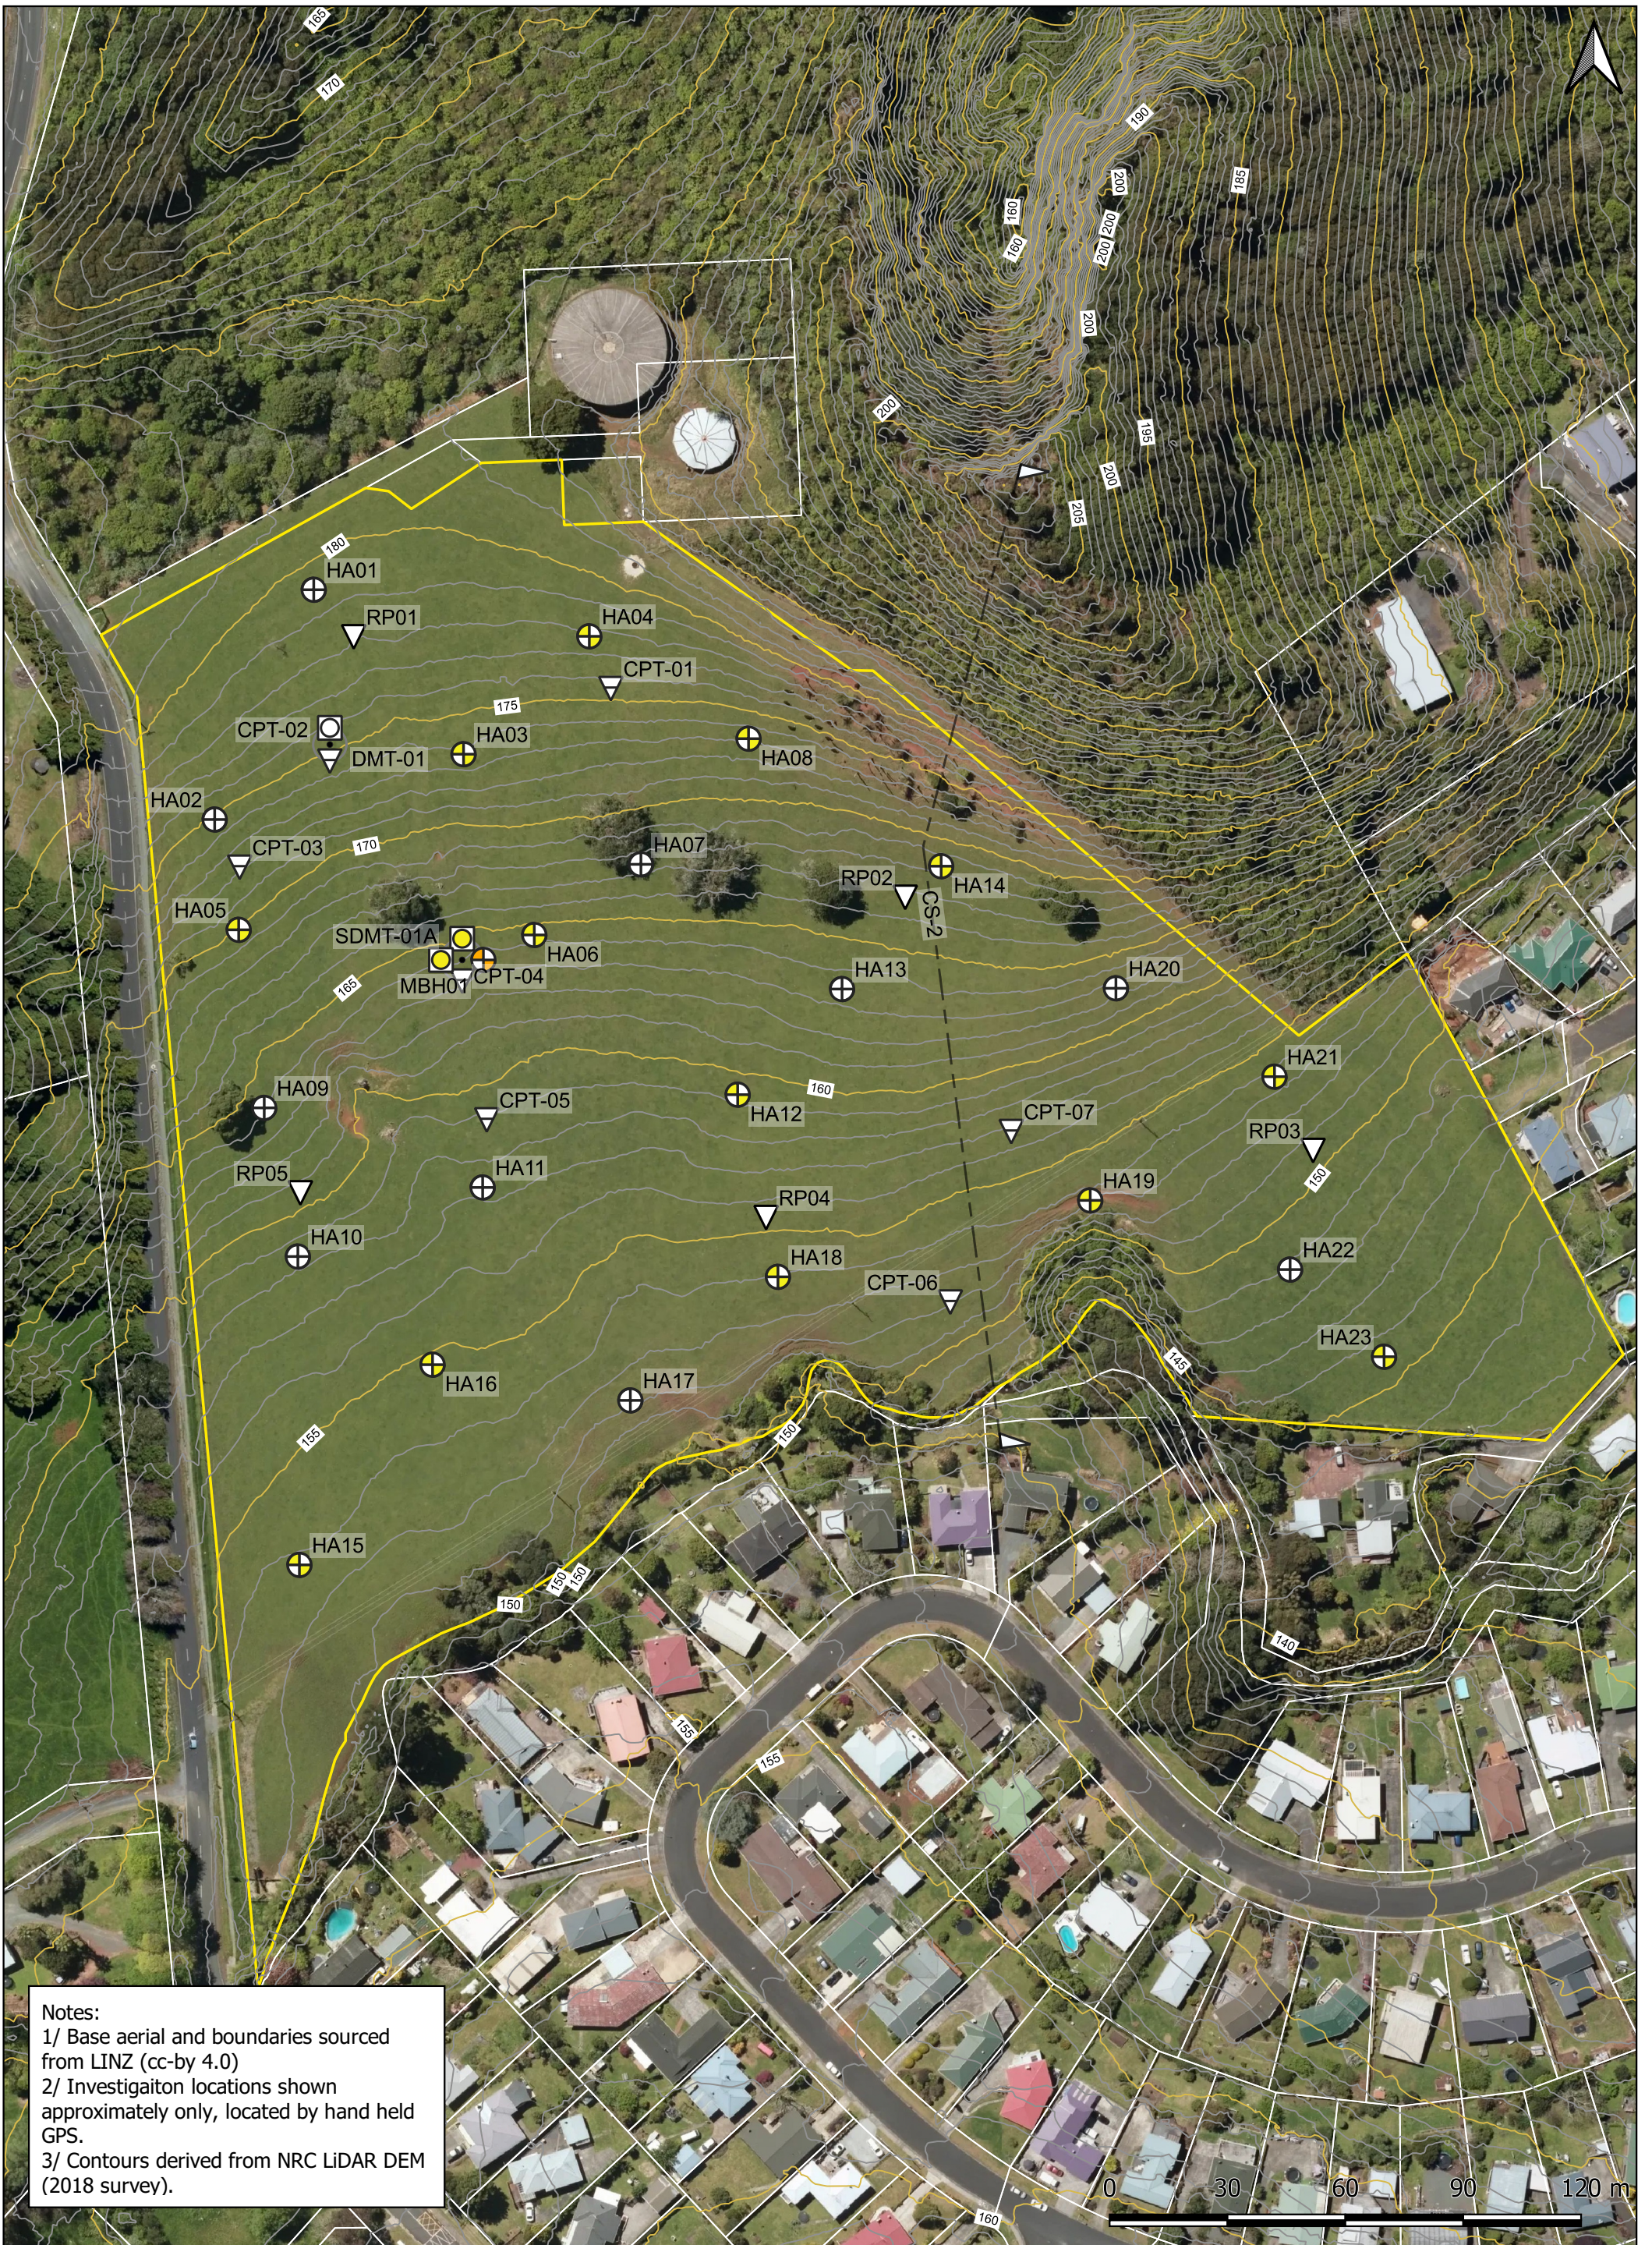
Notes:
 1/ Base aerial and boundaries sourced from LINZ (cc-by 4.0)
 2/ Investigaiton locations shown approximately only, located by hand held GPS.
 3/ Contours derived from NRC LiDAR DEM (2018 survey).

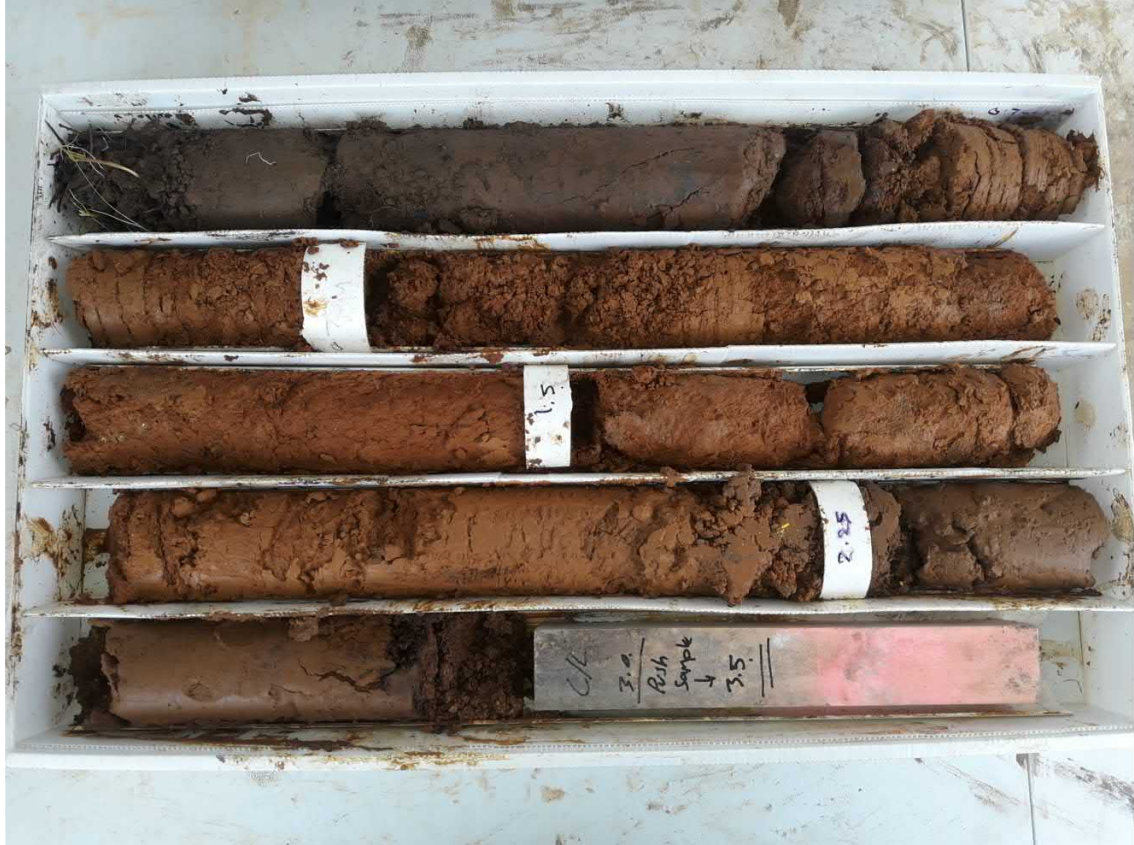
0.00-3.40m

CONE PENETRATION TEST (CPT) LOG
