Landslide Susceptibility Assessment for Whangarei District Council

Prepared for
Whangarei District Council
Prepared by
Tonkin & Taylor Ltd
Date
October 2022
Job Number
1012149.3000

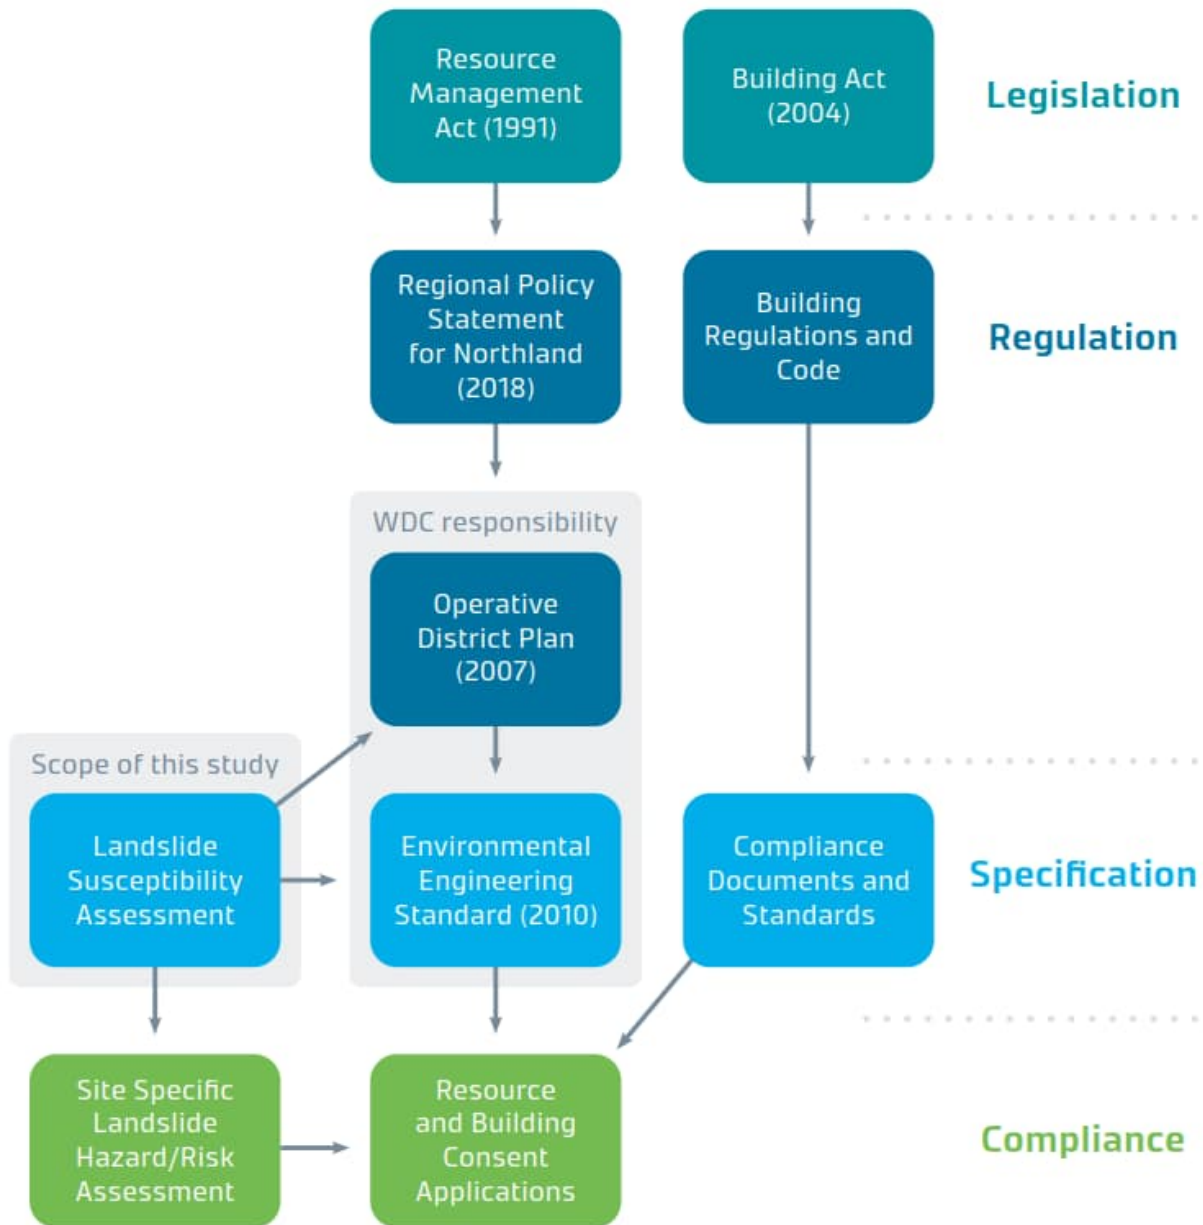
Figure 1.2: High-level legislative and regulatory context and compliance pathway to manage landslide hazards and assessments in the Whangarei District.

The Resource Management Act (New Zealand Government, 1991) and the Building Act (New Zealand Government, 2004) are the two primary pieces of legislation that define the responsibilities for the management of land hazards. The Regional Policy Statement for Northland (Northland Regional Council, 2016) outlines objectives, policies, and methodologies for the management of the natural hazards and the Operative District Plan (ODP) provides controls to achieve stated objectives with regards to natural hazards. These controls are normally in the form of rules to control activities based on their location in relation to a known hazard. The current WDC ODP (2007) does not specifically address landslide susceptibility, however, the EES does provide recommendations for assessments to be undertaken in areas subject to different levels of “land stability hazard”. These areas have been determined by the works outlined in Section 4 of this report. Further details on the provisions contained within each of the aforementioned documents is provided in Appendix D of this report. A high-level legislative and regulatory context and the pathway to compliance is shown schematically in Figure 1.2.

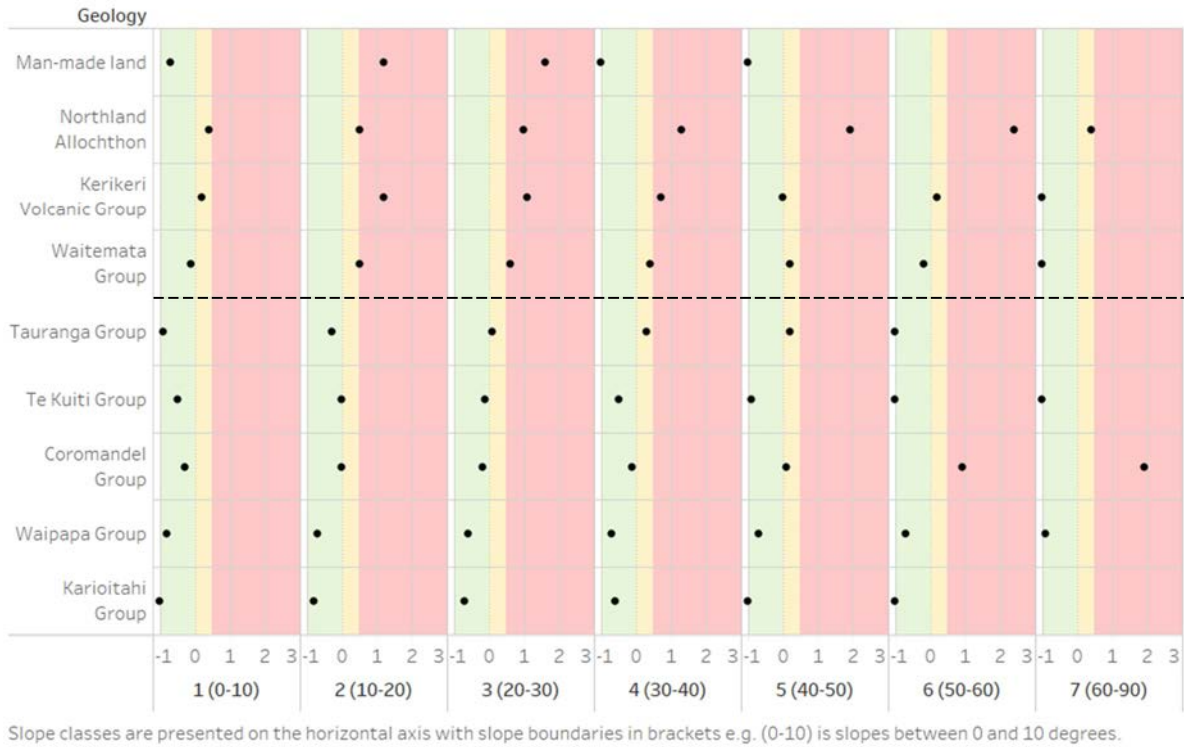
Figure 5.2: Normalised difference values based on Geological Unit and slope angle. Landslide debris ratios have been removed from this chart in order to keep a consistent scale. Please see tabulated figures below for ratios for landslide debris.

Adding slope angle to the Normalised Difference analysis gives further insight into the occurrence of landsliding. Figure 5.2 shows this relationship in chart form, these figures are also presented in Table 5.1. Of the more susceptible units (plotted above the dashed line), the Northland Allochthon is seen to be unstable at angles less than 10 degrees. The Kerikeri Volcanic group appears to have a threshold in the 10 to 20-degree range, although this is likely to be related to the underlying Northland Allochthon. Where we see higher Normalised Difference values in the Coromandel Group at higher slope angles it is likely that these are related to rock fall issues. The Waitemata Group has a stronger correlation with landsliding from slopes starting from 20-30 degrees. In response to the

findings of these assessments we were able to adjust the slope thresholds used in our final susceptibility map.

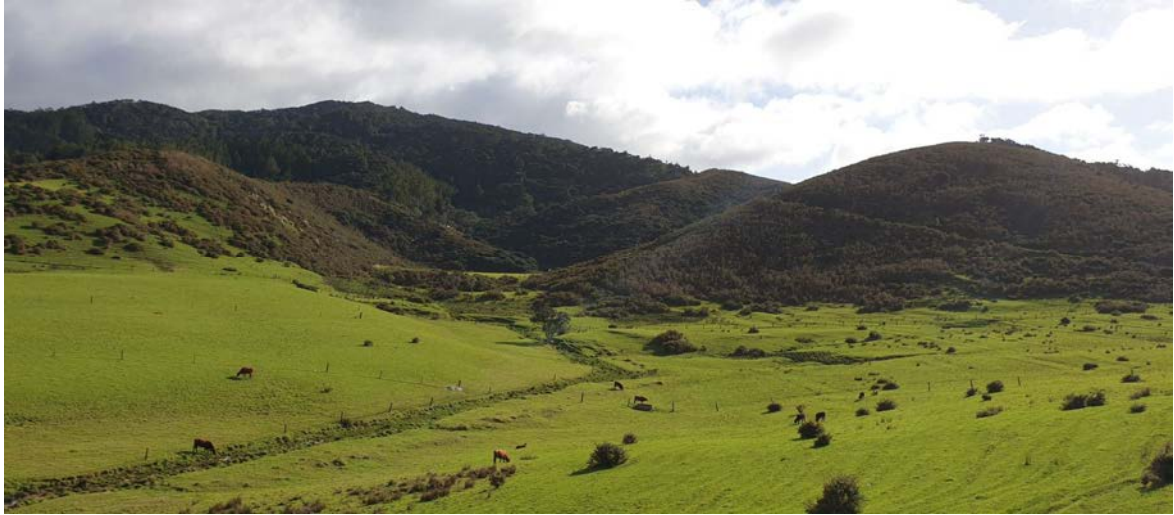
Photograph Appendix C.1: Moderate to steep slopes of Waipapa Group greywacke rocks.

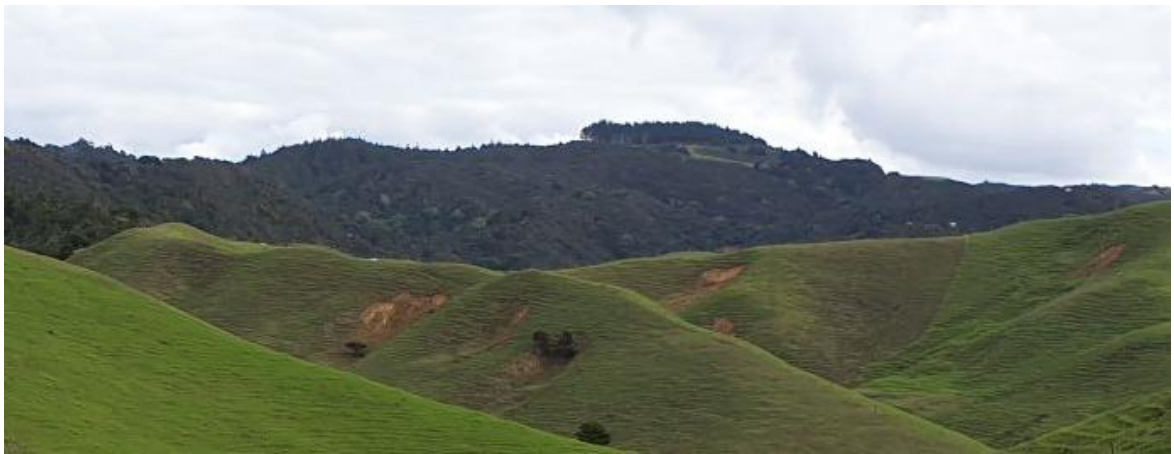
Photograph Appendix C.2: Multiple shallow landslides scarps over the hillslopes.

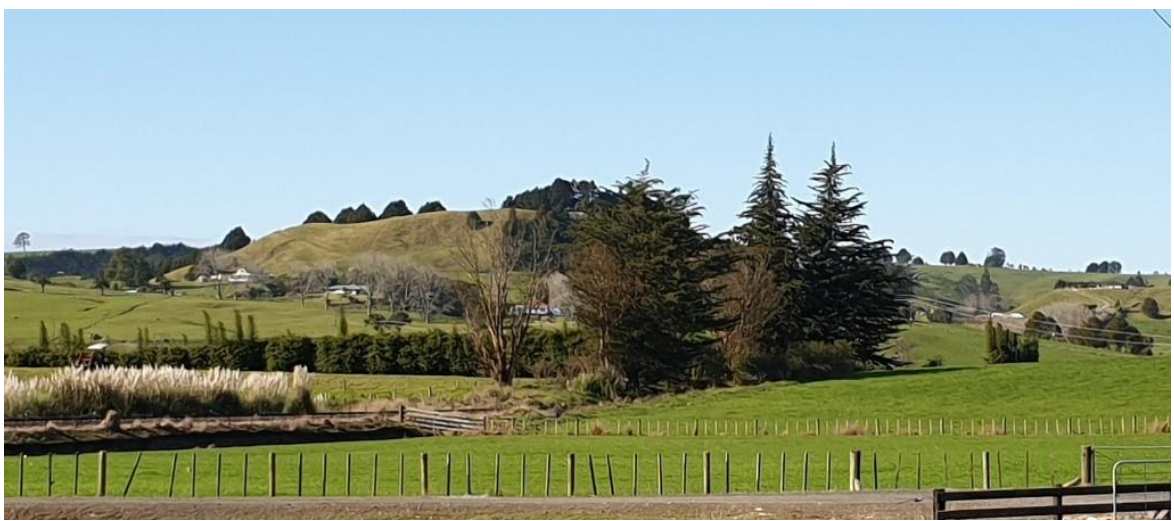
Photograph Appendix C.3: Predominantly stable hillslopes of Te Kuiti Group in the distance.

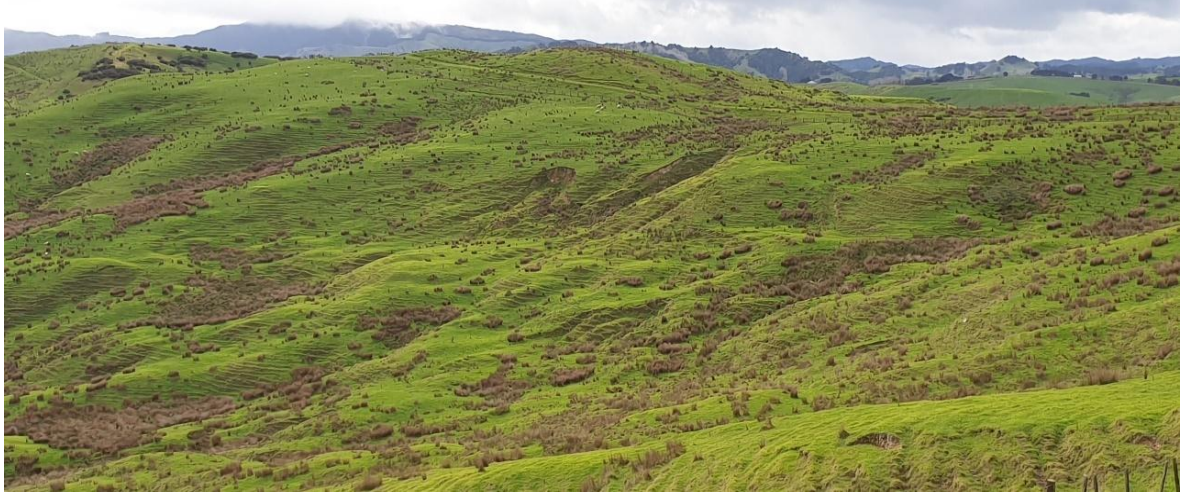
Photograph Appendix C.4: Multiple slump movements observed on very hummocky surface.

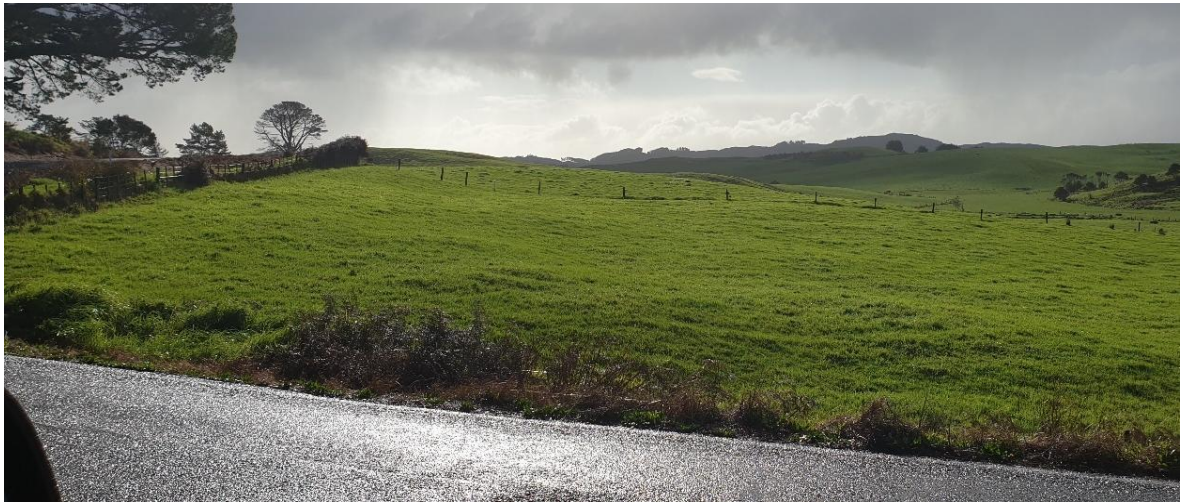
Photograph Appendix C.5: Gentle undulations in Northland Allochthon soils.

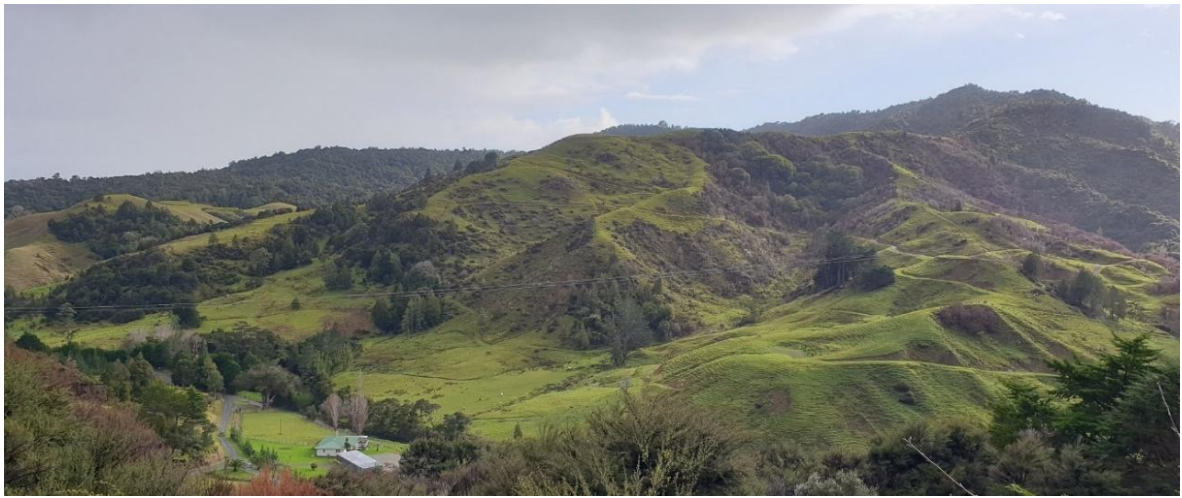
Photograph Appendix C.6: Steep hillsides of Tangihua Complex (Northland Allochthon) with shallow surficial erosion observed.

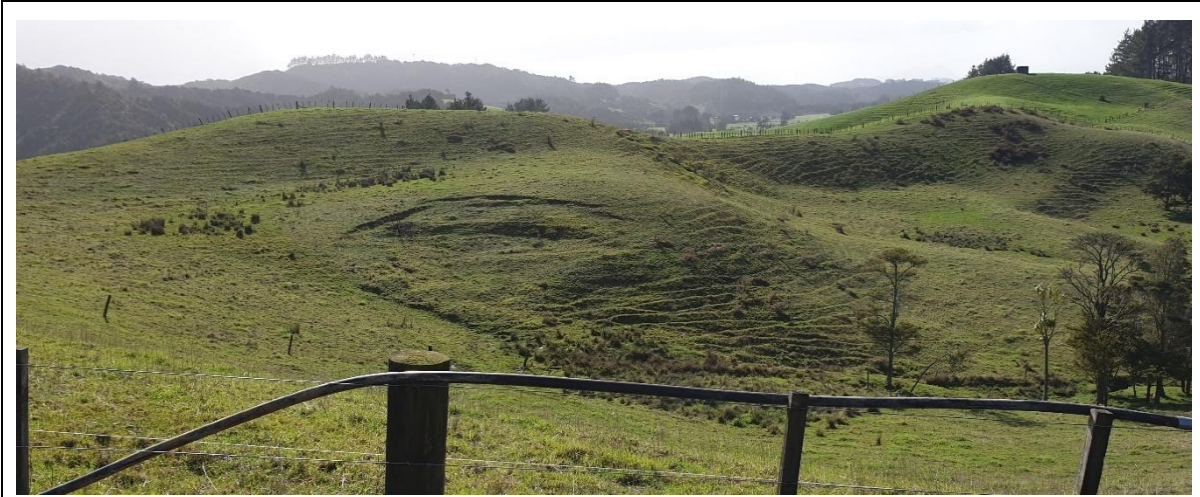
Photograph Appendix C.7: Rotational landslides within Waitemata Group soils, similar features are observed in translational movement also.

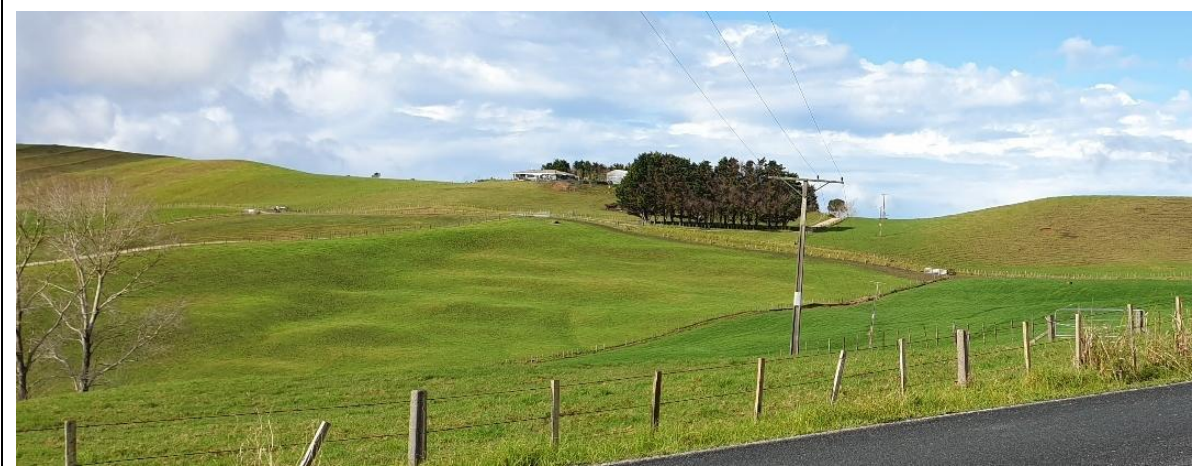
Photograph Appendix C.8: Linear features evident of translational sliding on gentle slopes.

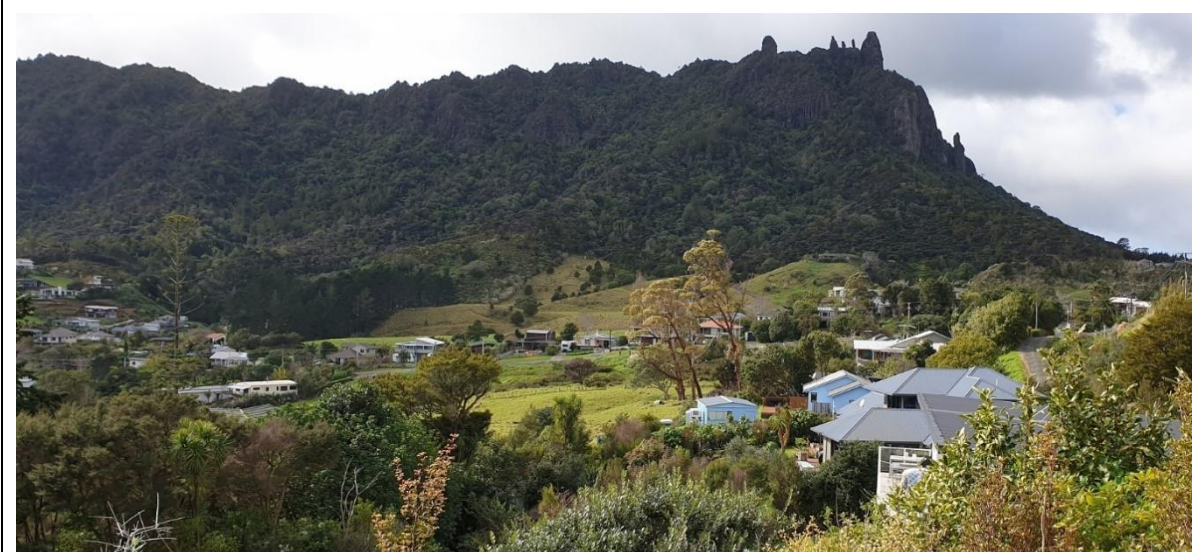
Photograph Appendix C.9: Steep hills with pinnacles of volcanic rock exposed at the surface.

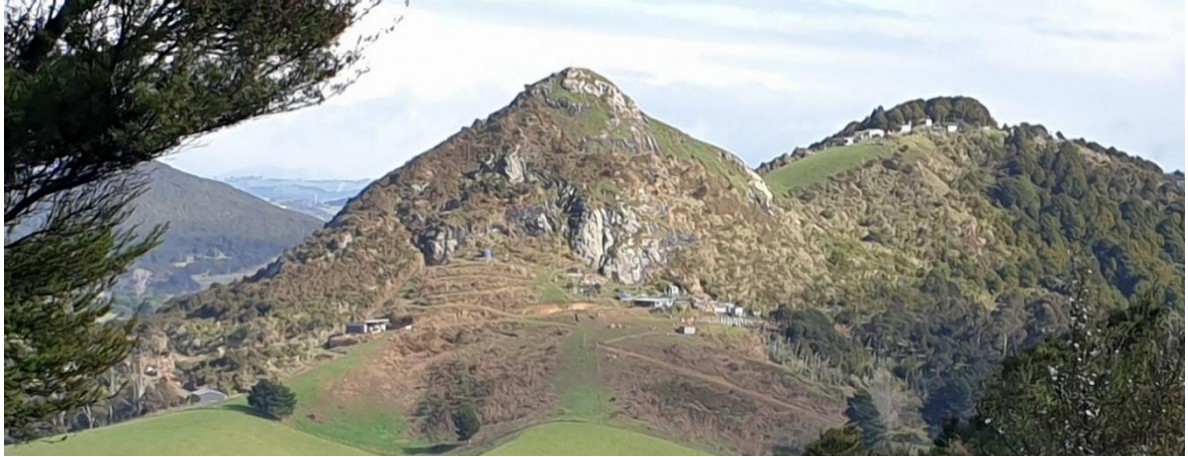
Photograph Appendix C.10: Volcanic rocks exposed on a steep hillslope posing possible rock fall issues.

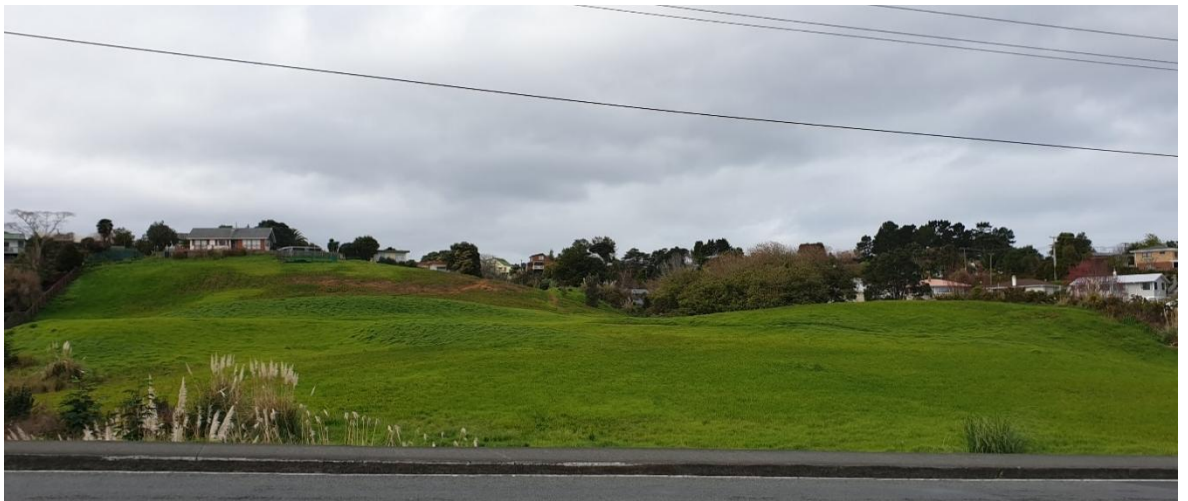
Photograph Appendix C.11: Undeveloped piece of land showing hummocky allochthon beneath volcanics.

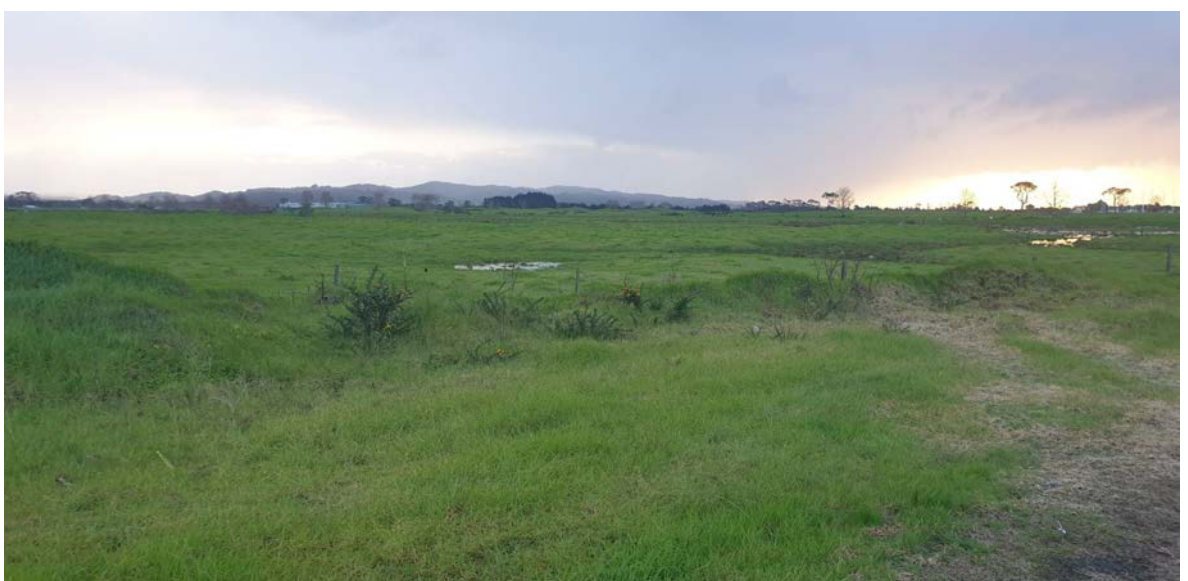
Photograph Appendix C.12: Gently undulating landforms of relict sand dunes with areas of ponding water.

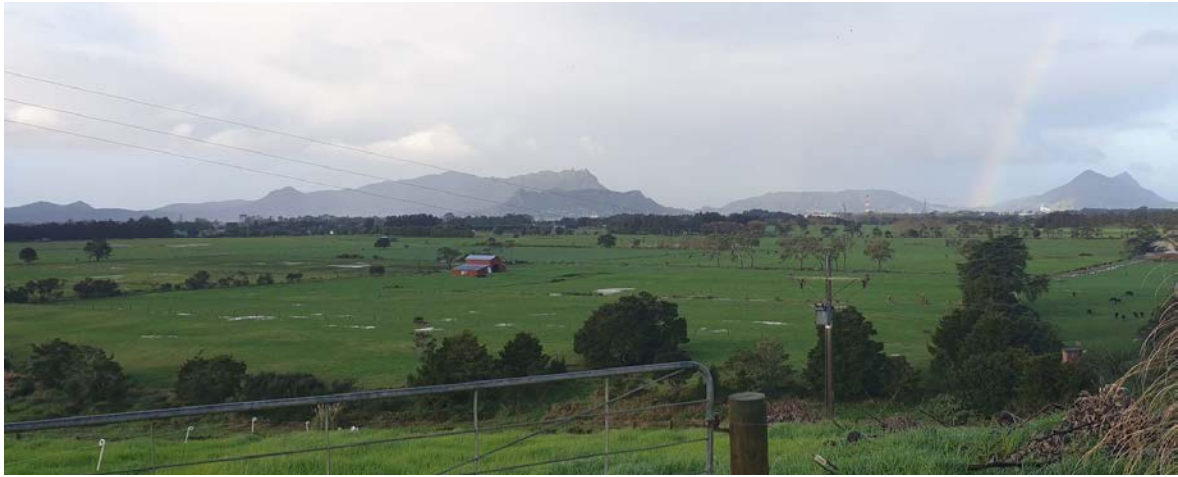
Photograph Appendix C.13: Flat to gently sloping land typical of recent alluvial deposits.

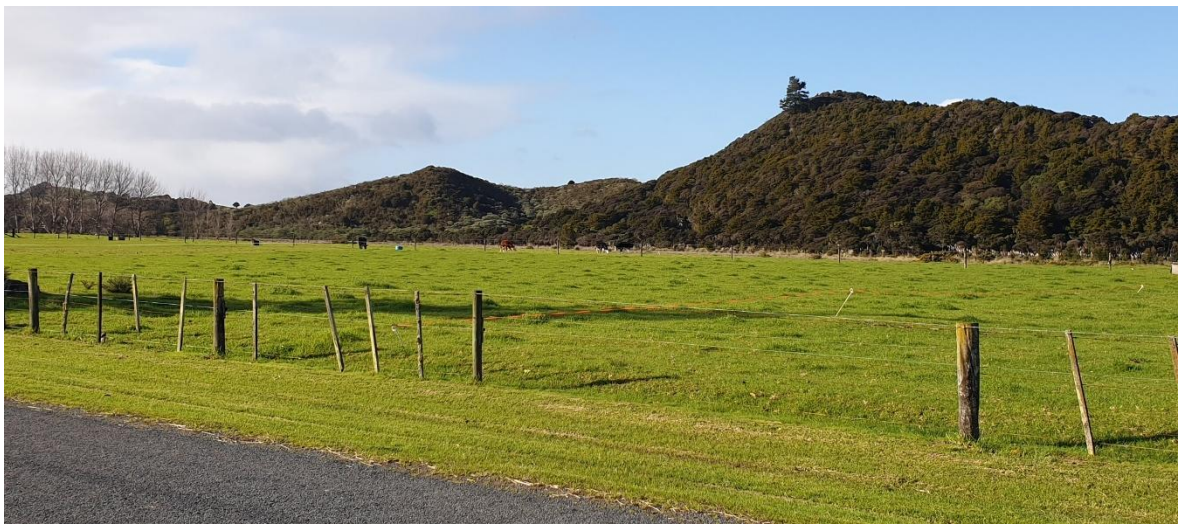
Photograph Appendix C.14: Area of fill observed as flat land surrounded by hills.

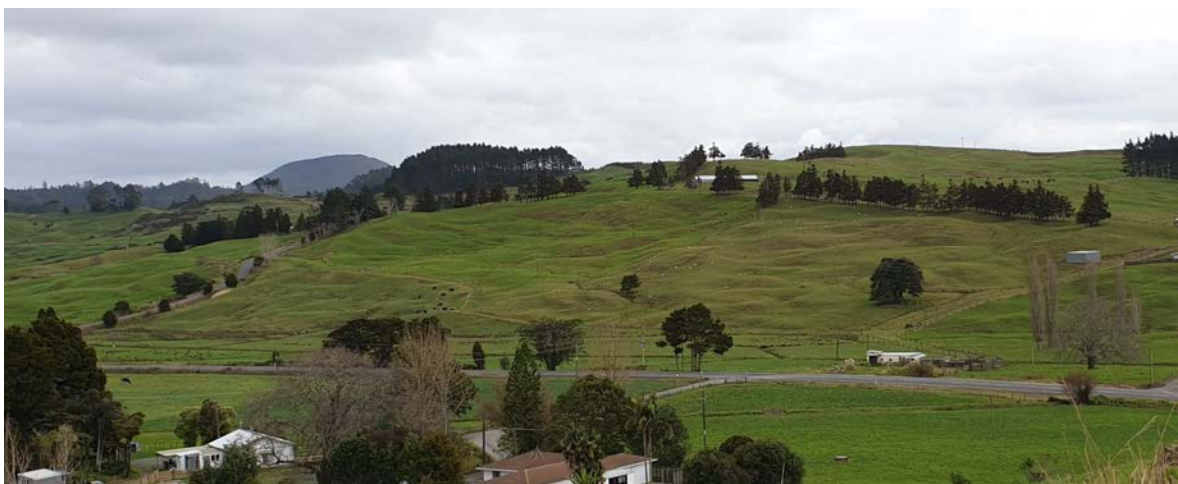
Photograph Appendix C.15: Mapped landslide on a slope underlain by Northland Allochthon soils.
