**RE: Wastewater Disposal Field Geotechnical Assessment - Corner SH1 and Port Marsden Highway, Ruakaka,**  
**(Our Reference: 16234.000.000\_03)**

## 1 Introduction

<b>Date</b>	Nov-19	<b>Client</b>	SK Aotearoa Trust	
<b>Drawn by</b>	BF	<b>Project</b>	Corner SH1 and Port Marsden Highway, Whangarei	
<b>Approved by</b>	HL	<b>Description</b>	Investigation Location Plan	
<b>Scale</b>	NTS	<b>Appendix:</b>	1	<b>Project Number</b> 16234.000.000

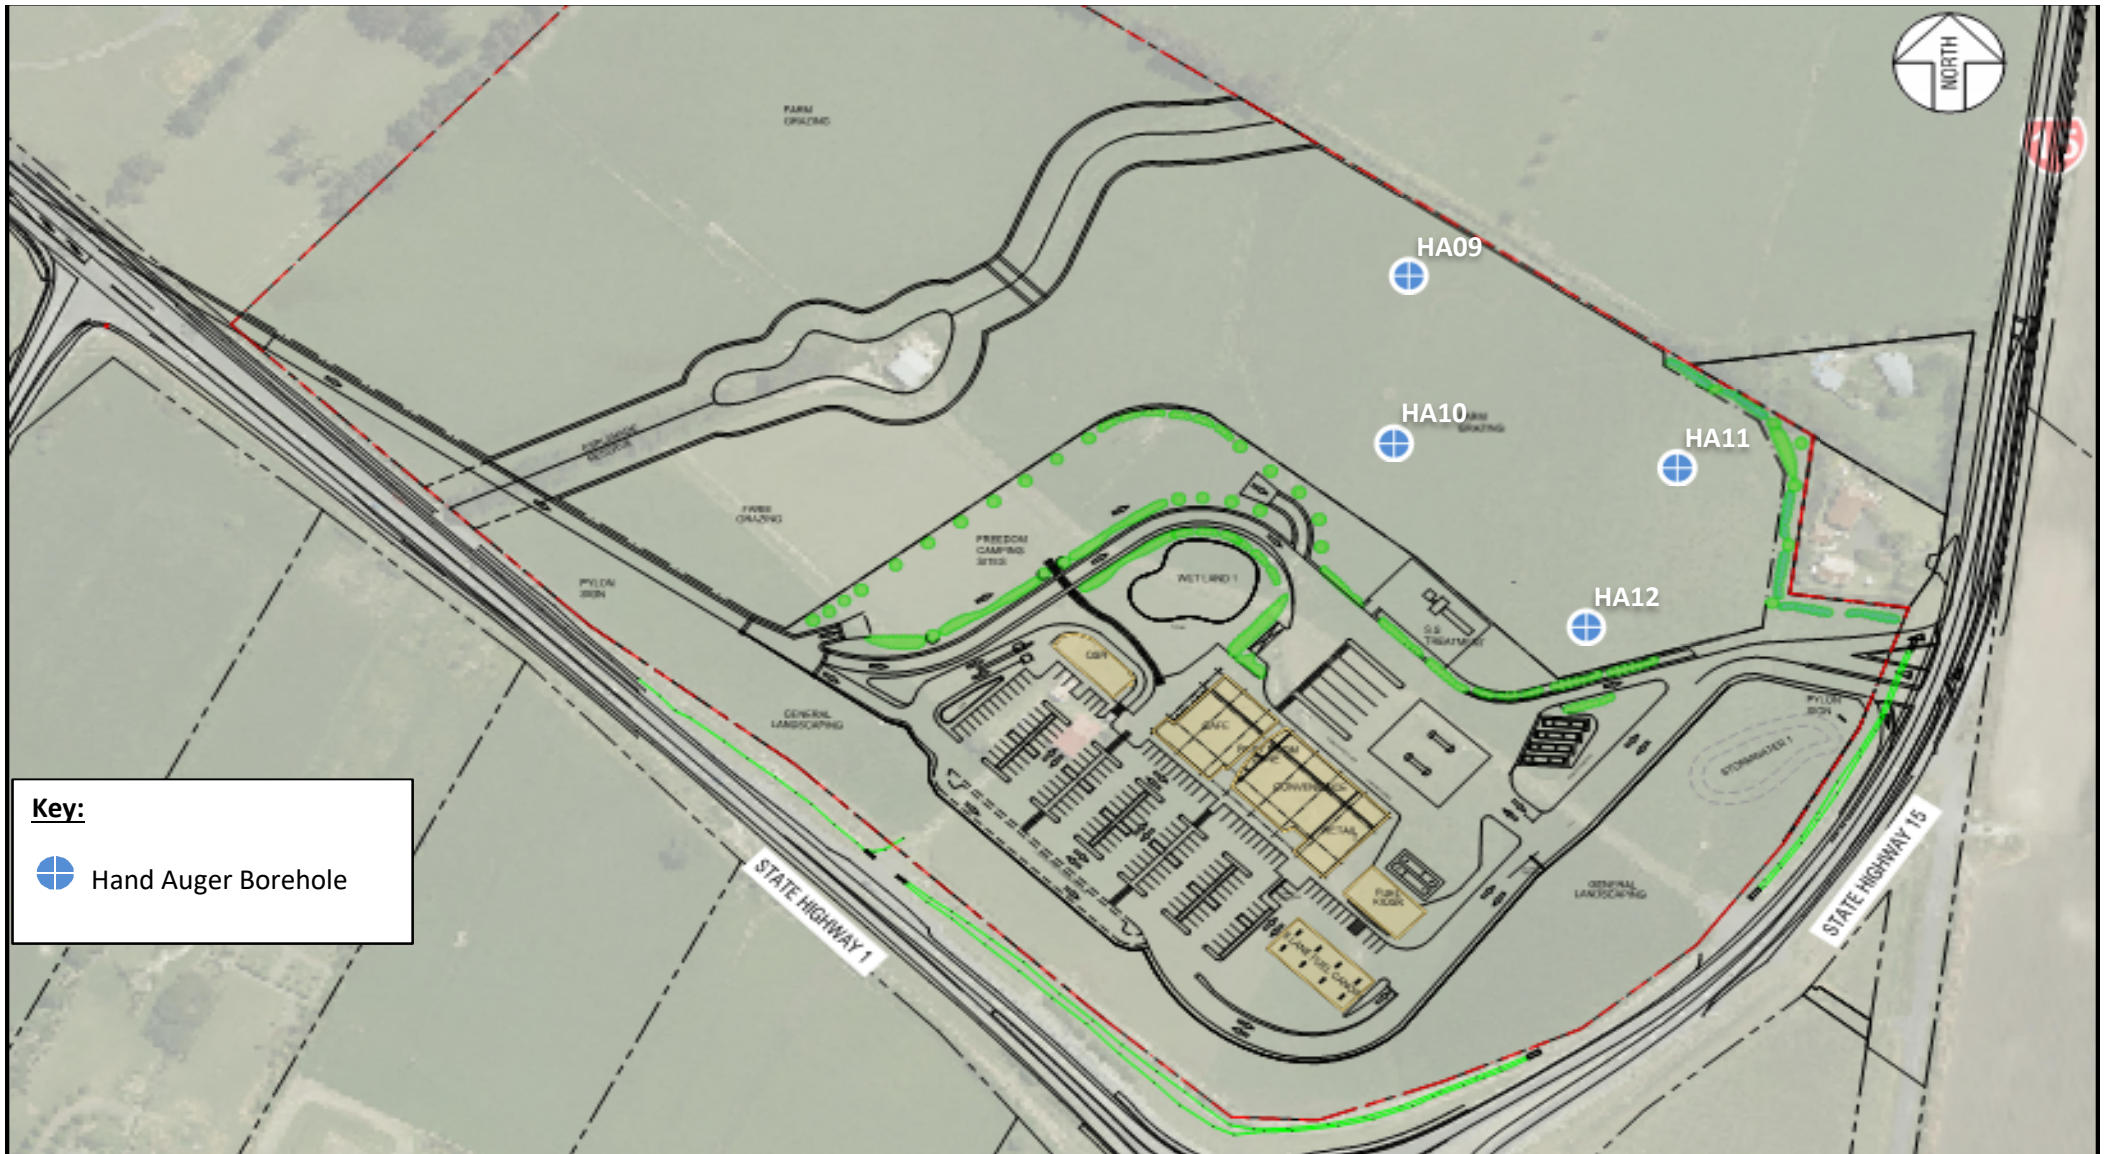
ENGEO visited the site on 29 October 2019 to drill four new hand auger boreholes within the footprint of the proposed wastewater disposal field. The locations of the boreholes are shown on the appended Investigation Location Plan.

Hand Auger Borehole
